Research Vessel Operators Committee El Faro accident

University of Rhode Island April 17-19 2018

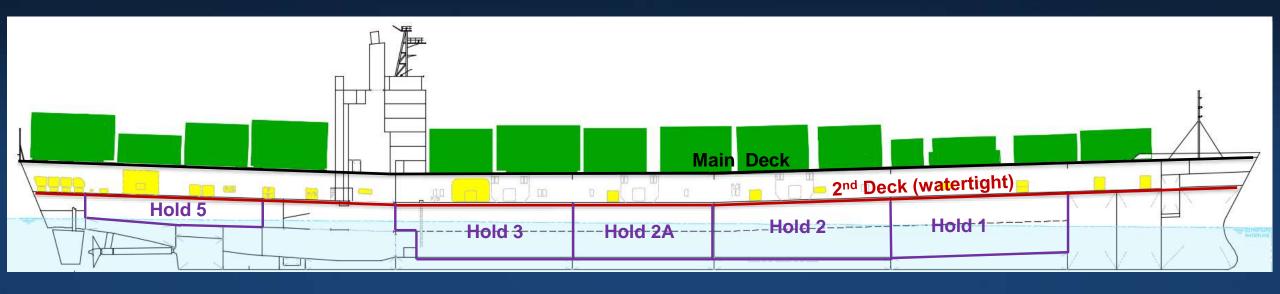
Watertight Deck

- Boarding seas (green water) was known to enter onto 2nd deck in past
- Partially enclosed 2nd deck was watertight

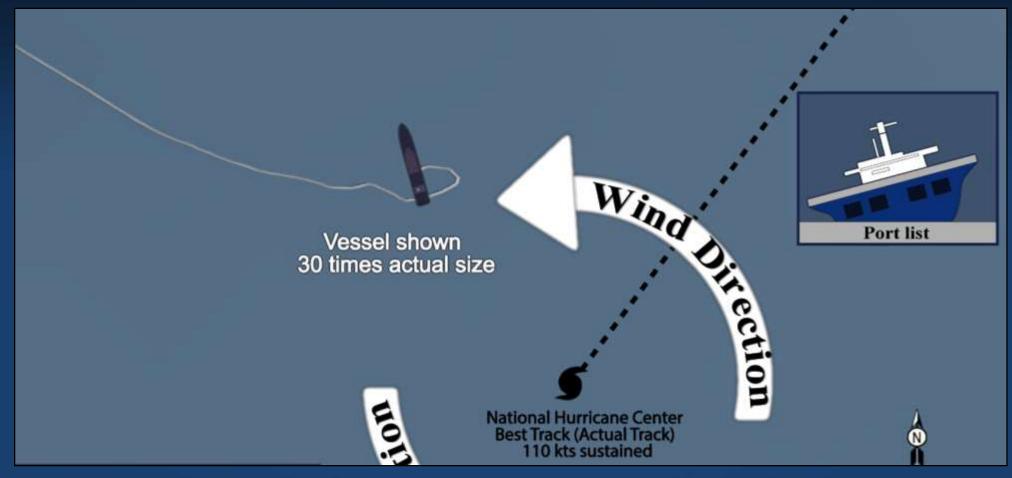
Extreme list to port

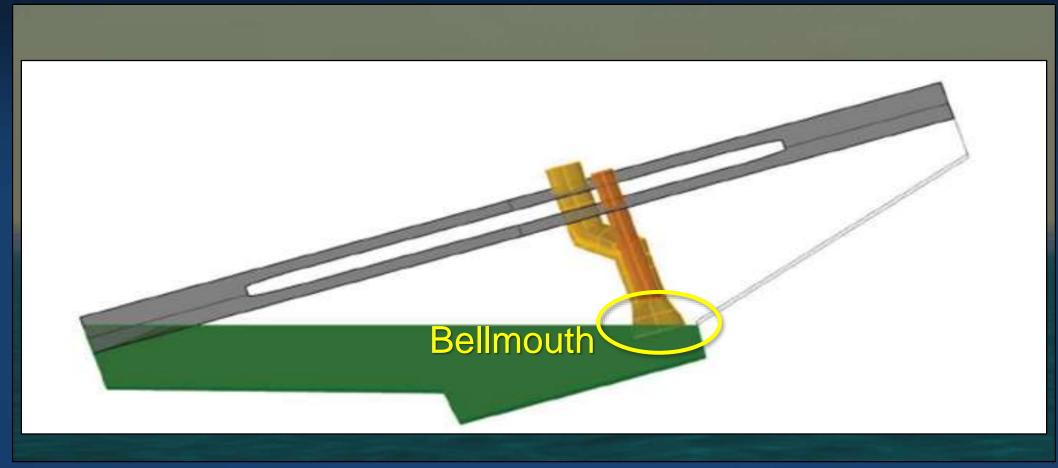
18° list to port – looking forward

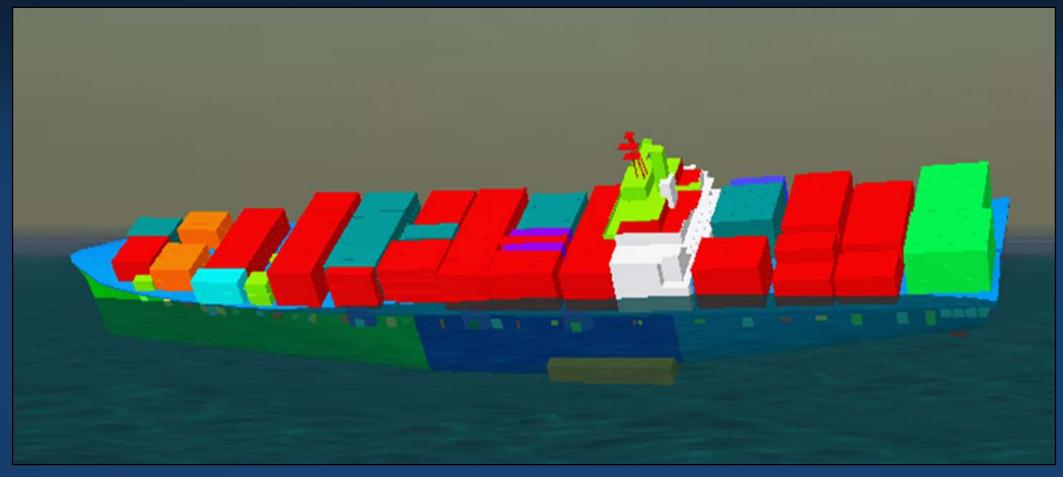
Extreme list to port

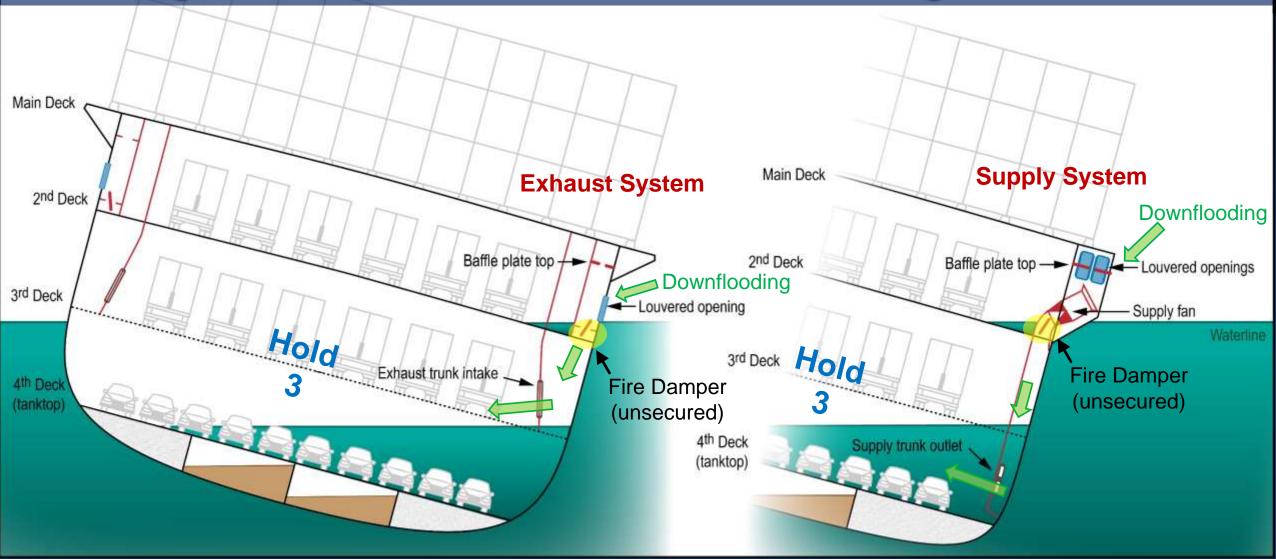
Cargo Hold Ventilation Downflooding
