*R/V THOMAS G. THOMPSON (AGOR-23)*

LINGERING ISSUES FROM MID-LIFE

UNOLS – FIC - 20 NOV 2019

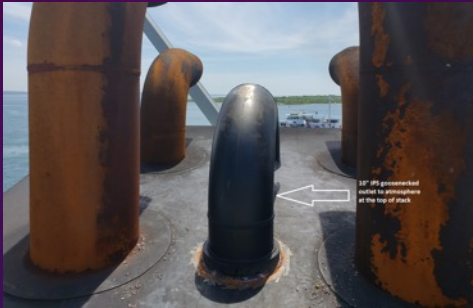
- The Cat valve failures in Aug 2018 and Feb 2019 caused the delay of one cruise and the cancellation of a second. Total lost science time was estimated at \$1.96M
- Cat concluded that valve failures were due to “closed crankcase ventilation” (CCV) setup of new engines = reingestion of crankcase vapors into engine

- Higher sulfur fuel (still commonly and only thing available in some countries) believed to contribute
- Solution was to route CV to atmosphere. Excellent help from WHOI shop service to complete (June 2019)

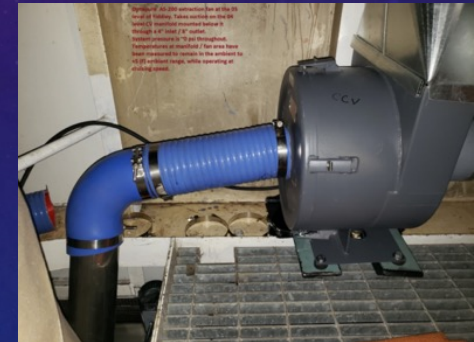
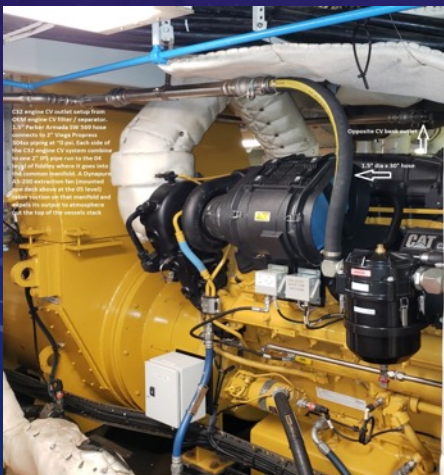
- Required USCG approval due to air emissions concerns – EPA compliance (IAPP) and types of material used
- Still awaiting final approval of installation materials as permanent from USCG Marine Safety Center
- Additional inspections of valves in drydock 2020

**Engines performing well since CV routing to atmosphere**
