NDSF Facility Update

NDSF NATIONAL
DEEP SUBMERGENCE
FACILITY

DSV Alvin

Root Cause Evaluation

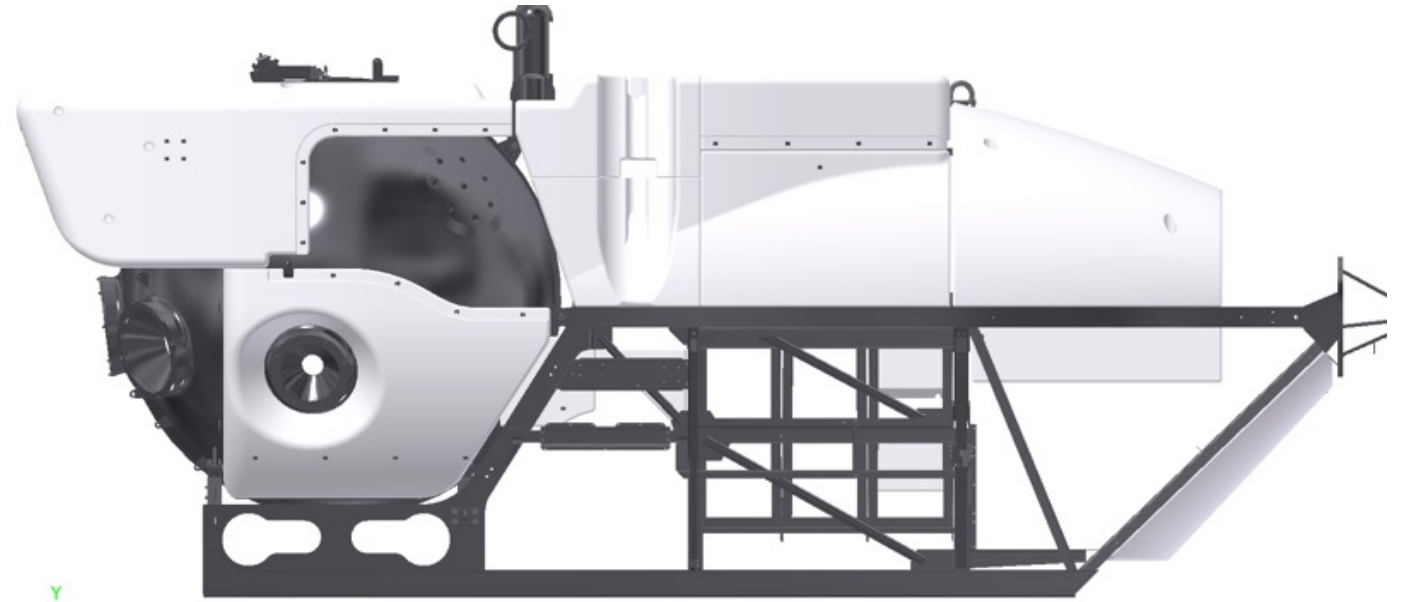
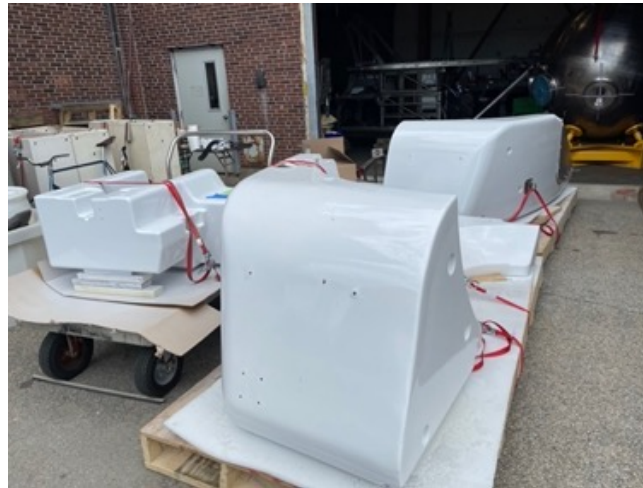
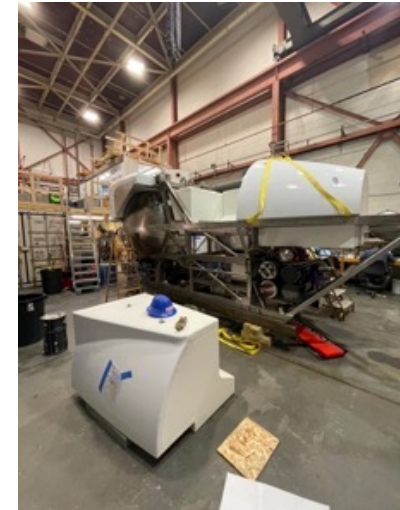
| 11/11/21 | First foam crack identified (Dive 5074) |
| 11/13/21 | Additional foam cracks identified (Dive 5075) |

- 20 individual pieces
- 10 pieces are either new or modified during most recent overhaul
- 1/3 of the total weight of Alvin is syntactic foam
- 332 cubic feet

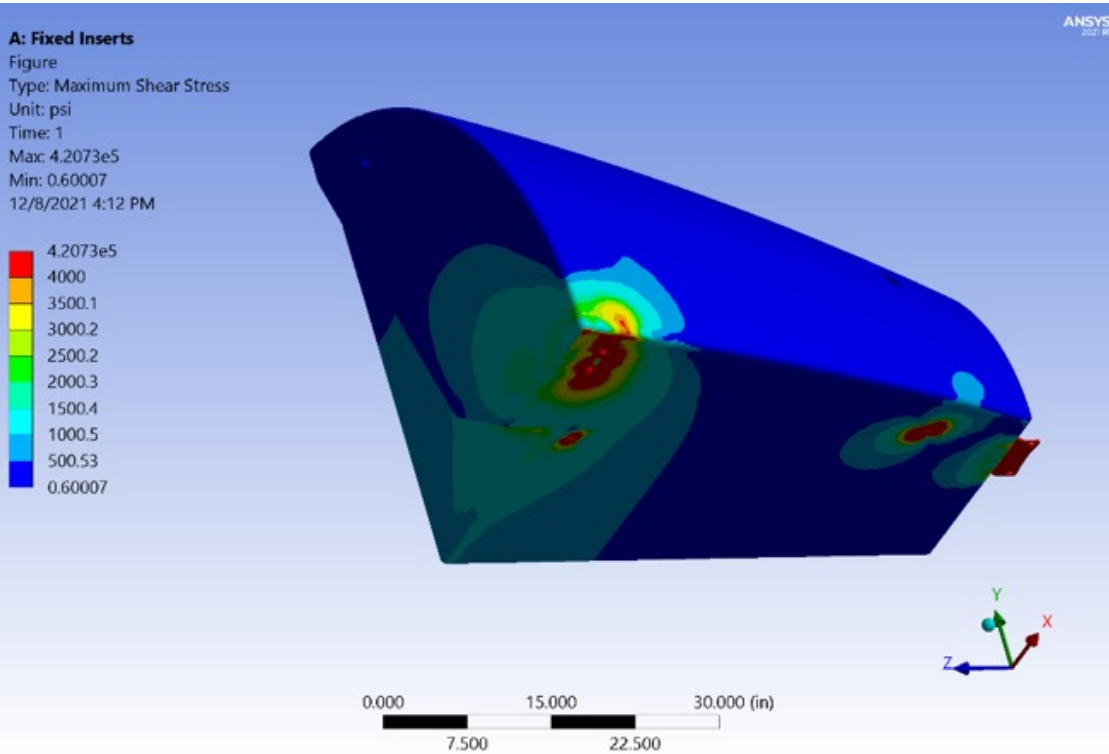
Shear Stress, existing

Non-uniform Loading of Syntactic Foam Material

Multiple fixed mounting points introduces shear stresses
Syntactic foam has limited tolerance for shear stress

- Shear >4000 psi at forward inserts extends around block corner
- Shear >2000 psi seen in extended area

High stresses are indicated in area where damage has occurred

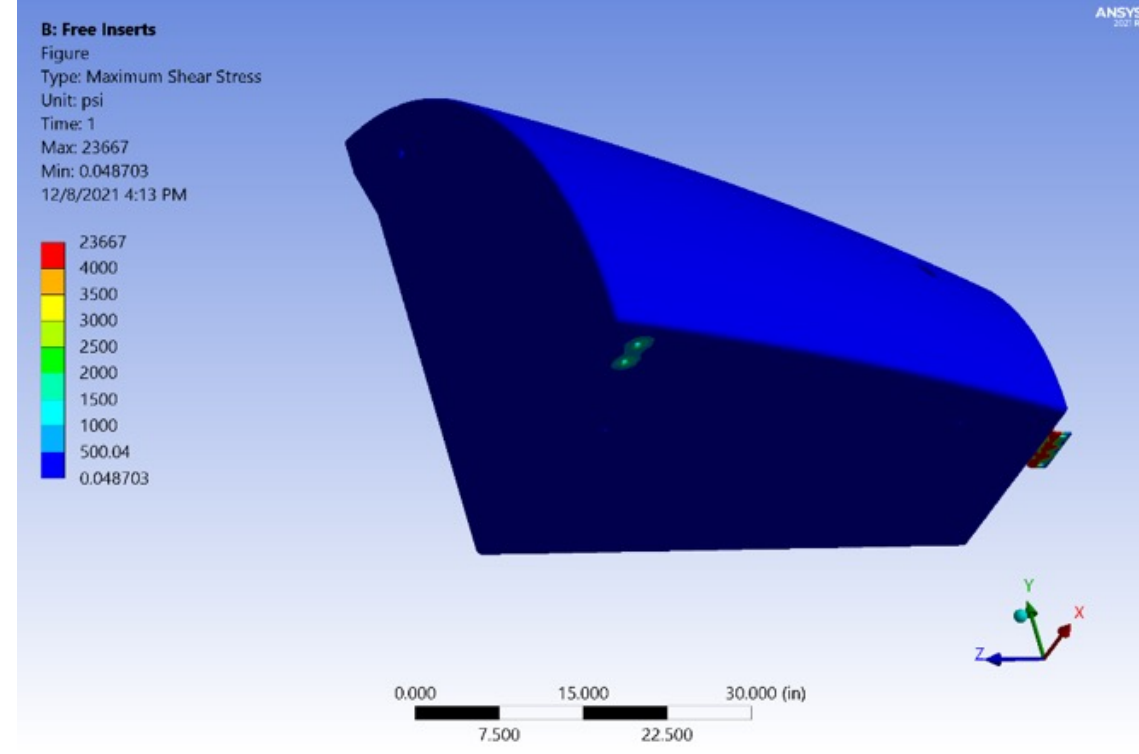
Shear Stress, modified

- Areas of high shear stress eliminated

Corrective Actions

- Choose fixed point for blocks to “shrink” towards and modify all other attachment locations to provide necessary D.O.F
- Similar design concepts used in most locations
 - ✓ Slide bearings
 - ✓ Tie-Rod springs/counterbores
 - ✓ Removing redundant fasteners

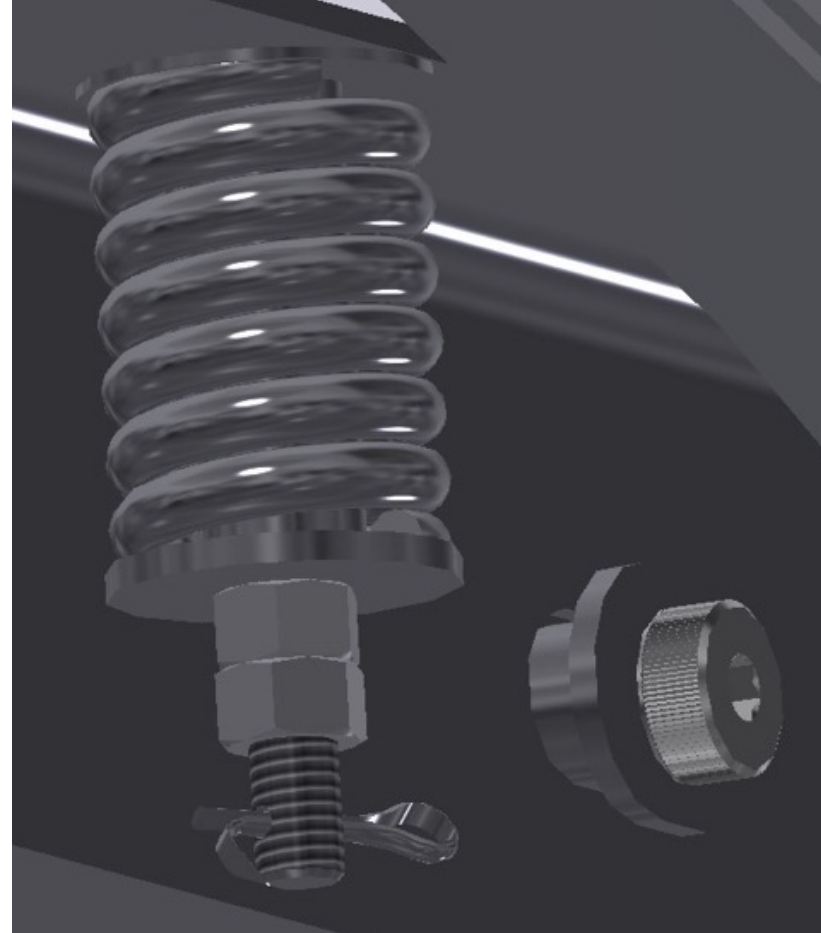
Syntactic Mounting Modifications

Tie Rod w/Spring

- Reduces tie-rod 'slack' and overloading at attachment points
- Transfers buoyancy forces and accelerations to the frame

Shoulder Bolt w/Bearing

- Combines slot and shoulder bolt for 1-2 degree of freedom)
- Reduces stress to acceptable levels
