ROSENSTIEL SCHOOL of MARINE & ATMOSPHERIC SCIENCE

SWAB REPORT # 1005

SWAB DATE: 7 July 2021

R/V Endeavor

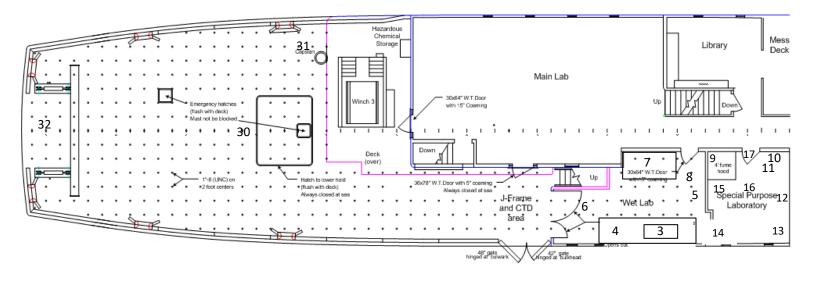
Figure 1 SWAB # 1005 7 July 2021

Sample # Sample Identification	³ H dp	³ H dpm/m ²			¹⁴ C dpm/m ²		
	activity		error	activity		error	
1 1st Vial Bkgnd	0	\pm	0	0	土	0	
2 Initial bucket blank	-18	\pm	33	28	\pm	37	
Wet Lab (Figure 1)							
3 Sink area	-15	\pm	43	23	\pm	37	
4 Starboard benchtop aft of sink	-31	\pm	59	19	\pm	39	
5 Inside shelf of hood/sink	4	\pm	24	10	\pm	35	
6 Deck inside aft entrance	24	\pm	45	6	\pm	29	
7 Port benchtop	112	\pm	53	19	\pm	27	
8 Deck inside port entrance	3	\pm	17	12	\pm	35	
Special Purpose Lab (Figure 1)							
9 Inside fume hood	-13	\pm	39	18	\pm	37	
10 Top of Kenmore freezer	2	\pm	8	18	\pm	35	
11 Benchtop opposite of Kenmore freezer	315	\pm	67	14	\pm	16	
12 Forward benchtop	-42	\pm	82	19	\pm	40	
13 Starboard sink area	8	\pm	23	19	\pm	35	
14 Starboard benchtop adjacent to -80°C freezer	13	\pm	36	10	\pm	33	
15 Inside Thermo refrigerator	1	\pm	6	13	\pm	35	
16 Deck between forward benchtop and refrigerator	-21	\pm	40	15	\pm	38

Sample # Sample Identification		³ H dpm/m ²			¹⁴ C dpm/m ²		
		activity	(error	activity		error
Main Deck (Figure 1)							
30 Aft deck below Van door		2	\pm	9	22	\pm	36
31 Aft deck where incubator stood		2	\pm	31	3	\pm	34
32 Aft deck under A-frame		-28	土	53	18	±	39
01 Deck and Upper Lab (Figue 3)							
33 Starboard aft benchtop		-21	\pm	40	42	\pm	38
34 Deck inside aft entrance		-52	\pm	103	34	\pm	40
35 Deck at bottom of stairs to bridge		-36	\pm	71	-5	\pm	32
36 Deck aft of Electronic Repair Shop		-38	\pm	74	7	\pm	49
37 Center benchtop		24	\pm	48	5	\pm	28
38 Final bucket blank		-22	\pm	42	14	\pm	39

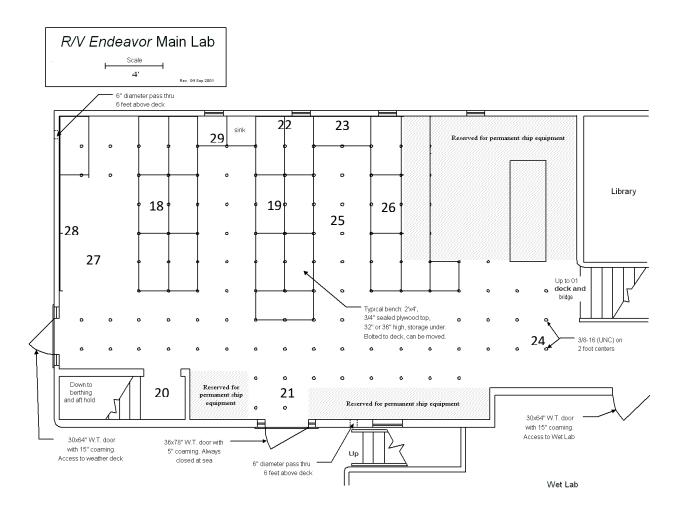
Figure 2 SWAB #1005 7 July 2021

17 Deck inside entrance	15	\pm	36	14	\pm	34	
Main Lab (Figure 2)							
18 Aft center benchtop	-9	\pm	50	37	\pm	37	
19 Mid center benchtop	-8	\pm	20	9	\pm	37	
20 Deck at top of stairs to living quarters	7	\pm	19	27	\pm	36	
21 Deck inside starboard entrance	-7	\pm	19	10	\pm	37	
22 Inside Laminar Flow Hood - benchtop	0	\pm	3	6	\pm	35	
23 Port benchtop	-42	\pm	83	42	\pm	39	
24 Deck at forward entrance	-59	\pm	28	11	\pm	49	
25 Deck between middle & forward benches	-62	\pm	29	13	\pm	47	
26 Forward center benchtop	8	\pm	80	-6	\pm	37	
27 Deck in front of aft sink	-32	土	63	18	土	39	
28 Aft sink area	20	土	37	22	土	34	
29 Port sink area	6	土	103	-6	土	38
