Woods Hole Oceanographic Institution

R/V Atlantis Bow Thruster Issue

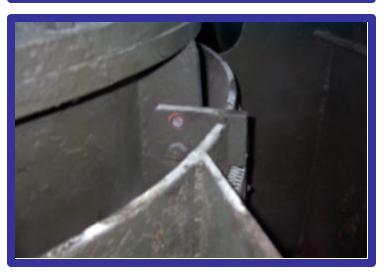
- Replaced 3 of 4 bolts that backed out from anti-torque plates after maintenance in Jacksonville.
- Specs required bolts to be tack welded (they were not).
- Repairs required drydocking in Mar 2003.
- Only available dry dock was Grand Bahama Ship in Freeport, Grand Bahamas.
- 10 day delay (7 going in & 3 coming out) encountered due to availability of dry dock.
- •Claim has been filed against Atlantic Dry Dock Corp to recover costs & loss of 6 science days.
