Healy Multibeam Options

Summer '03 Underhull Status

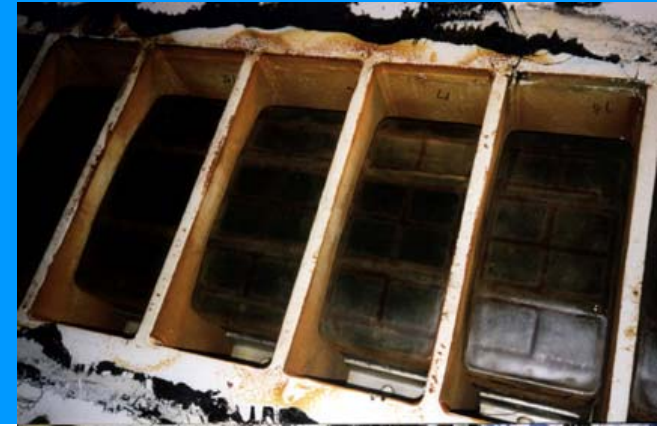
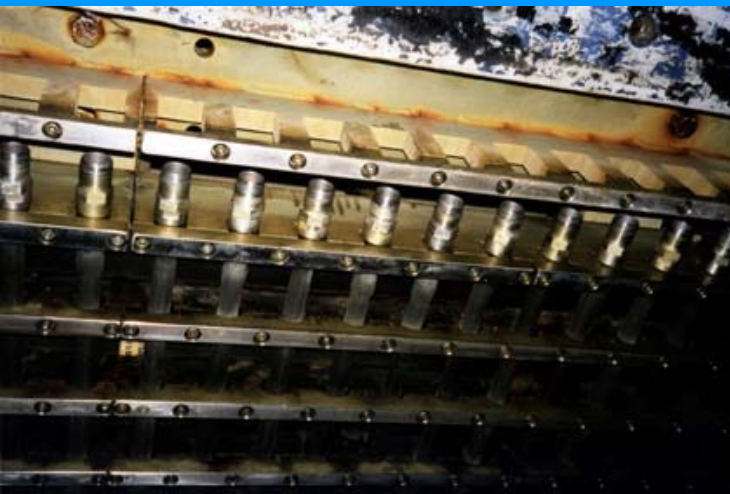
- At least 17 failed hydrophones (found annual check)
 - Probably happened during HLY02 or DF03
- Multibeam and subbottom profiler head tanks non-functional
- Remedial effort in a few weeks
- Must understand the failure mode(s)
- Possible failure modes:
 - Manufacturing failure
 - Window strength
 - Exceptional event
 - ?
- Need post remedial evaluation

- Replace failed hydrophones/cables
- Check hydrophones, projectors and cables
- Check window (replace if necessary)
- Evaluate failure mode(s)
- Fix multibeam head tank system
- Fix subbottom profiler head tank system
- Offset survey
