MVP

Circumstances of Loss

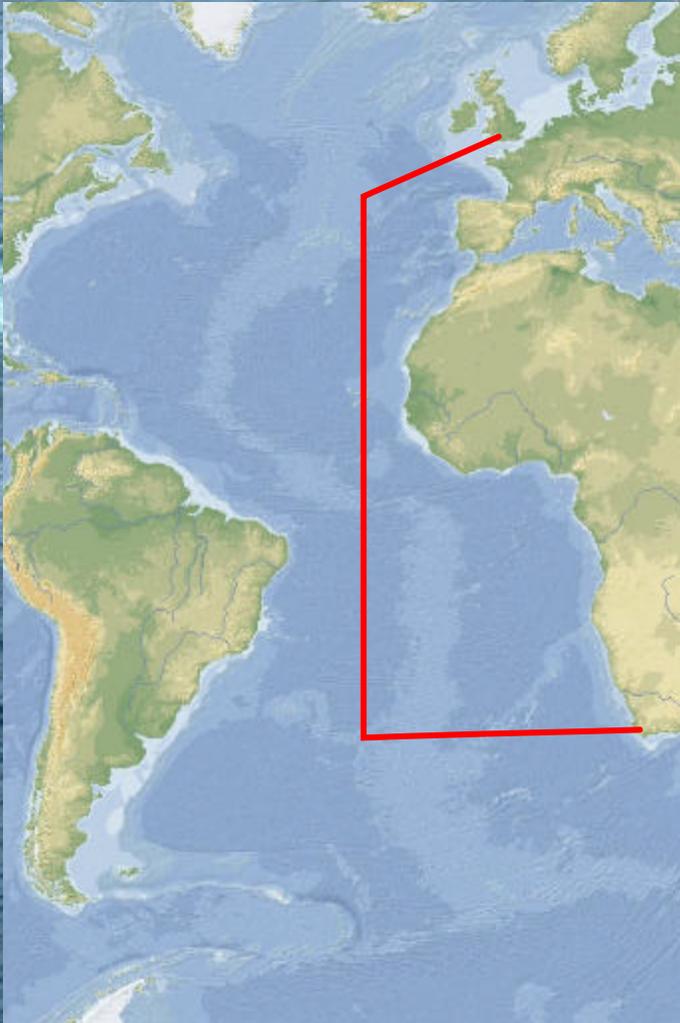
- Discovery 284 – Atlantic Meridional Transect 14
- 1830 - Deployed over the side
- 2100 - Profiling automatically. Behaving well and giving good profiles.
- 0200 - Brought the fish to the surface for CTD station.
- 0400 - End of CTD station - set profiling again.
- 0445 – MVP left after watching casts closely, but being checked at 20 - 30 minute intervals
- 0550 – Emergency stop message noticed during a check. it was also immediately noticed that the wire was no longer leading aft out of the sheave and that the winch drum had lots of slack cable on it. The PC controller lost contact with the fish at about 0535) when the fish was at 180m on it's downwards profile. Coincidentally this was when the ship took a violent roll which shifted unsecured gear around the ship.

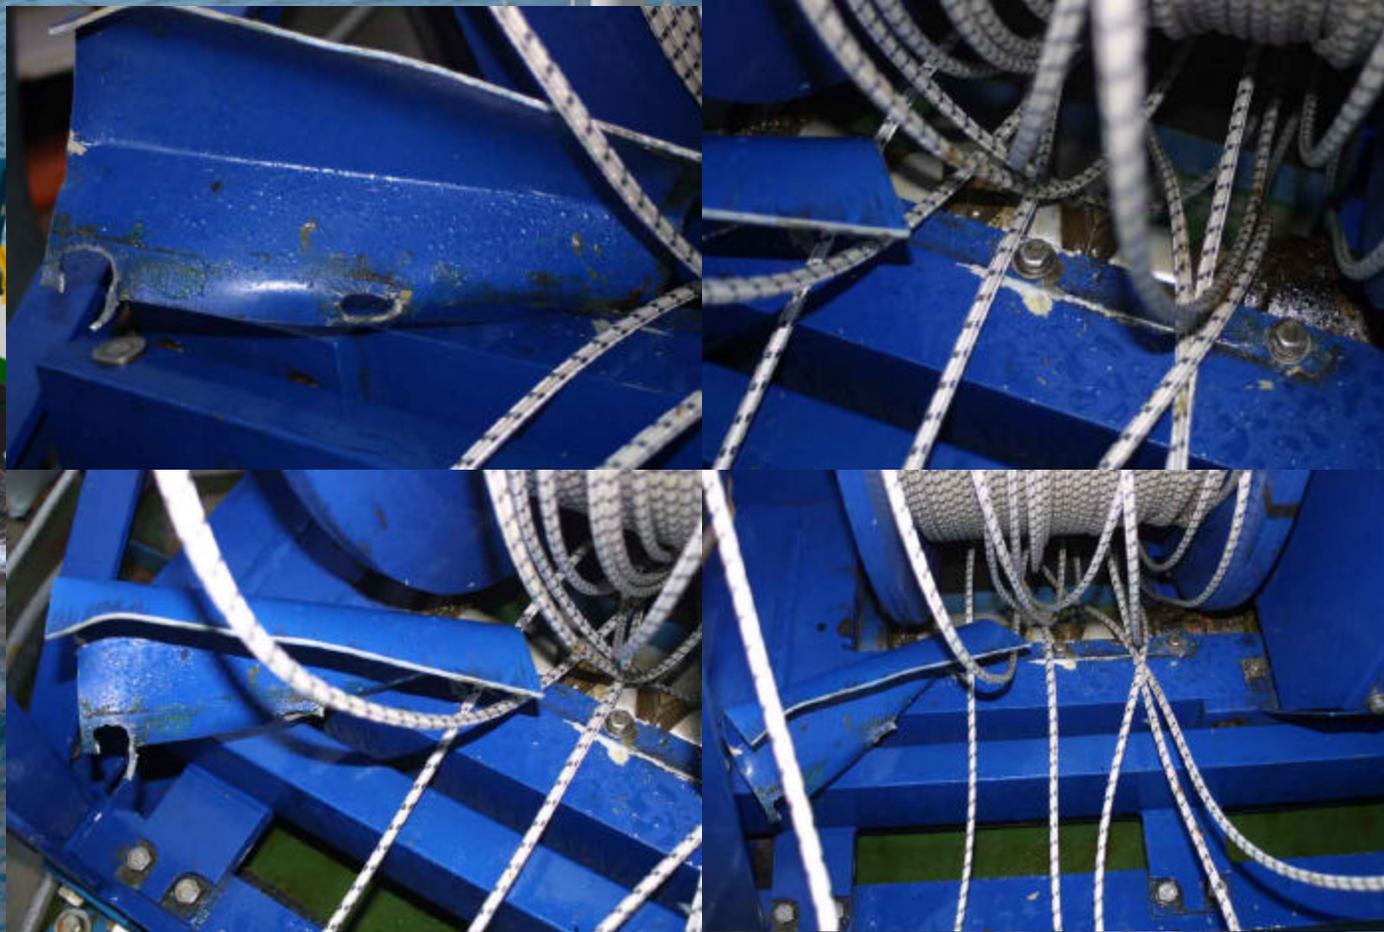
Damage to Guard

- BOT - "Our conclusion is that with the rough sea state the cable became slack and caught on the "traversing shaft guard". The guard should not allow this to happen and may have been bent or out of position. This interaction allowed the cable to essentially destroy the guard and cut the cable which then parted."
- The techs who mobilised the equipment are naturally adamant that the guard was not bent or out of position.
- We therefore do not positively know what caused this incident, but:
- The violent roll seems too coincidental, and we must consider that perhaps the equipment is more sea-state limited than we understood.
