# Western Flyer Grounding Report

RVOC – April 2008

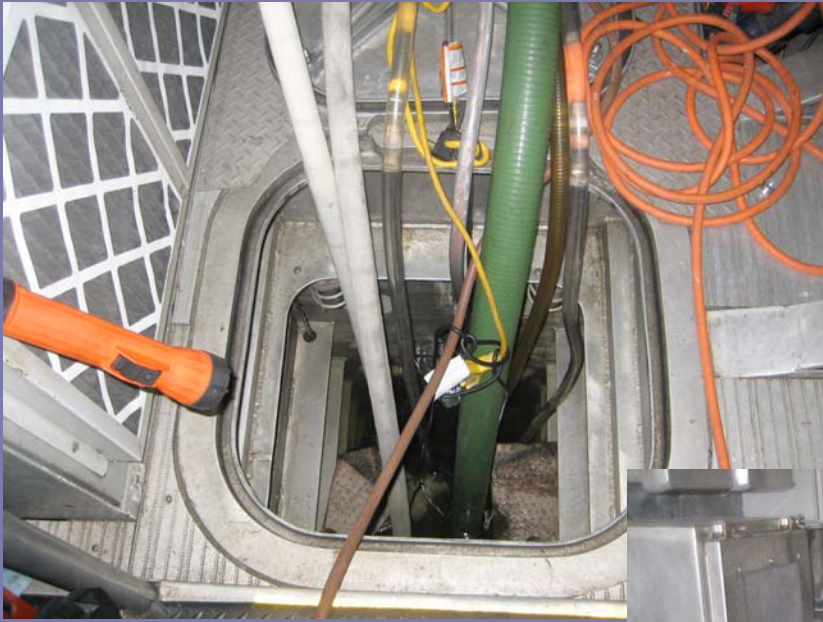
Can't have enough portable pumps

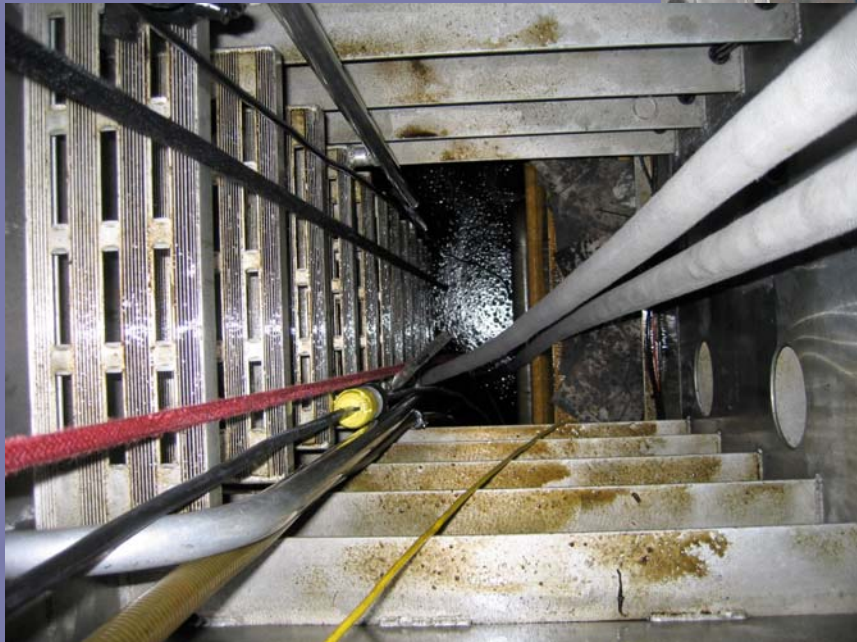
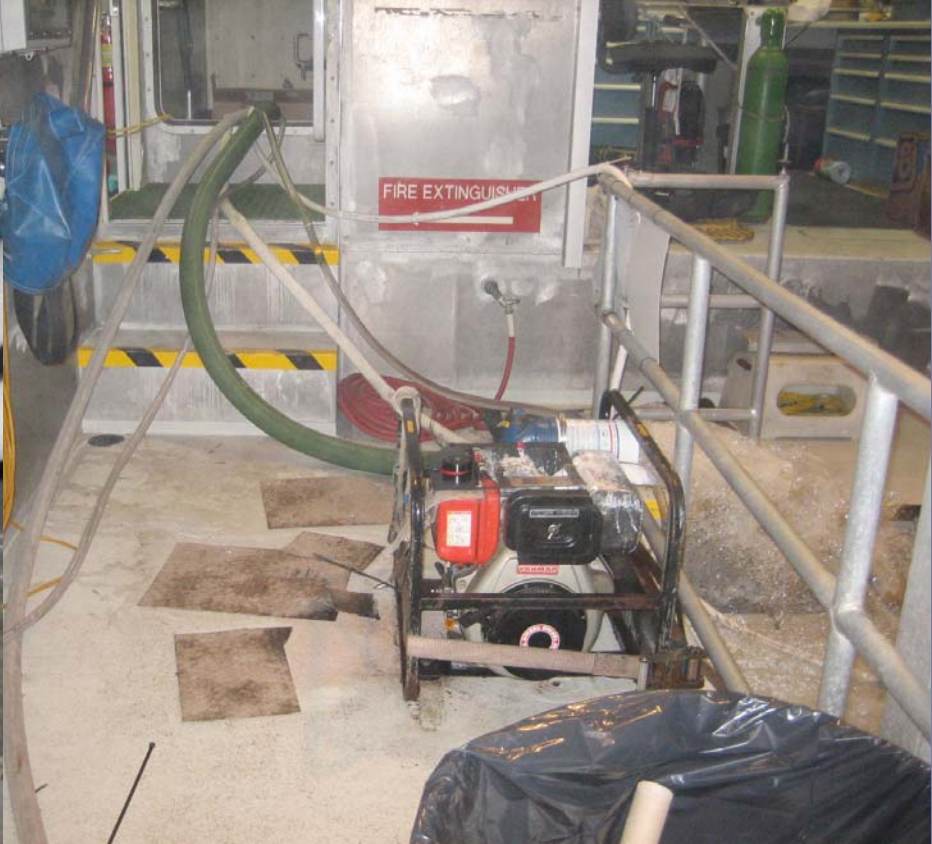
# Cat 3512 space

- Flooding of a Cat 3512 engine compartment
- 43 hours on the shoal
- Nearby vessels supplied diesel de-watering pump.
- Redirected MBARI R/V Zephyr to assist (7hr eta)
- Mexican Coast Guard boarded vessel with 4 crew.  
( independent communications to Port Captain)
