CTD Troubleshooting

Examples and Suggestions for Identifying and Solving *SBE911plus* Problems

Dave Murphy, SeaBird Director of Science,
Marshall Swartz, WHOI Physical
Oceanography Dept.

Nov 17, 2011 for RVTEC 2011

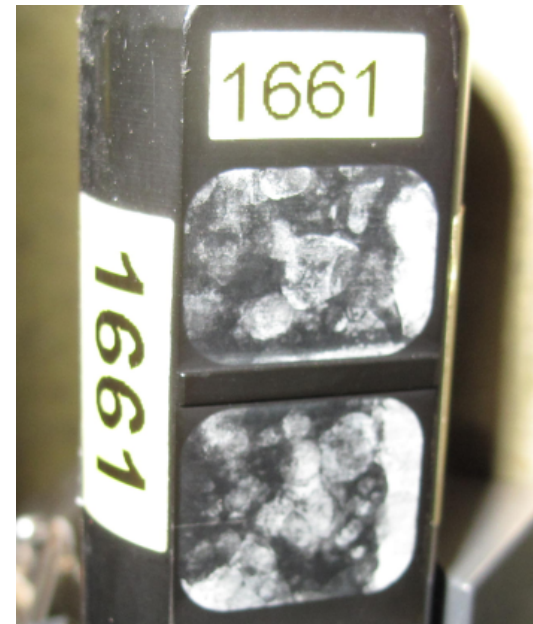
- Used on rosettes and towcam.
- Earlier 2-piece design prone to moisture damage. Look for seam on case. Rx: none- must replace.
- Failure of voltage output most common issue, 6x / 4 yrs. No warranty on these.
- Clouding of optical face on some (see photo). Rx: found car headlight lens restorer kit works well.

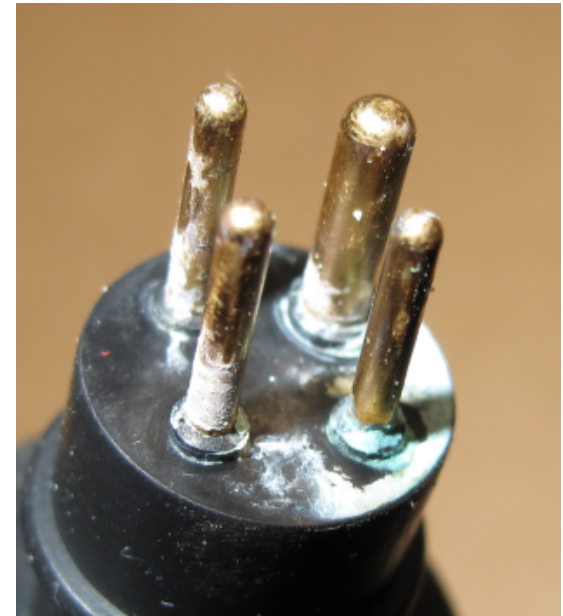
- Biggest issue with XSG/RMG connector systems is moisture failure at connector.
- Causes:
 - Moisture on connector before seating,
 - Inability to “burp” the connector properly,
 - Excessive or insufficient grease,
 - Loss of pliability of RMG due to cold or age embrittlement.
- Next biggest issue is pin bending or breakage due to misalignment.

- Always dry connectors before removing.
- If cold, warm with warm water or warm air.
- Always wipe clean both XSG and RMG after disconnecting, use isopropanol to clean if needed.
- Always inspect both sides before lubing.
- Lubricate XSG side *lightly* with DC4. Do NOT use silicone spray.
- Carefully orient, install and burp. Repeat, and install locking sleeve.

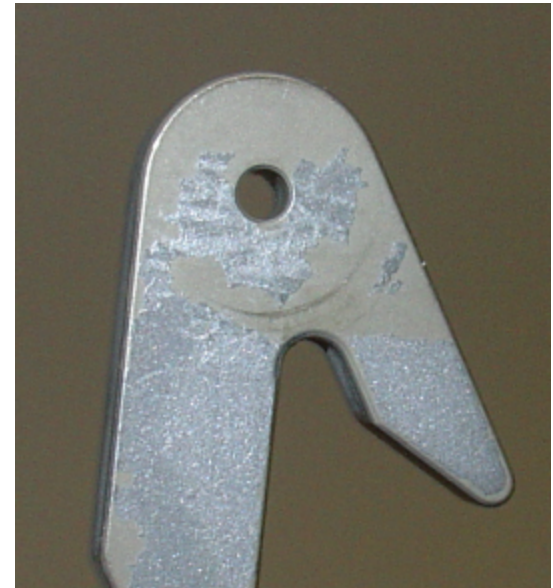
- Few issues, but most due to lack of rinsing and maintenance.
- Sticking release levers:
 - Dirt, armor rust flakes, bio-fouling.
 - Tiodizing failure, flaking and titanium exposure. (see to right->)
 - Bent lever arms.
- Bad lanyard geometry from bottle to lever.
- Solenoid damage from potting failure from corrosion.

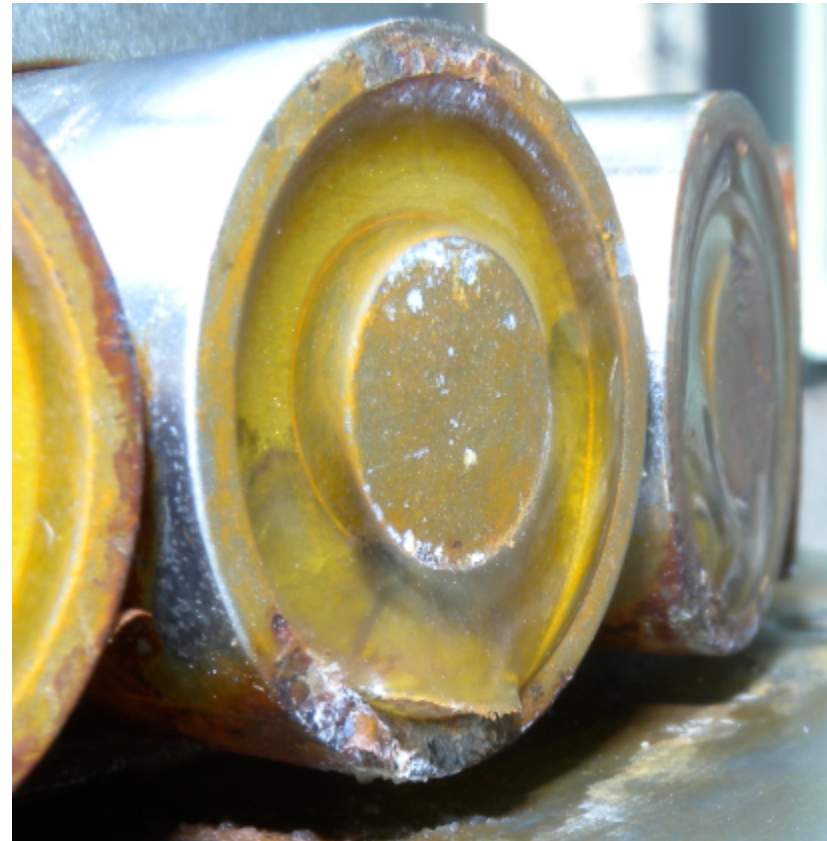
Solenoid corrosion

- Solenoid potting failure due to corrosion on inside perimeter of armature can allow moisture ingress into SBE32. Factory repair 5x/6yrs. One case caused flooding destruction of entire SBE32.

- First symptom may be erratic lever release.
- Rx:
 - Clean with high-pressure fresh water rinse after EVERY cast.
 - Weekly, remove release assembly and clean to SBE recommendations (placing in dishwasher hot wash cycle with NO detergent works well.)
 - Inspect solenoids weekly for corrosion, take pictures.
 - No field solution for corrosion. Return to SBE.
