RV KILO MOANA FLOODING CASUALTY, JANUARY 6, 2012

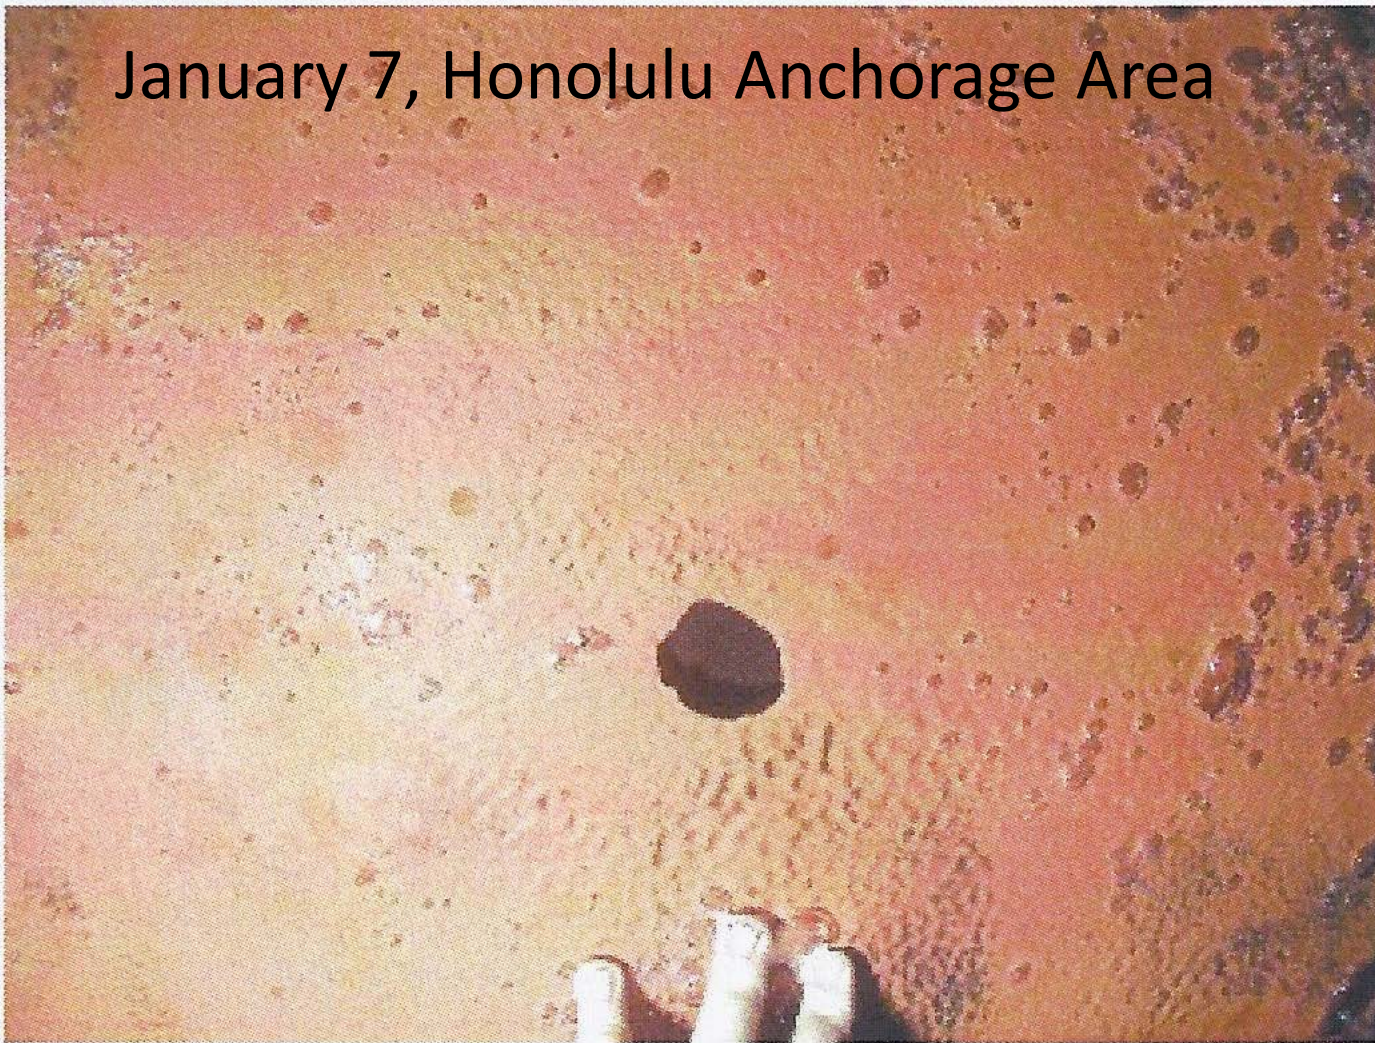
2. The hole as found.

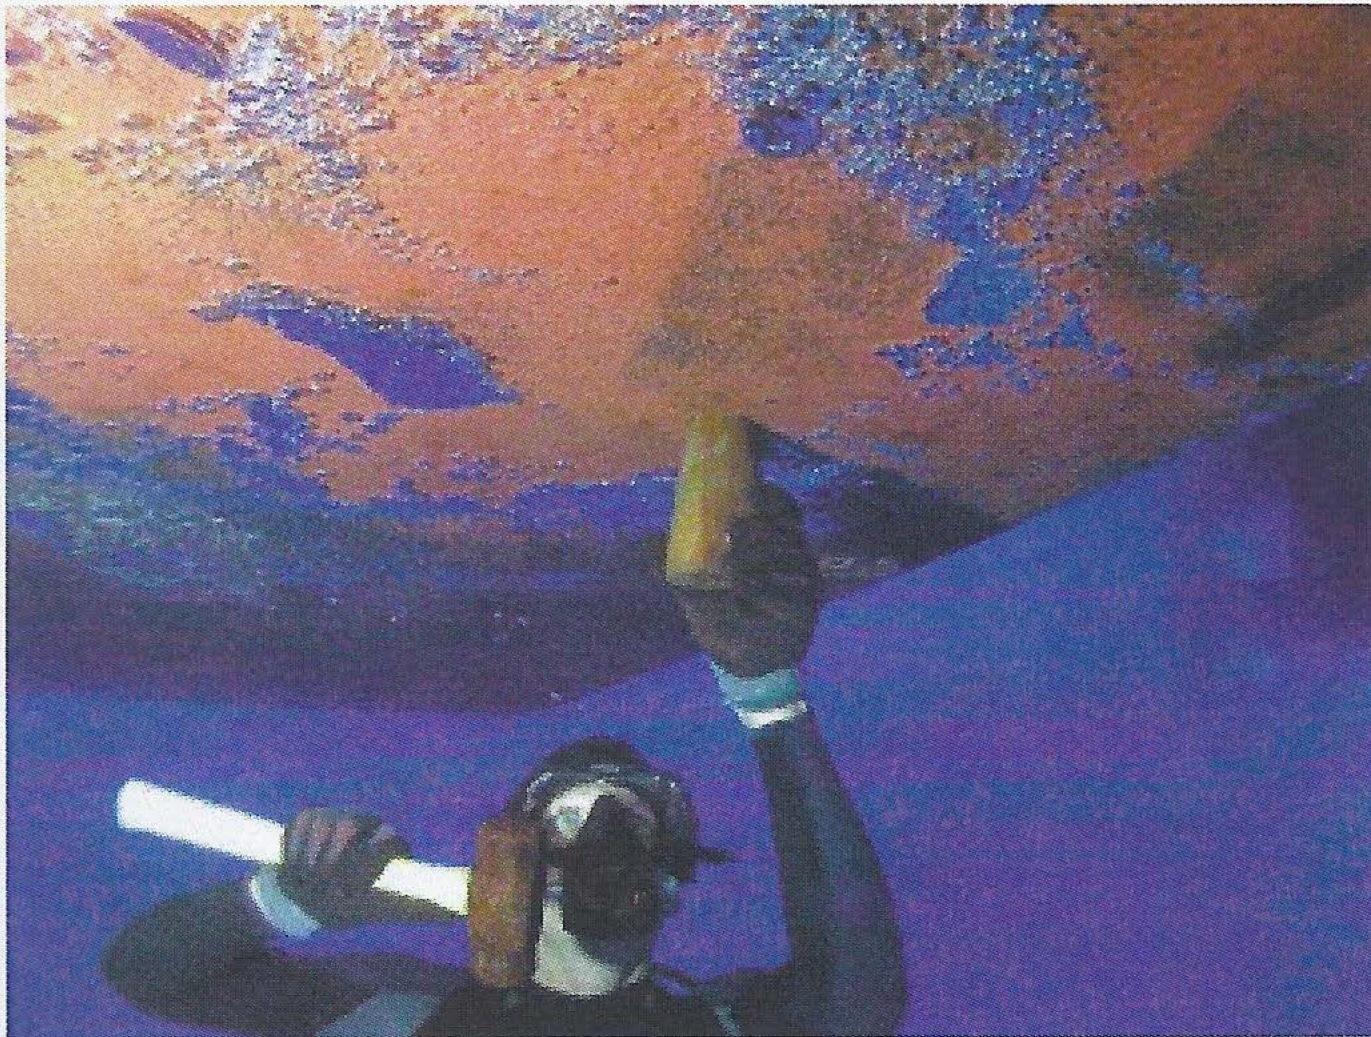
3. Installing the damage control plug. Point of view is looking aft (the port running gear is visible in the background).

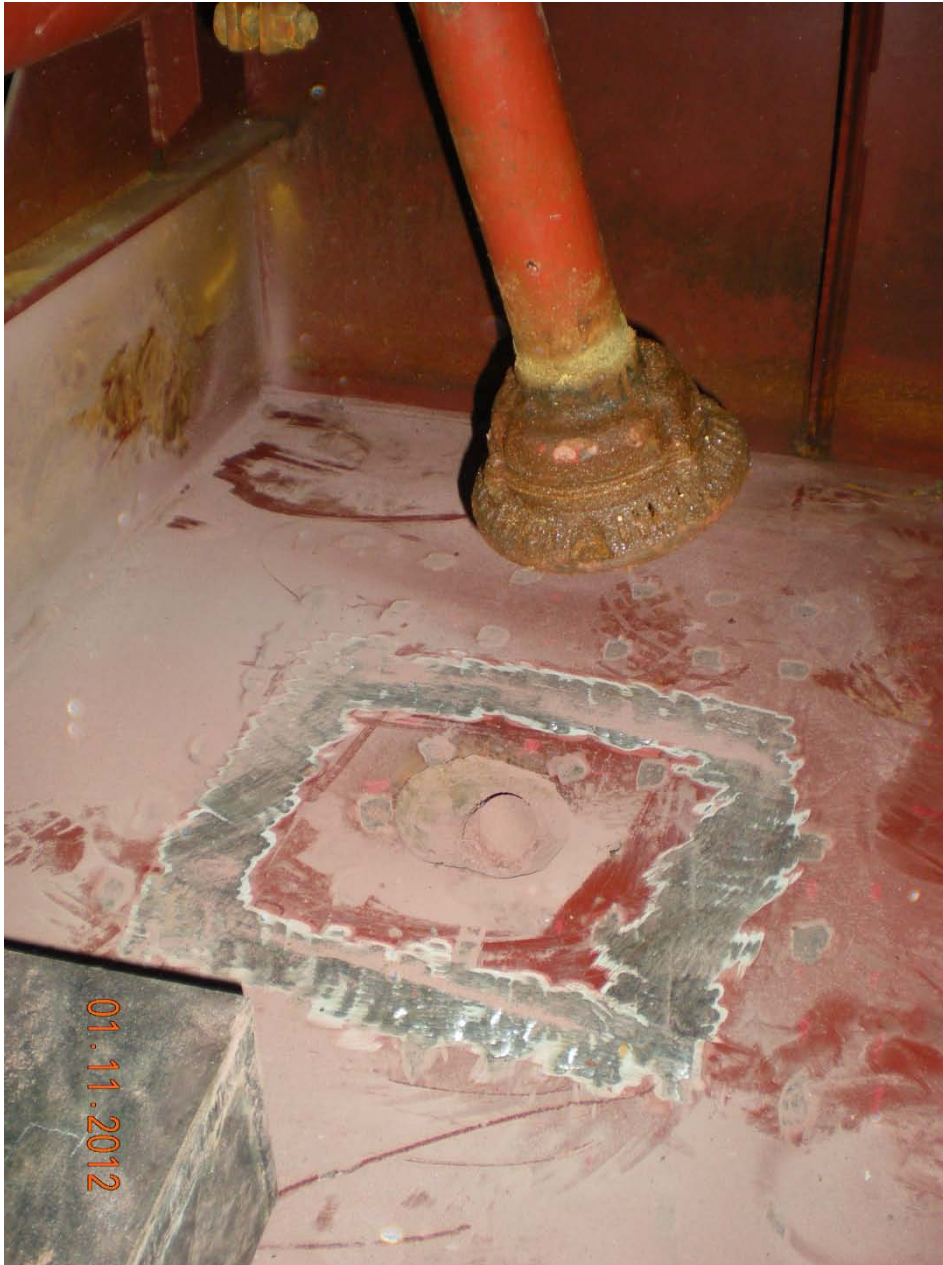
Bilge deck with suction foot valve removed. Note coffer dam and plug.

- Galvanic Corrosion
- Electric Cell During High Velocity Flow
- Erosion
- Stray Currents
- Other Sites, only slight pitting

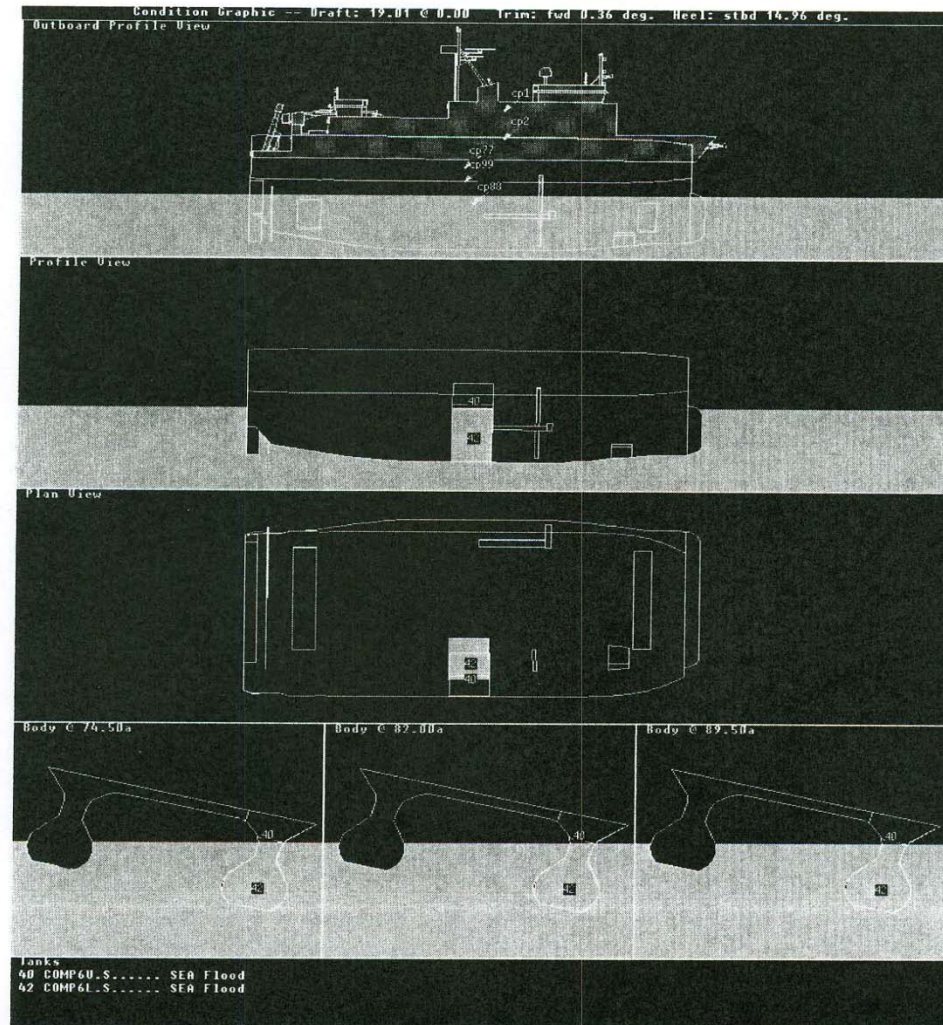
** DAMAGE:

1. MACHINERY ROOM NO.3 (S) FLOODED. (PERMEABILITY = 95%)
2. PUMP ROOM NO.1 & ACCESS (S) FLOODED. (PERMEABILITY = 95%)
