R/V Thompson Update

22 Oct 2012

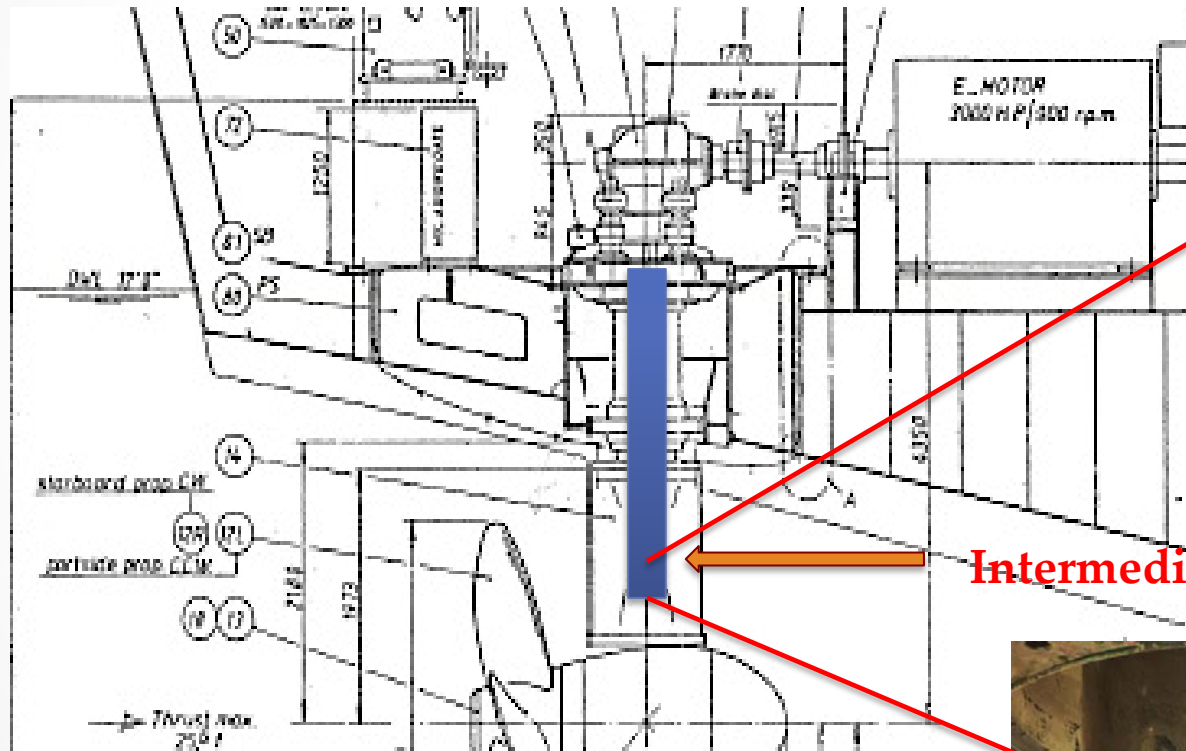
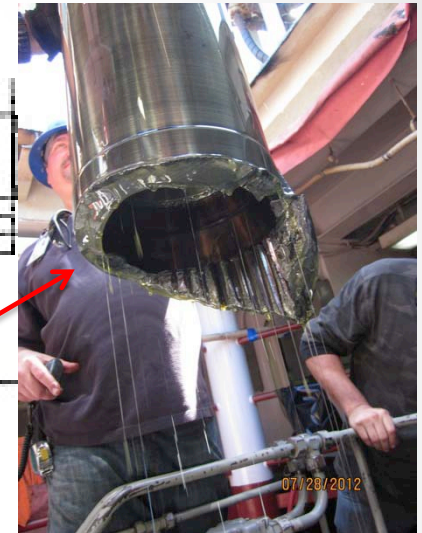
Z-drive Internal Arrangement & the Failure

- Failure occurred 23 July in Puget Sound during return to homeport from a science cruise
- In Dakota Creek Industries shipyard since 25 July – Anacortes, WA
- Expected return to service nlt 10 Jan 2013
- Cause: bent lower Z-drive resulted in high stress in the intermediate shaft lower coupling and eventually a low cycle fatigue failure
 - Independent analysis concludes that a “soft” strike (e.g. whale, water logged dead head) caused the bend to the lower Z-drive
- Cost: > \$1.5M
- Biggest schedule drivers:
 - long lead time for intermediate & vertical shafts, shank & steering pipe
 - late identification of the bent lower Z-drive problem
