# Pelagic Research Services

## Shallow Profiler Recovery on the OOI Cabled Array

## RSN Endurance Vertical Mooring

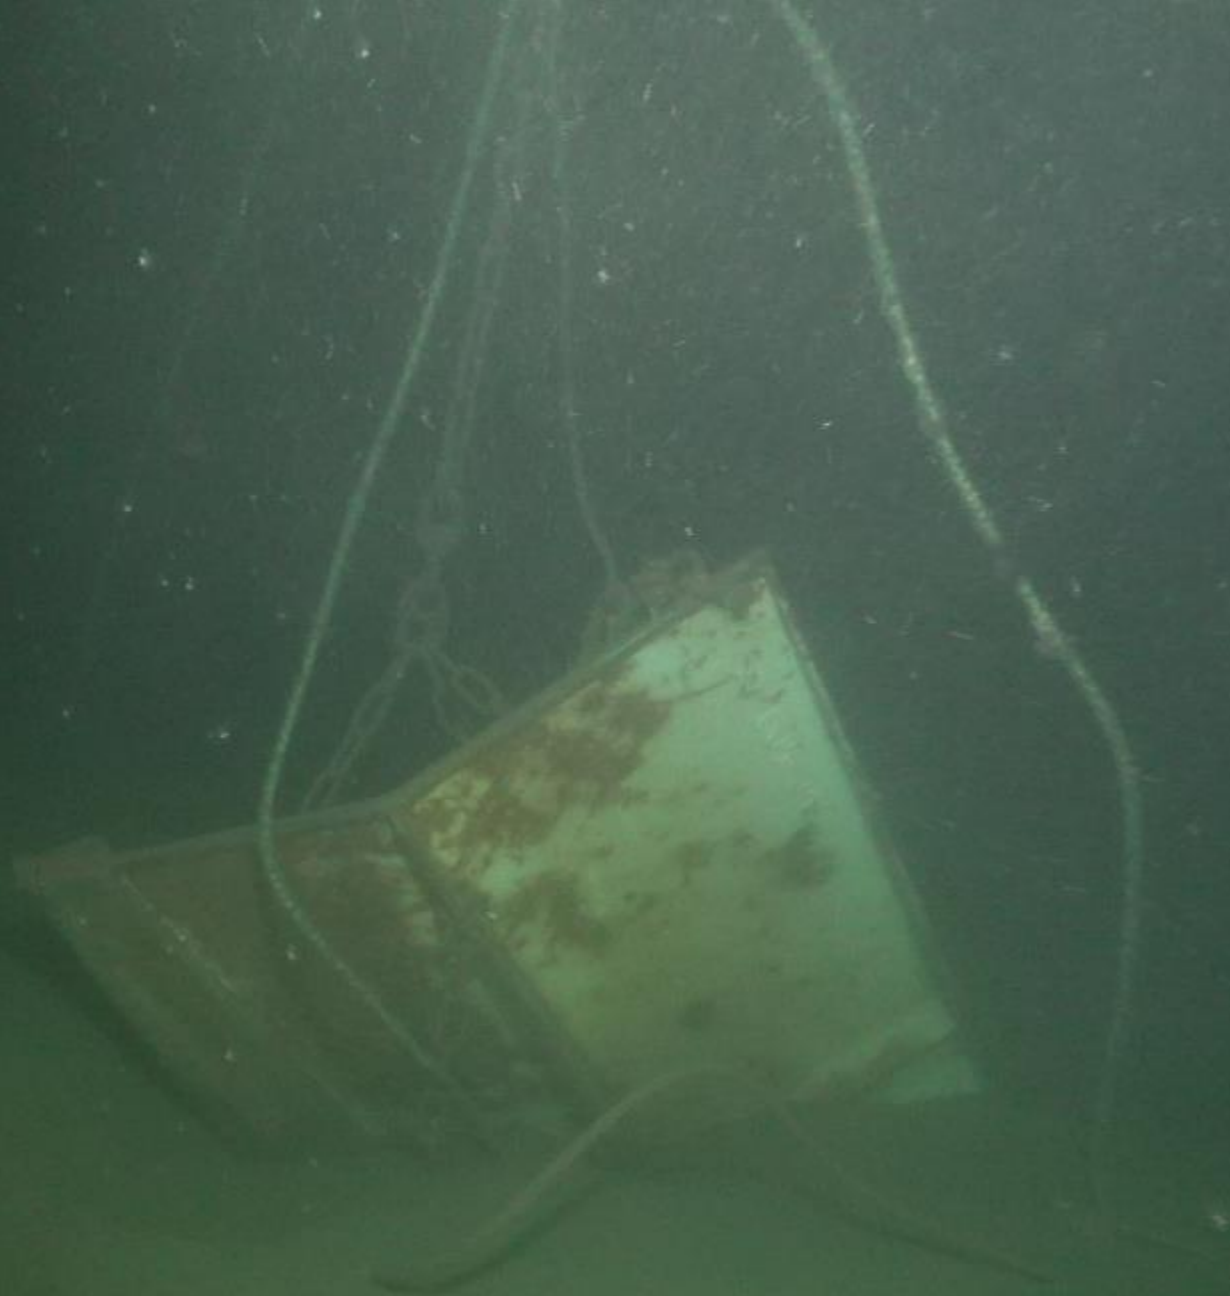
UW018 Dive 01 Initial visual survey  
7/7/2018 10:23:07  
44 21.4139244 N  
124 57.66606257 W

Heading 167.9  
Depth (m) 588.4  
Alt (m) 35.9  
Pitch (deg) -8.6  
Roll (deg) -6.8

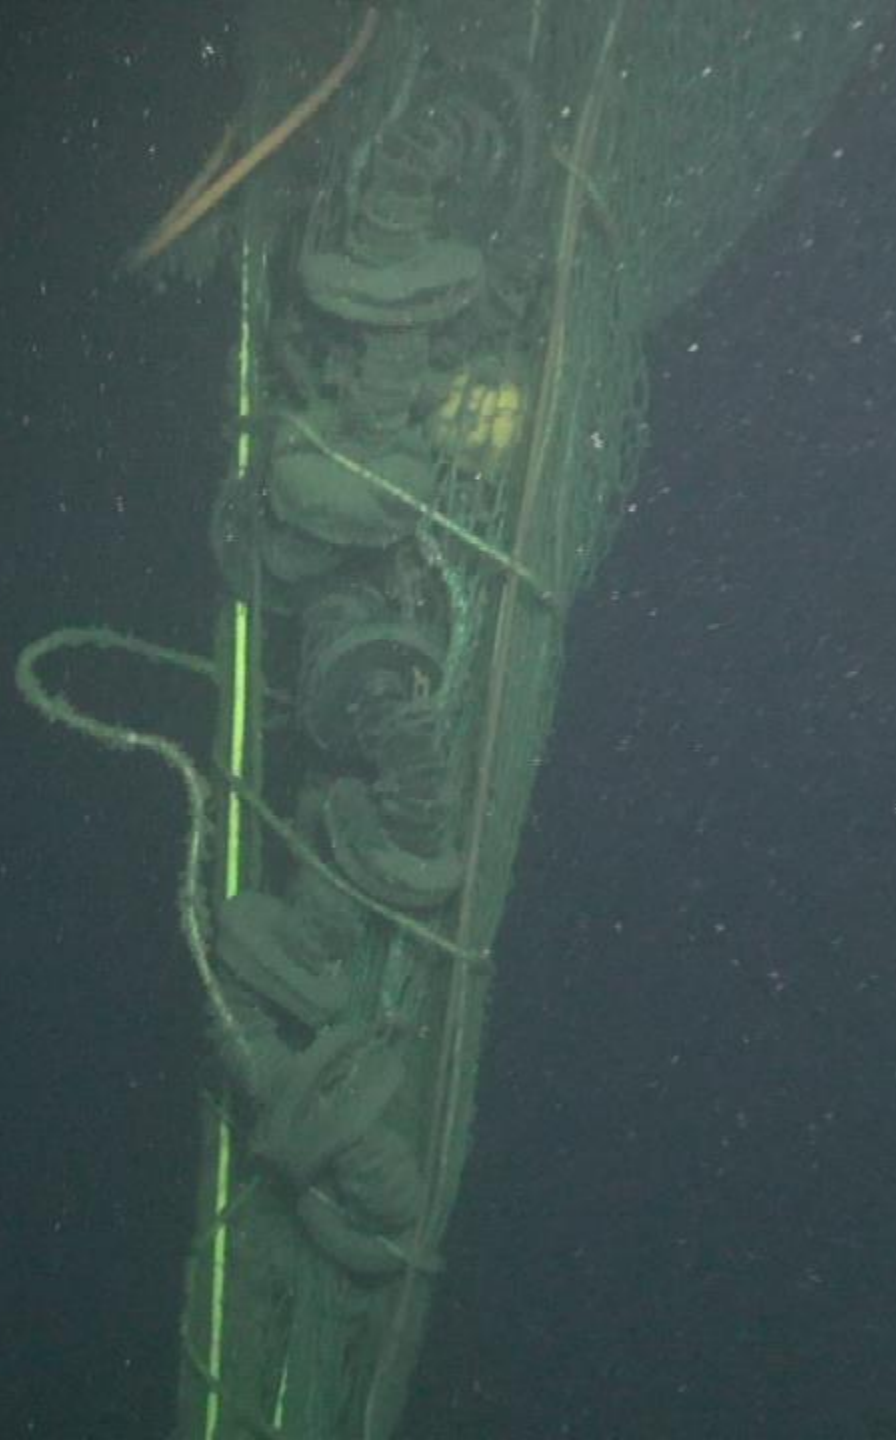
UW018 Dive 01 Initial visual survey  
7/7/2018 10:25:21  
44 21.41243702 N  
124 57.66718545 W

Heading 195.8  
Depth (m) 562.4  
Alt (m) 62.3  
Pitch (deg) -2.4  
Roll (deg) -12.4

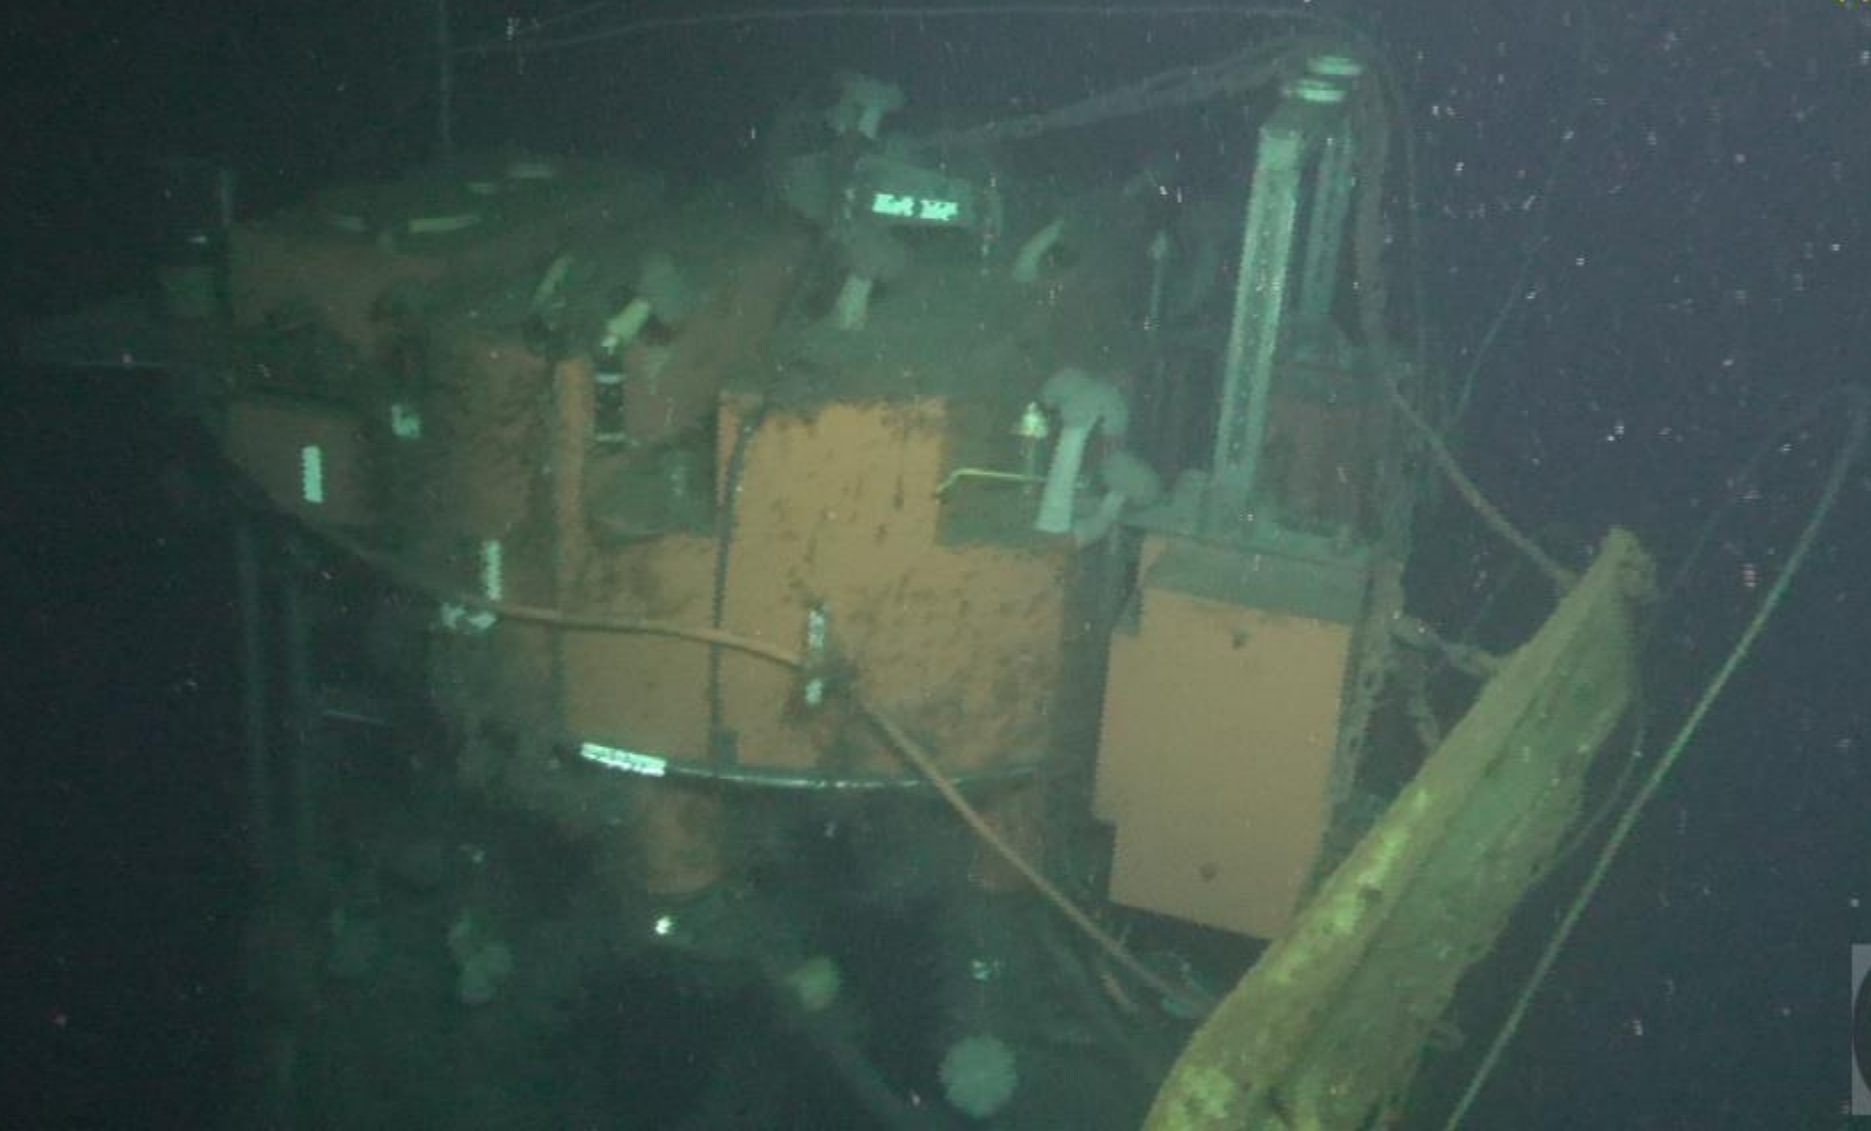
UW018 Dive 01 Initial visual survey  
7/7/2018 10:29:03  
44 21.42423978 N  
124 57.66622066 W

Heading 199.7  
Depth (m) 555.0  
Alt (m) 70.8  
Pitch (deg) -9.4  
Roll (deg) -5.4
