SWAB REPORT # 588

R/V Melville

REPORT FOR SWAB # 588

LOCATION: Point Loma, San Diego, CA DATE: 22 July 2011

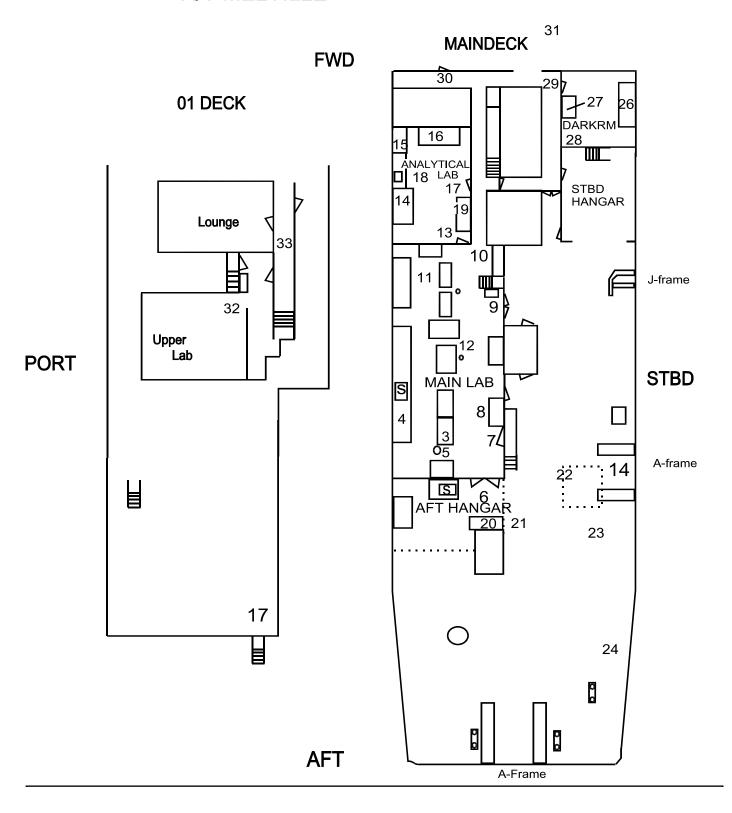
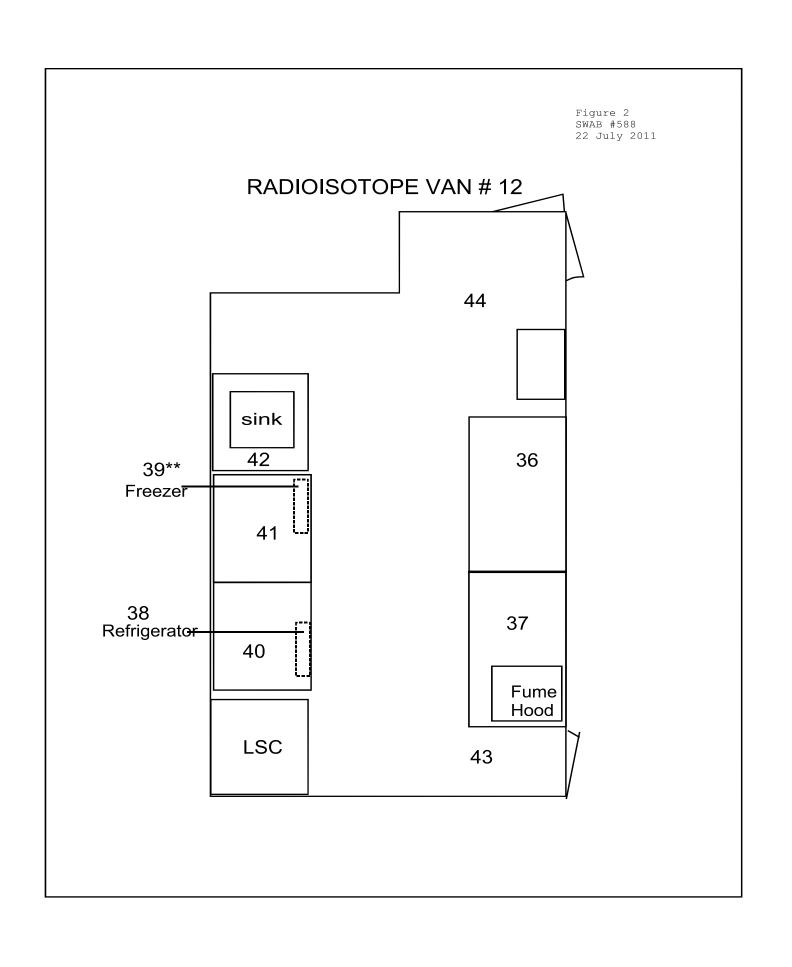
R/V MELVILLE

Please note that the error reported for each isotope is the two-standard deviation counting error. All areas tested on the ship were free of contamination. Radioisotope Van freezer tested positive for minor ³H and ¹⁴C contamination. We recommed that the freezer be cleaned.
