SWAB REPORT #732

SWAB DATE: 25 July 2014

R/V Melville and SIO Van #12

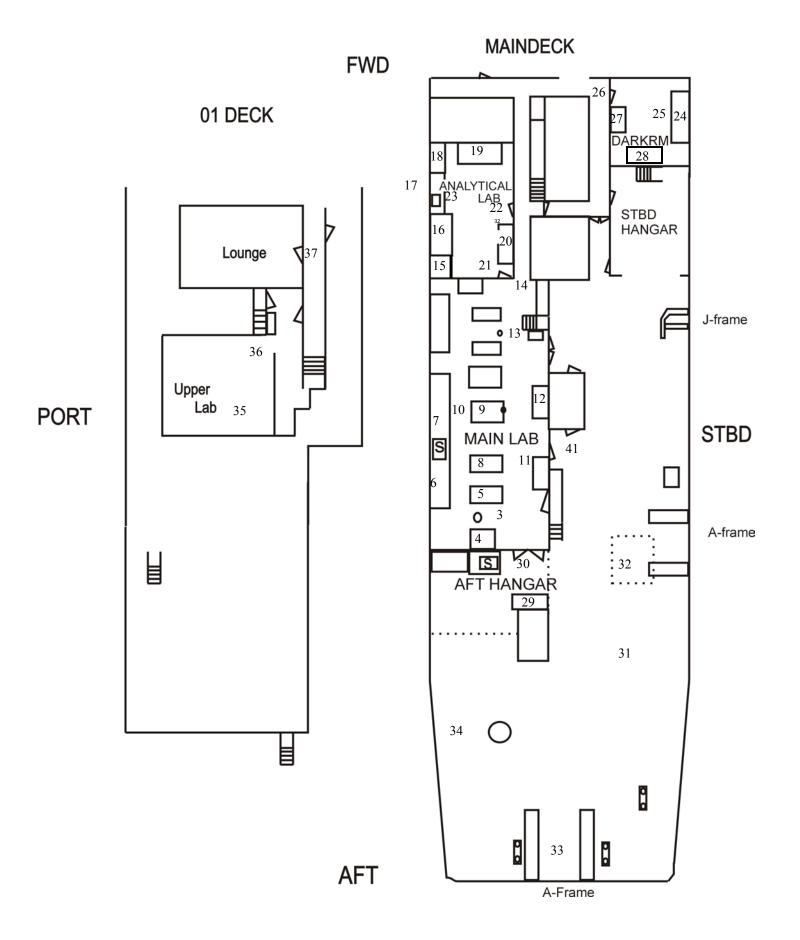
R/V MELVILLE

Sample # Sample Identification	³ H dpn	³ H dpm/m ²			¹⁴ C dpm/m ²		
	activity	(error	activity	(error	
1 1st Vial Bkgnd	0	±	0	0	±	0	
2 Initial bucket blank	0	±	0	3	±	38	
Main Lab (Figure 1)							
3 Deck in front of aft freezer	0	\pm	0	0	±	0	
4 Aft center benchtop	14	\pm	128	0	\pm	0	
5 Deck in front of aft stairs	31	\pm	95	0	\pm	0	
6 Benchtop aft of port sink	8	\pm	663	0	\pm	0	
7 Aft port sink area	13	\pm	187	0	\pm	0	
8 Benchtop across from sft port sink	27	\pm	100	0	\pm	0	
9 Center benchtop	0	\pm	0	16	\pm	37	
10 Deck in front of port bench	20	\pm	130	0	±	0	
11 Deck in front of -80 freezer	47	\pm	69	0	±	0	
12 Starboard benchtop	32	\pm	68	0	±	0	
13 Deck next to flamable materials locker	0	±	0	0	±	0	
14 Deck at companionway	59	±	78	0	±	0	
Analytical Lab (figure 1)							
15 Inside fume hood	19	\pm	57	0	±	0	
16 Becchtop between fumehood and sink	2	\pm	0	0	±	0	
17 Sink area	29	\pm	94	0	±	0	
18 Port benchtop forward of sink	26	\pm	100	0	±	0

19 Forward benchtop	38	\pm	114	0	±	0	
20 Starboard benchtop	0	±	0	0	±	0	
21 Deck at aft entrance	6	\pm	0	0	±	0	
22 Deck inside forward starboard entrance	26	\pm	0	0	±	0	
23 Deck in front of port sft sink	14	±	166	0	±	0	
Dark Room (Figure 1)							
24 Sink area	32	\pm	67	0	±	0	
25 Deck below sink	0	±	0	0	±	0	
26 Deck outside lab entrance	2	±	0	0	±	0	
27 Port benchtop	11	±	0	0	±	0	
28 Aft benchtop	4	\pm	0	0	±	0

Sample #	Sample Identification	³ H dpm/m ²			¹⁴ C dpm/m ²		
		activity	(error	activity		error
	Main Deck (Figure 1)						
29	Benchtop in aft hanger	25	\pm	89	0	±	0
30	Deck at aft entrance to main lab	17	\pm	99	0	±	0
31	Deck where rad van door located	14	±	0	0	\pm	0
32	Aft deck near starboard A-frame	38	\pm	76	0	±	0
33	Fantail deck between aft A-frame	22	±	100	0	±	0
34	Port aft deck	29	±	78	0	±	0
	Upper Lab/01 Deck (Figure 1)						
35	Deck near aft entrance	1	\pm	94	0	±	0
36	Deck near forward entrance	0	±	0	0	±	0
37	Companionway near lab entrance	0	±	0	0	±	0
	Main Deck Miscellaneous (Figure 1)						
38	Companionway outside lounge	0	\pm	0	0	±	0
39	Deck outside forward entrance to mess	25	±	125	0	±	0
	SIO Van #12 (Figure 2)						
40	Fume hood	197	土	58	38	\pm	30
41	Benchtop	163	\pm	69	0	±	1
42	Benchtop	49	土	72	0	土	0
43	Sink area	10	±	137	0	±	0
44	Benchtop	191	\pm	63	0	±	0
45	Benchtop	31	土	57	0	\pm	0
46	Inside freezer	382	\pm	54	*403	±	48

Please note that the error reported for each isotope is the two-standard deviation counting error. All areas tested on the Melville were free from radioisotope activity that requires cleaning. Minor ¹⁴C contamination was found in Van #12. No action is necessary

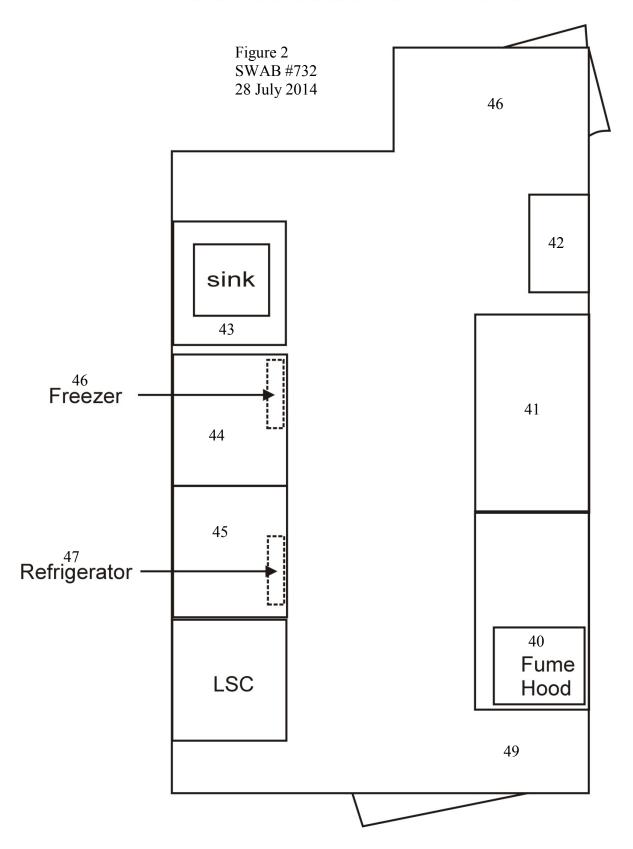
SIO RADIOISOTOPE VAN #12

47	Inside refrigerator	56	±	58	0	±	0
48	Deck at entrance	115	±	46	*64	±	35
49	Deck at entrance	93	\pm	39	*89	\pm	37
50	Final bucket blank	1	±	0	0	土	0
