SWAB REPORT # 952

SWAB DATE: 13 July 2019

R/V Atlantic Explorer

LOCATION: St. Georges, Bermuda VESSEL: *R/V Atlantic Explorer*

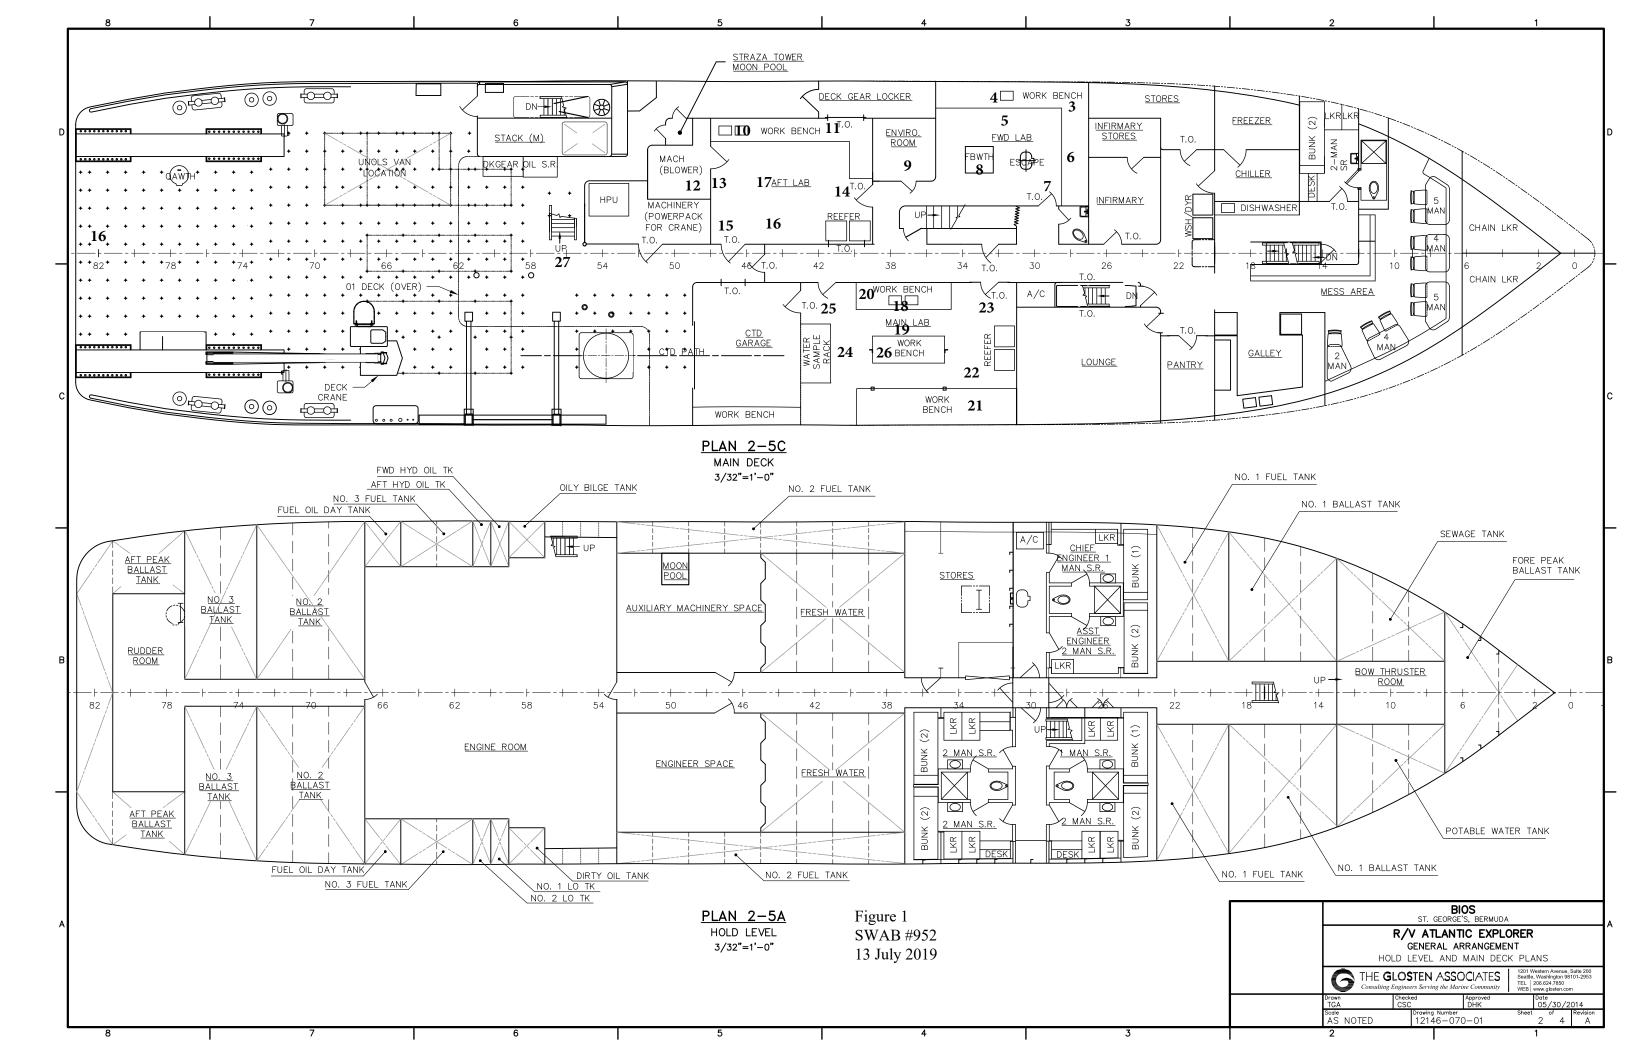
Sample # Sample Identification	³ H dpm/m ²			¹⁴ C dpm/m ²		
	activity		error	activity	e	rror
1 1st Vial Bkgnd	0	±	0	0	±	0
2 Initial bucket blank	-34	±	45	4	±	76
Forward Lab (Figure 1)						
3 Port benchtop forward of sink	17	\pm	75	-11	\pm	38
4 Sink area	-8	\pm	19	-8	\pm	43
5 Deck in front of sink	4	\pm	35	-27	\pm	52
6 Forward benchtop	3	\pm	43	-13	±	47
7 Deck inside starboard entrance	-4	±	72	-11	±	35
8 Center benchtop	-14	±	31	11	±	41
9 Deck inside Enviro Room	12	±	48	-25	±	19
Aft Lab (Figure 1)						
10 Port sink area	41	±	73	-24	±	42
11 Benchtop forward of sink	5	±	26	-29	±	28
12 Inside fume hood	-1	\pm	34	-3	±	15
13 Deck in front of fume hood	20	\pm	101	-20	±	63
14 Deck inside forward entrance	58	\pm	65	-20	±	39
15 Inside aft entrance	9	±	153	-12	±	71
16 Deck below -80 °C freezer	-14	±	37	5	±	44
17 Center benchtop	7	±	44	-29	±	37
Main Lab (Figure 1)						
18 Port sink area	4	±	19	-14	±	93
19 Deck in front of sink	-1	\pm	22	-4	\pm	82

20 Benchtop aft of sink	7	\pm	96	-5	\pm	53
21 Inside laminar flow hood	4	\pm	36	-16	±	46
22 Deck in front of laminar flow hood	-7	\pm	28	6	\pm	41
23 Deck inside forward entrance	-28	±	39	1	±	18
24 Deck below CTD racks	24	±	51	3	±	28
25 Deck inside aft entrance	-2	±	70	-22	±	46
26 Center benchtop	-36	±	99	-5	±	37
Aft Deck (Figure 1)						
27 Deck at bottom of stairs to 01 Deck	-4	\pm	32	-20	±	34

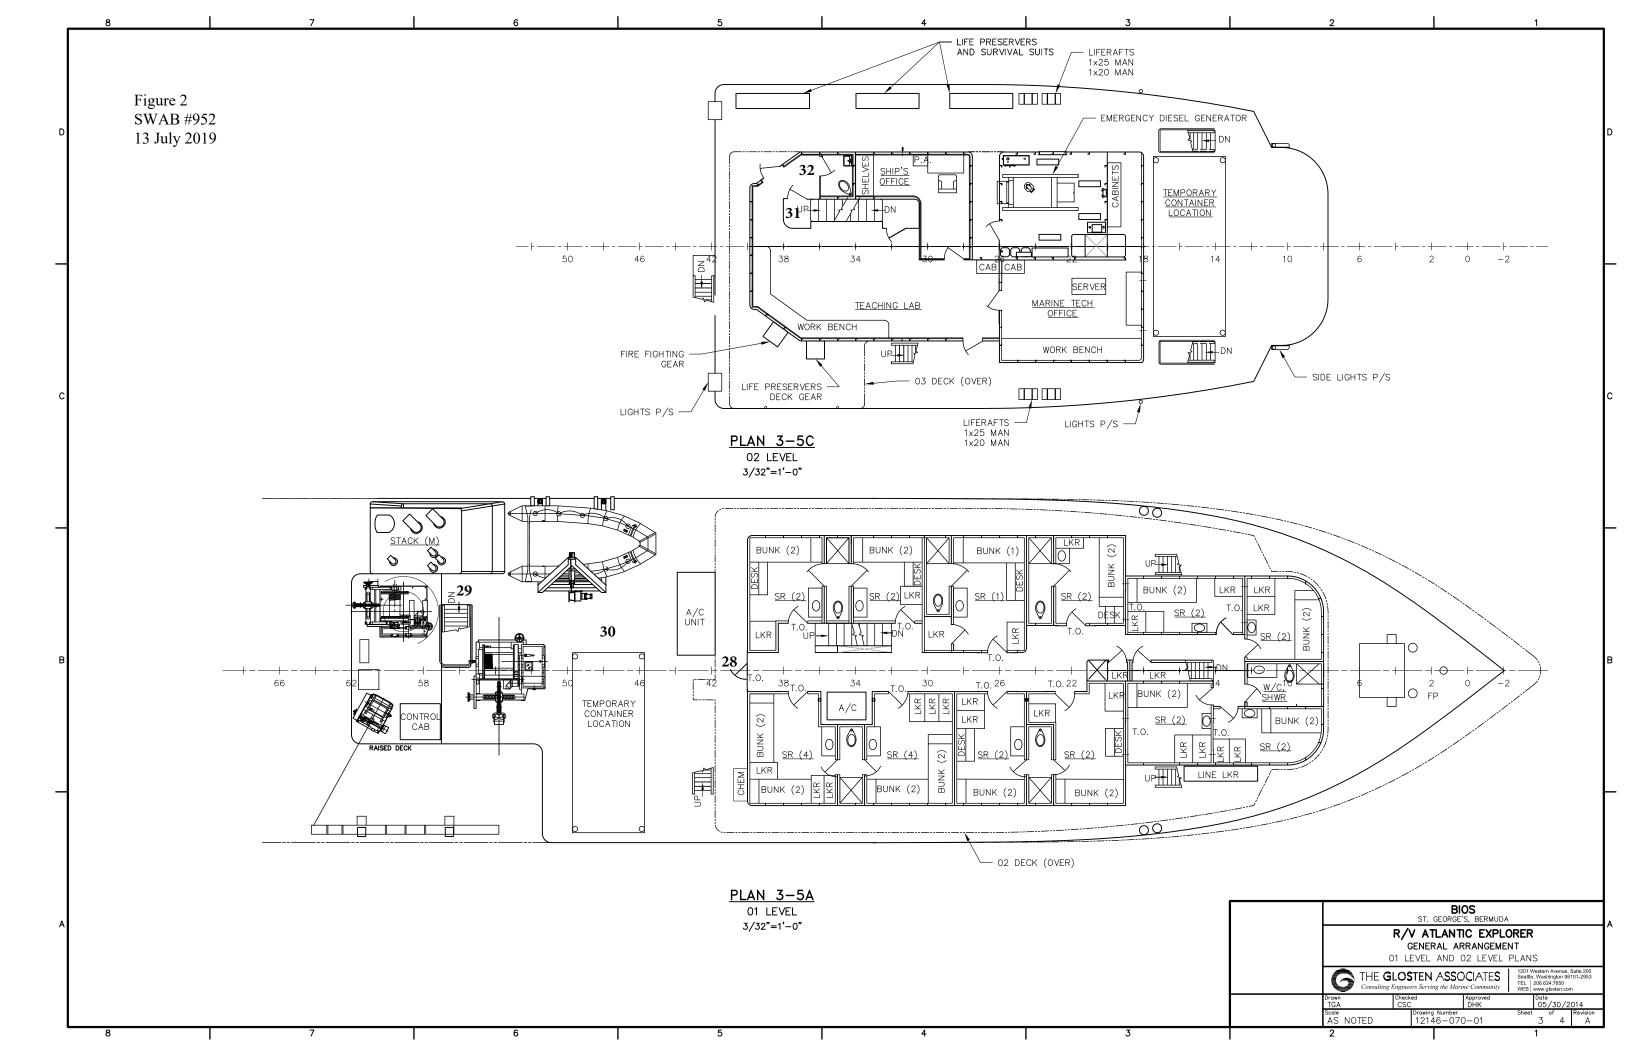
Sample # Sample Identification	³ H dpm/m ²			¹⁴ C dpm/m ²		
	activity	(error	activity		error
01 Deck (Figure 2)						
28 Deck outside aft entrance from sleeping quarters	-21	±	39	3	±	62
29 Deck at top of aft stairs	-37	±	46	5	±	65
30 Deck outside Rad Van door	40	±	92	-21	±	25
02 Deck (Figure 2)						
31 Top of stairs to science study	24	±	67	-11	±	43
32 Deck inside aft entrance next to head	4	±	51	-20	±	37
03 Deck (Figure 3)						
33 Top of stairs to bridge	-5	±	90	-4	\pm	26
34 Intermediate bucket blank	13	±	107	-14	±	30
Radiation Van #625.5.02 (Figure 4)						
35 Sink area	205	±	66	8	\pm	17
36 Benchtop adjacent to sink	247	±	63	11	\pm	17
37 Benchtop adjacent to fume hood	3	±	17	12	\pm	38
38 Deck between LSC and fume hood	134	±	61	-7	\pm	23
39 Top of LSC	271	±	65	40	±	29
40 Benchtop adjacent to LSC	113	±	54	30	±	33
41 Inside freezer	110	±	61	-9	±	28
42 Inside refrigerator	81	±	27	213*	\pm	44
43 Deck in middle of van	207	±	65	-3	\pm	13

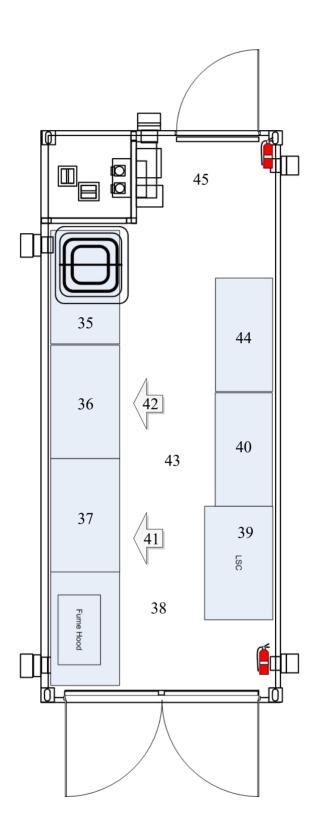
Figure 4 SWAB #952 13 July 2019

Please note that the error reported for each isotope is the two-standard deviation counting error. The reports may now contain values less than zero. When decay counting background samples will be distributed about the background vial, which means that negative values are possible. In the past we rounded the negative values to zero. Values are only significantly above background when they are positive and larger than the error. All areas tested on the ship were free from isotope contamination that requires cleaning, The refrigerator in the Rad Van had some minor ¹⁴C contamination. No action is necessary in the van.
