SWAB REPORT # 757

SWAB DATE: 5 January 2015

*R/V Atlantic Explorer and UNOLS Van # 2409.01*

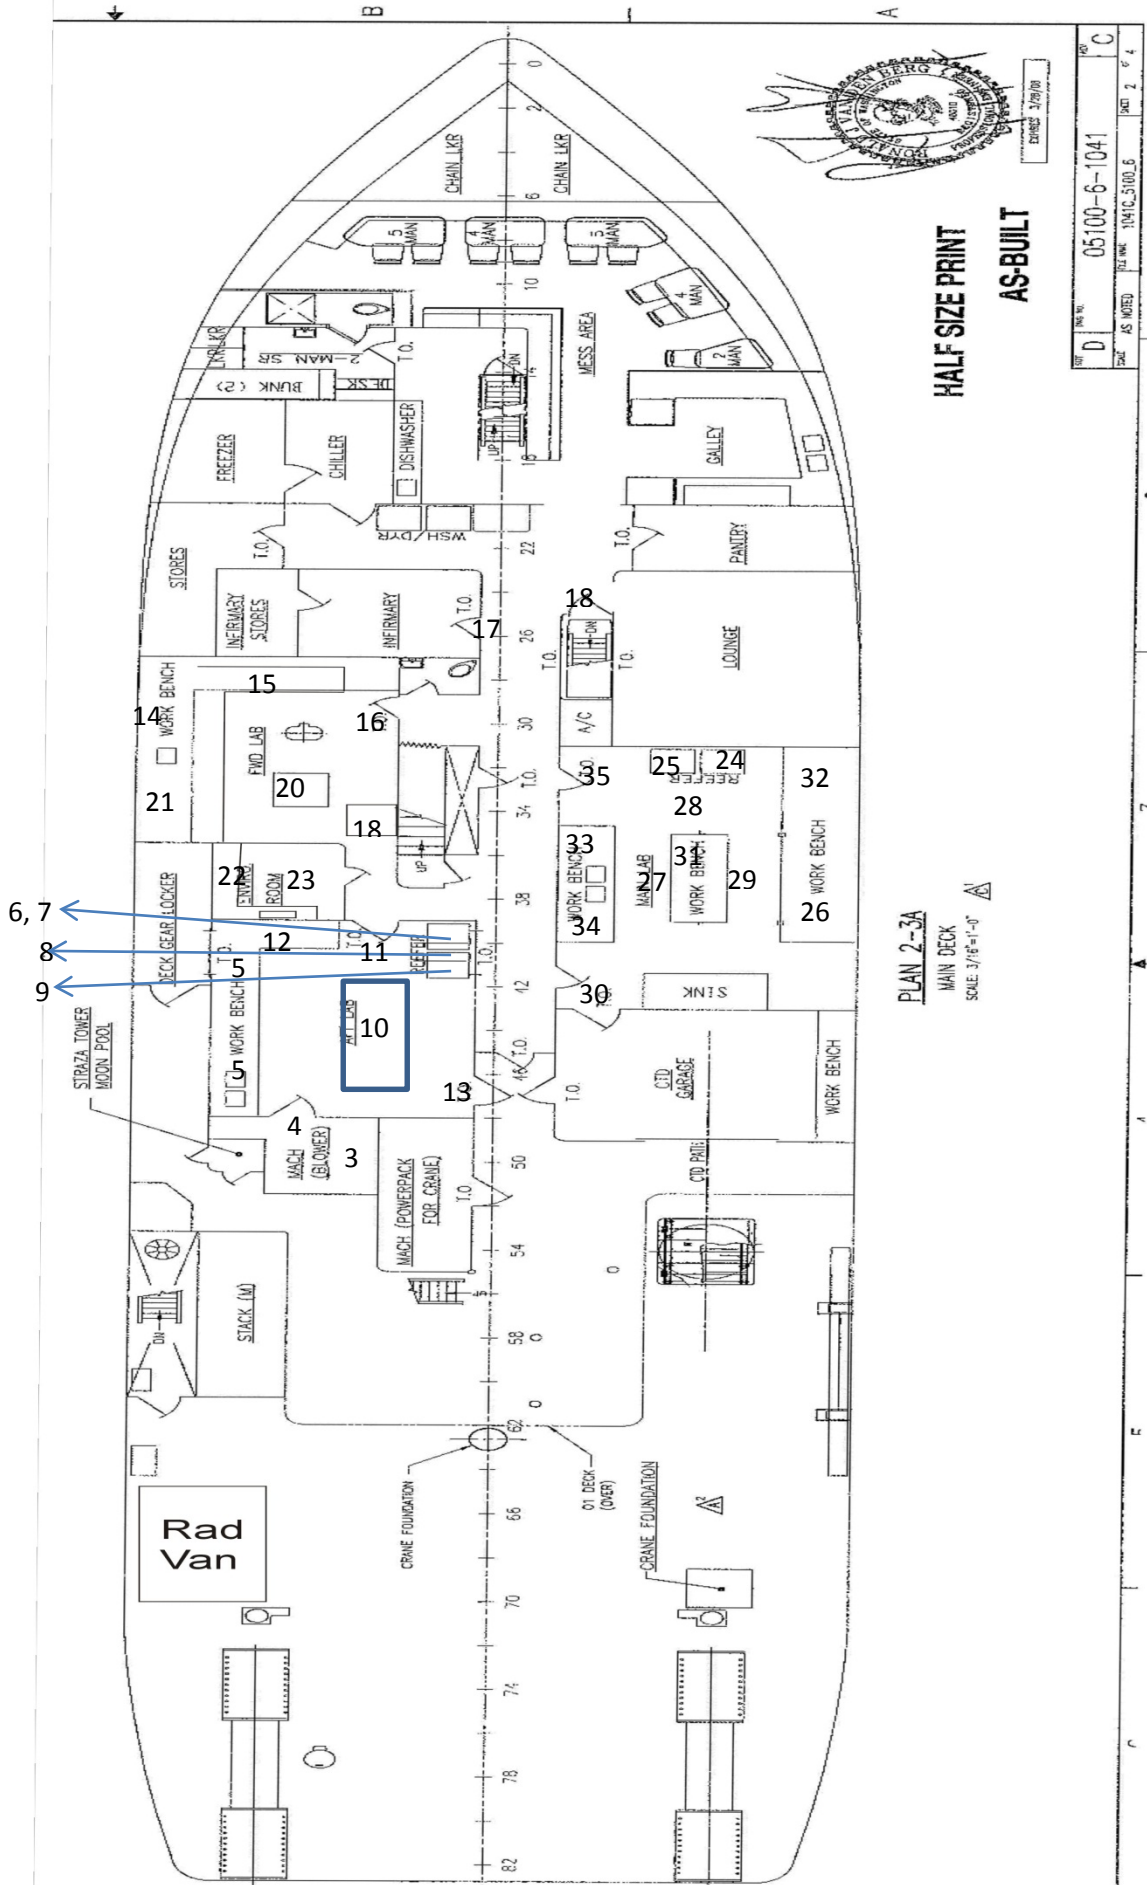
Figure 1  
 SWAB #757  
 5 January 2015

All areas tested in the ship were free from isotope contamination that requires cleaning.

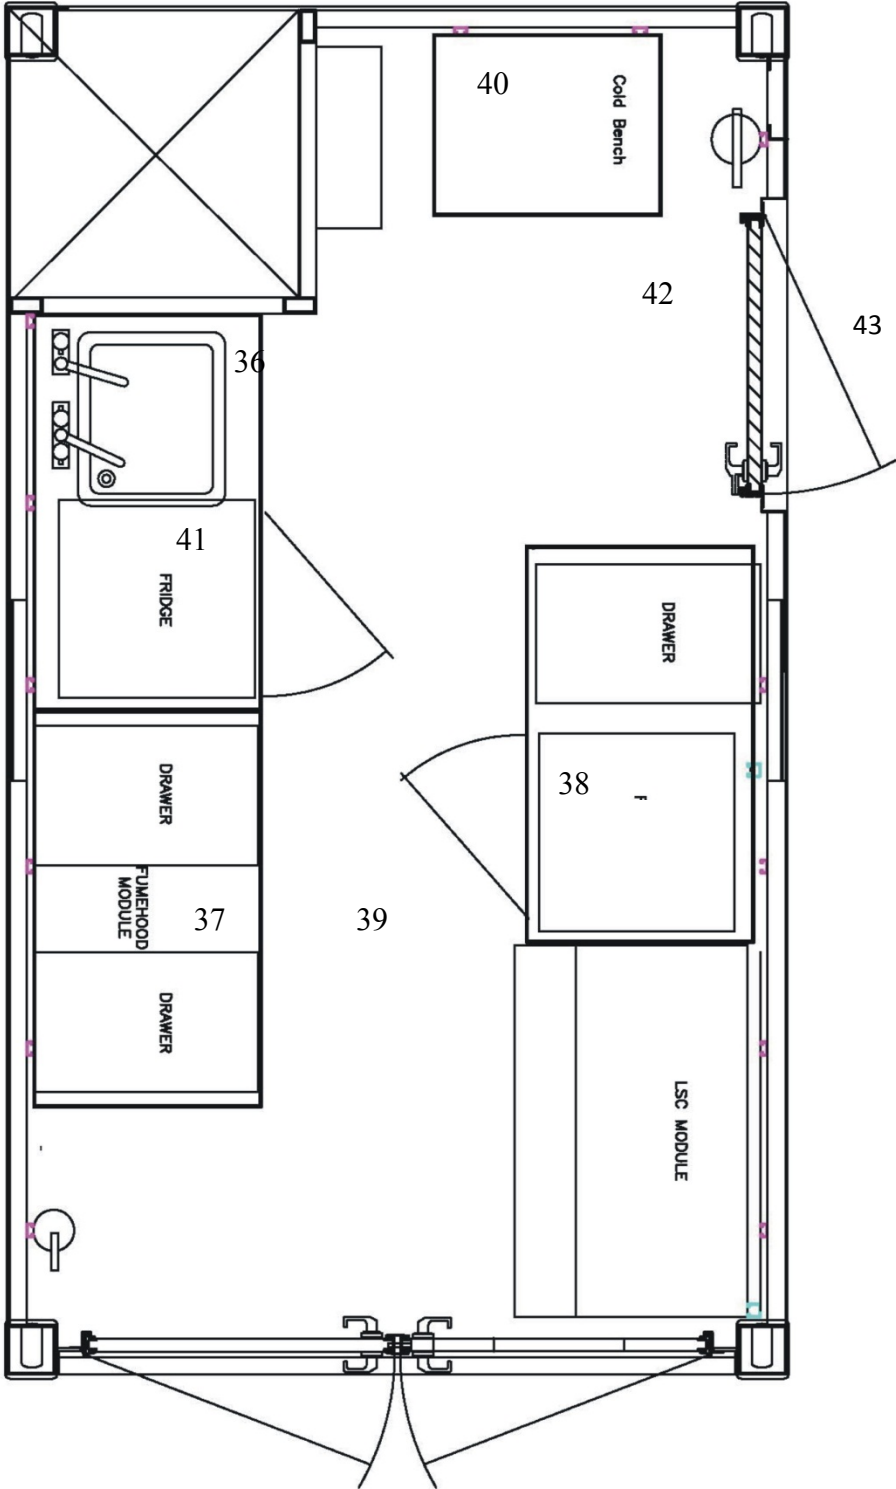
Figure 2

Minor <sup>3</sup>H and <sup>14</sup>C contamination was detected in the radioisotope van. Deck areas should be cleaned.
