**RMYoung 27600 firmware and wind dir error
Originated by Phil White on March 20, 2013**

From: Phil White (NOAA) on Wed, 20 Mar 2013

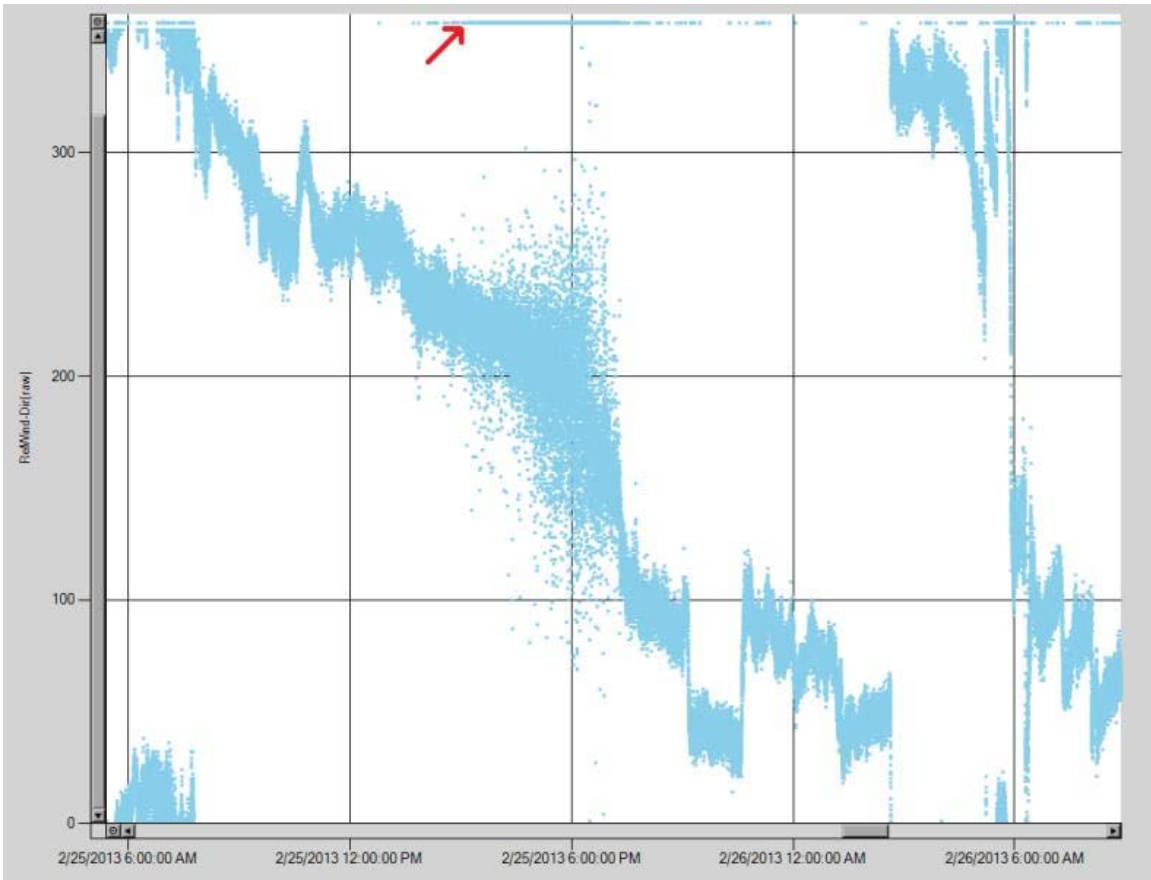
An R.M. Young service rep reported (after we bought a replacement 05106 wind bird) that 26700 translators with firmware versions older than 4.7 will return a value of 358 when direction varies rapidly on a mechanical wind bird. The rapid movement of the vane results in a rapidly changing voltage from the potentiometer and is interpreted by the translator as an error and sends 358 as an error flag (why use a valid number as a flag?).

On the NOAA's Oscar Dyson the mechanical wind bird on the jack staff whips around when the wind is on the stern due to the interference of the massive superstructure. I'd never seen this before as most ships I've sailed have wind birds on the main mast and don't routinely see this kind of turbulence.

The first attached shows the relative wind swinging around slowly and gets noisy when the wind is + - ~40 deg of 180. The straight line of 358 readings at the top (red arrow) is a random but frequent logging of the "error" value.

OK, that's the answer. The solution is to flag a raw relative wind output of 358 from the 26700 as a "no data" message - because it is. Complexities of allowing for alignment correction inside the translator etc. are left as an exercise for the student 😊

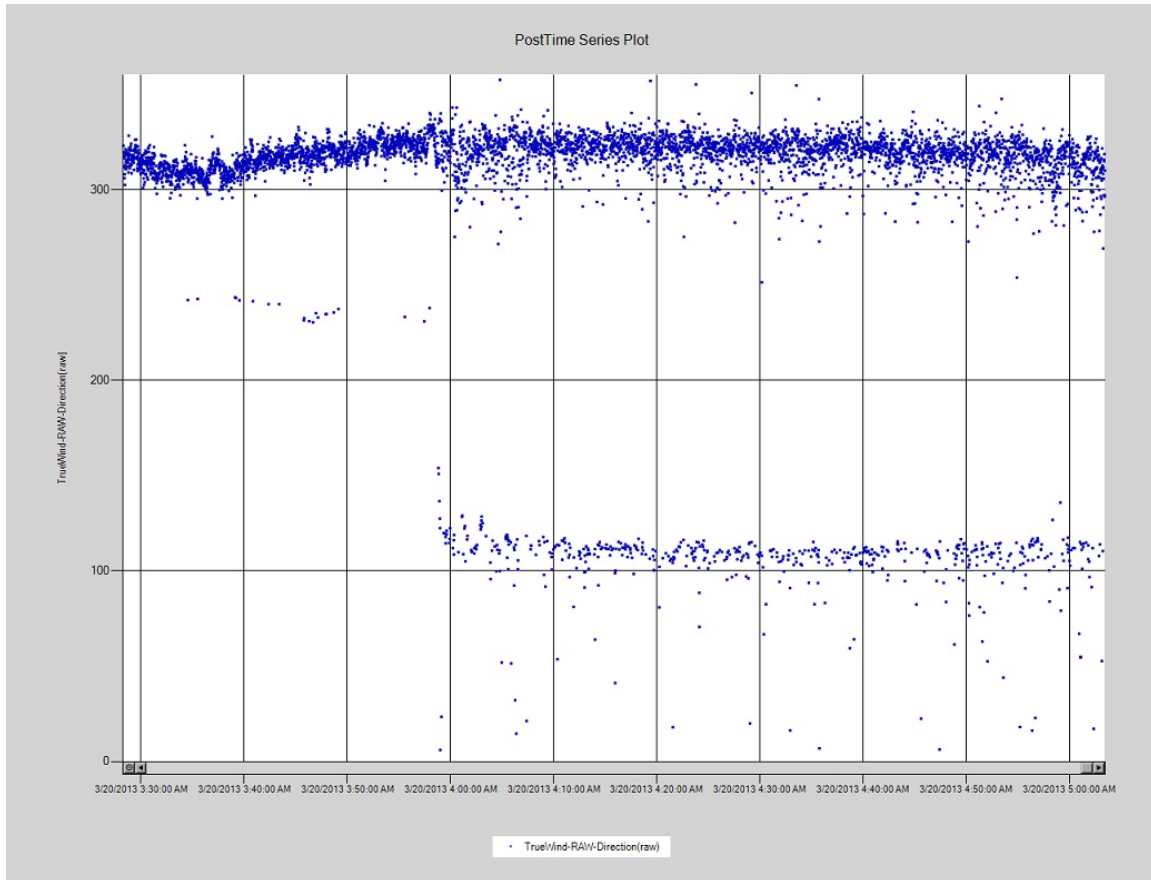
This can be a problem even if it occurs rarely and you use instantaneous readings. For SAMOS and other users of average values it will drag your averages around. Instantaneous true wind calculations will show regular ghost values as if the wind was from two different directions (see second attached).
