SWAB REPORT # 918

SWAB DATE: 30 October 2018

R/V Sally Ride
CalCOFI Van

LOCATION: San Diego, CA
VESSEL: R/V Sally Ride

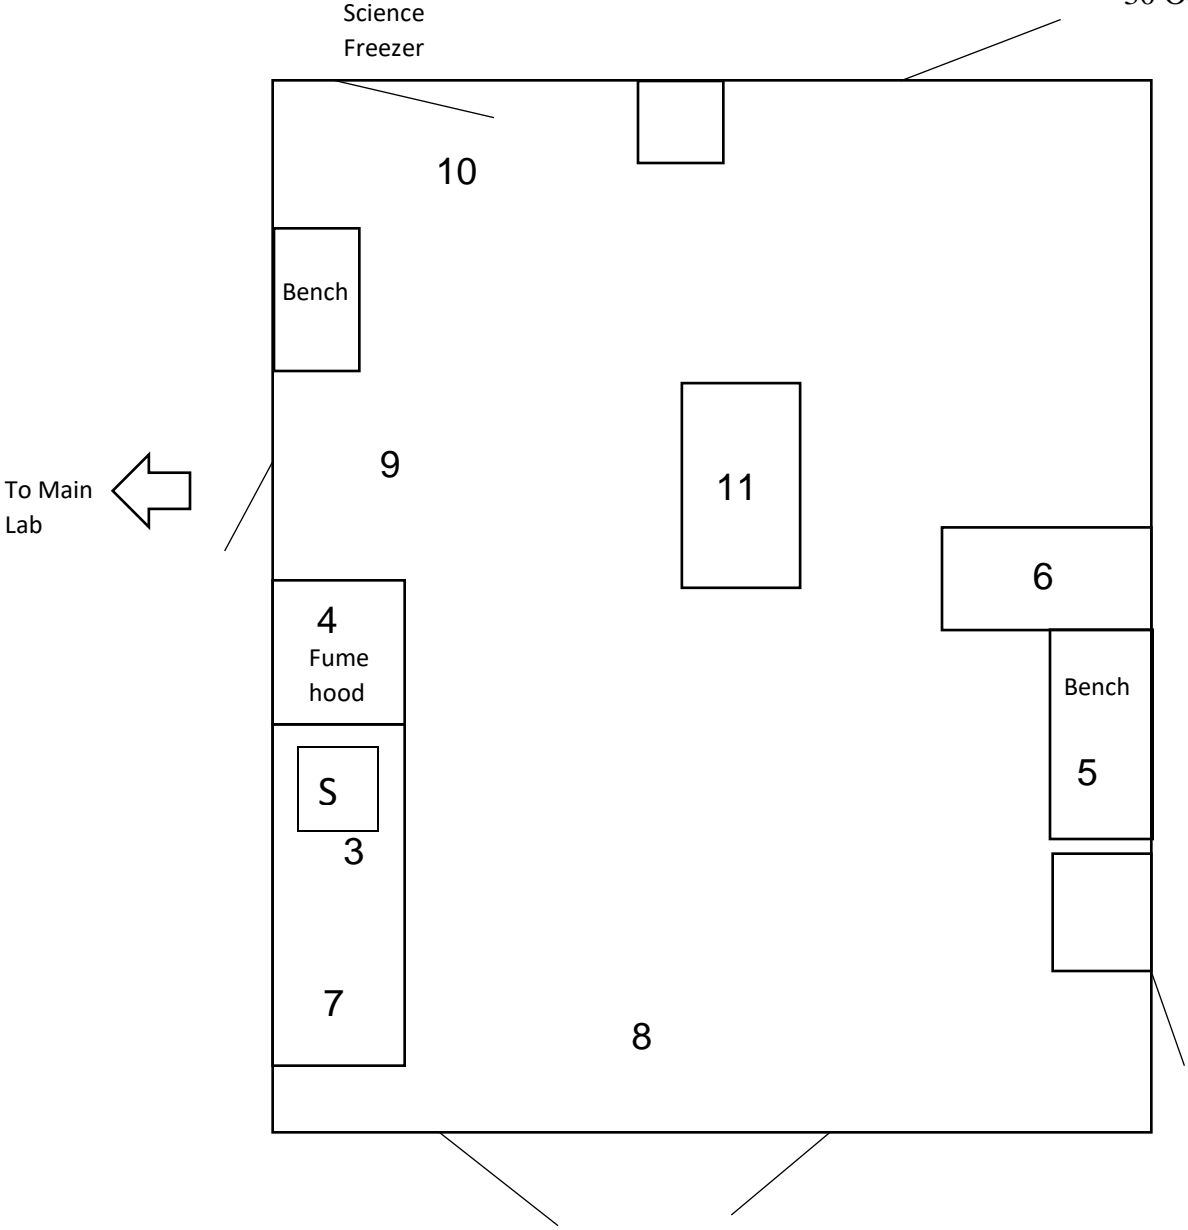
Figure 1
SWAB # 918
30 October 2018

Sample # Sample Identification	³ H dpm/m ²		¹⁴ C dpm/m ²	
	activity	error	activity	error
1 1st Vial Bkgnd	0	± 0	0	± 0
2 Initial bucket blank C.O. # 1	58	± 61	-25	± 40
<u>Wet Lab (Figure 1)</u>				
3 Sink area	21	± 117	-27	± 35
4 Inside fume hood	20	± 89	-20	± 33
5 Starboard bench	5	± 15	-25	± 36
6 Wooden benchtop forward of starboard benchtop	-20	± 23	-19	± 42
7 Benchtop aft of sink	46	± 60	-17	± 28
8 Deck inside aft entrance	28	± 70	-20	± 31
9 Deck inside port entrance	22	± 178	-35	± 22
10 Deck in front of Science Freezer	21	± 62	-11	± 16
11 Benchtop opposite of port entrance	16	± 131	-21	± 15
<u>Main Lab (Figure 2)</u>				
12 Starboard sink are	7	± 27	-25	± 32
13 Inside starboard fume hood	6	± 16	-12	± 19
14 Inside port fume hood	43	± 85	-41	± 23
15 Deck in front of port fume hood	-15	± 32	-30	± 41
16 Deck in front of starboard fume hood	-1	± 20	1	± 40
17 Aft section of port bench	-1	± 18	-38	± 22
18 Forward section of port bench	20	± 131	-28	± 35

19 Aft section of center bench	-6	± 35	-35	± 8
20 Forward section of center bench	1	± 14	-1	± 16
21 Deck in front of Science Freezer	-15	± 17	-32	± 23
22 Deck inside forward entrance to lab	-35	± 23	-2	± 29
23 Benchtop across from starboard fume hood	3	± 18	-22	± 50
24 Deck at aft entrance between starboard benches	-19	± 25	-9	± 7
25 Benchtop opposite of starboard aft entrance	9	± 339	-18	± 21

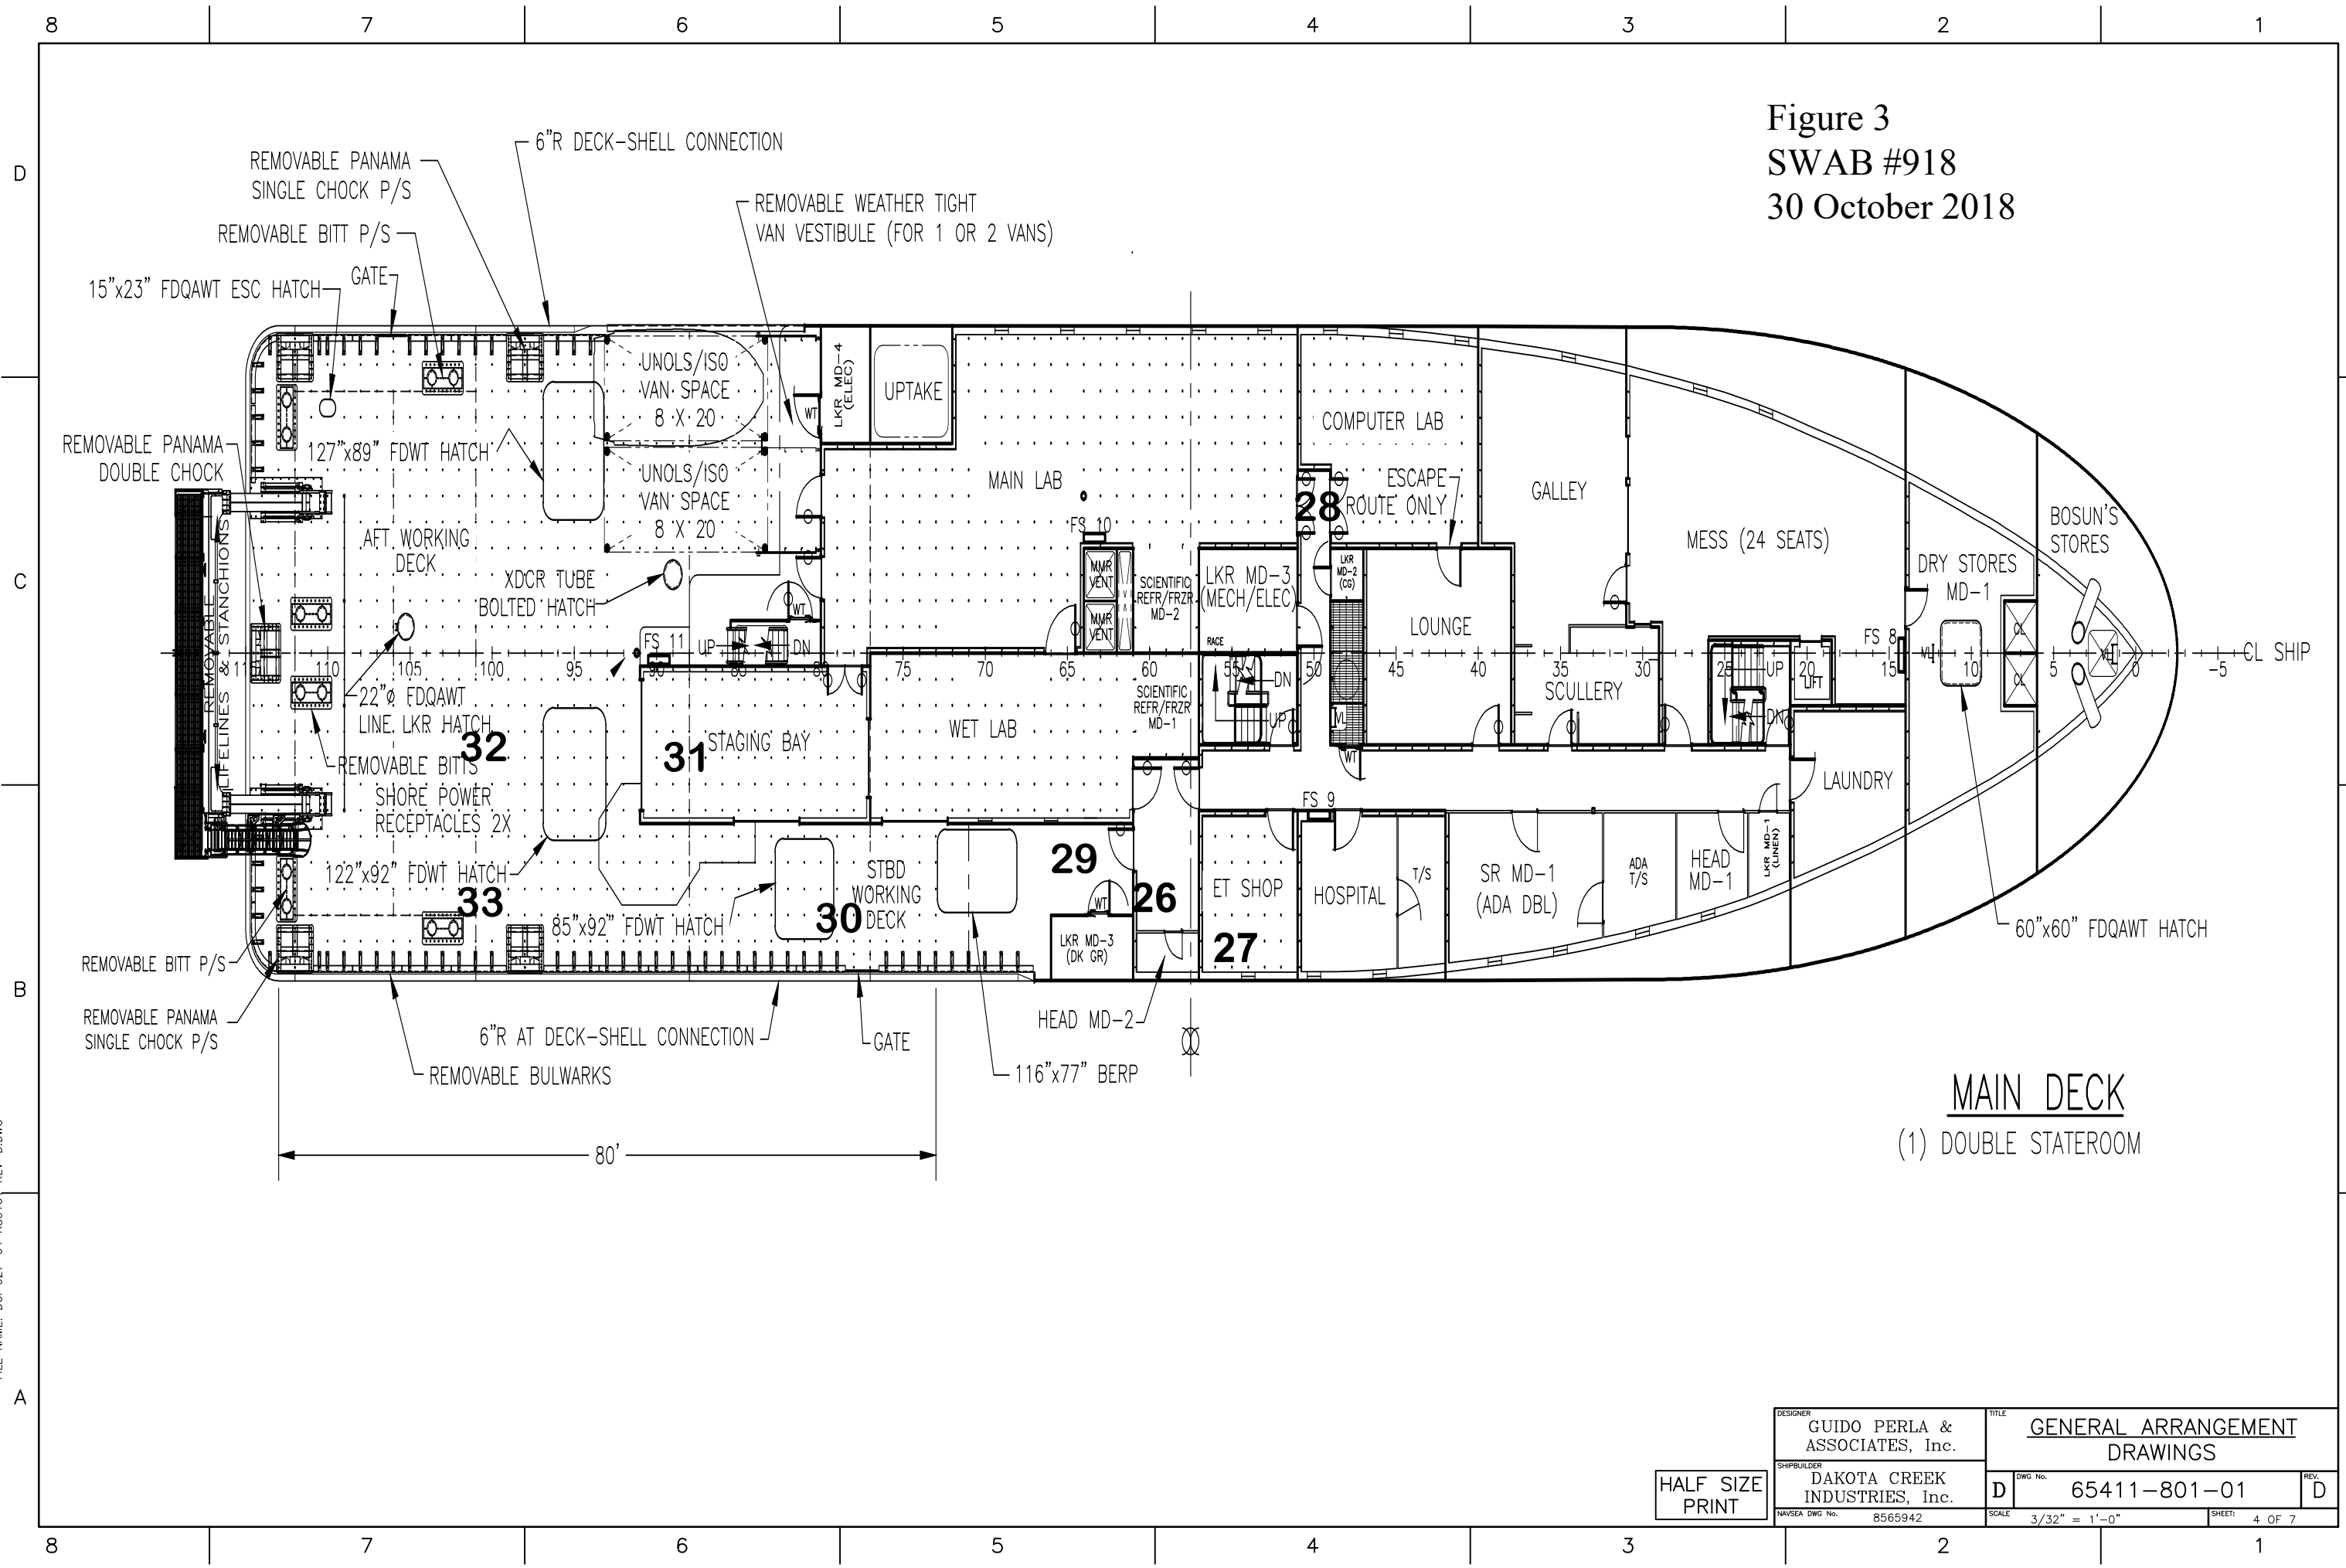
Figure 3
SWAB #918
30 October 2018

Sample #	Sample Identification	^3H dpm/m ²		^{14}C dpm/m ²	
		activity	error	activity	error
	<u>Main Deck (Figure 3)</u>				
26	Inside head aft of Electronics Shop	26	± 113	-35	± 28
27	Deck in center of Electronics Shop	5	± 21	-32	± 17
28	Deck between Main Lab and Computer Lab	17	± 433	-33	± 26
29	Starboard working deck aft of entrance to vestibule	-9	± 18	-19	± 33
30	Deck where CTD rosette was located	-5	± 17	-29	± 25
31	Aft deck of Staging Bay	32	± 128	-46	± 18
32	Deck below entrance to CALCofi Van	-4	± 22	-28	± 21
33	Deck behind van where incubator stood	11	± 145	-16	± 42
	<u>CalCOFI Rad Van</u>				
34	Inside refrigerator on bottom	2	± 19	-31	± 11
35	Benchtop adjacent to refrigerator	5	± 38	3	± 34
36	Sink area	-3	± 15	-26	± 16
37	Top of refrigerator	25	± 277	-43	± 18
38	Desk across from sink	12	± 31	-34	± 25
39	Deck in center of van	10	± 399	-19	± 30
40	Final bucket sample	14	± 23	-37	± 32
