ALVIN Overhaul and Upgrades

ALVIN Overhaul

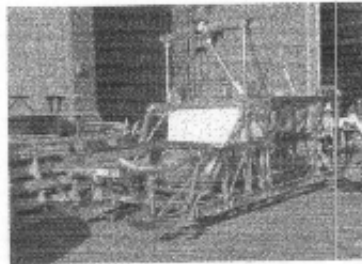
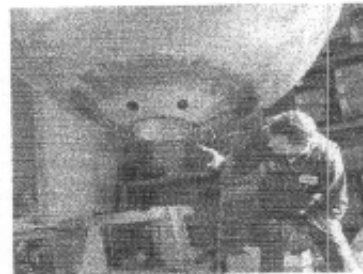
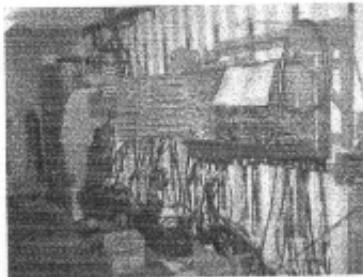
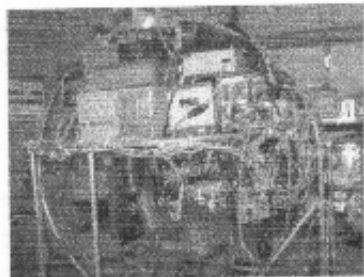
- Some personnel on ROV ops
- Frame repaired..100%
- Variable ballast rebuilt..70%
- Manipulators rebuilt..90%
- Electronic Equip maint..75%
- Personnel/VB/HP spheres insp..100%
- Pressure test implodables..50%
- Hydraulic system rebuild..80%
- Electrical J-boxes rebuild..75%
- Explosive bolts..20%
- Battery Boxes..10%
- Foam repairs..50%
- Blow/vent system.. 100%
- Internal panels/wiring.. 75%
- Skin repairs/painting..5%
- Component re-installations started..5%
