Draft comments by S. D'Hondt (Chief Scientist) on

piston-coring effort of Knorr expedition 195(3), Jan-Feb 2009,

Highlights of first scientific coring attempts with the long piston-coring system

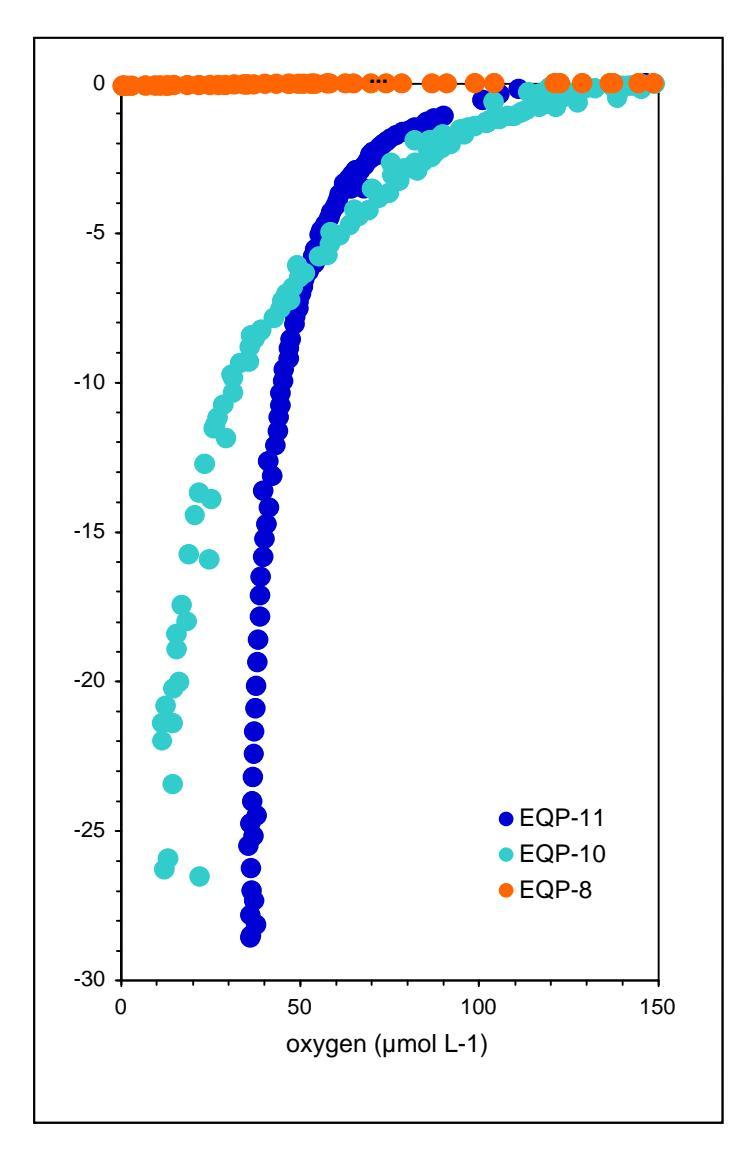
Figure caption. The long piston coring capability enabled us to identify the deepest penetration of oxygen ever observed in marine sediment. This in turn, allowed us to determine that rates of O_2 reduction per unit volume varied by eight orders of magnitude from site to site, in concert with seasurface productivity and organic flux to the seafloor. 2. In the process, one or two long piston cores were recovered at 8 of 11 sites. The longest of these was 41 m.

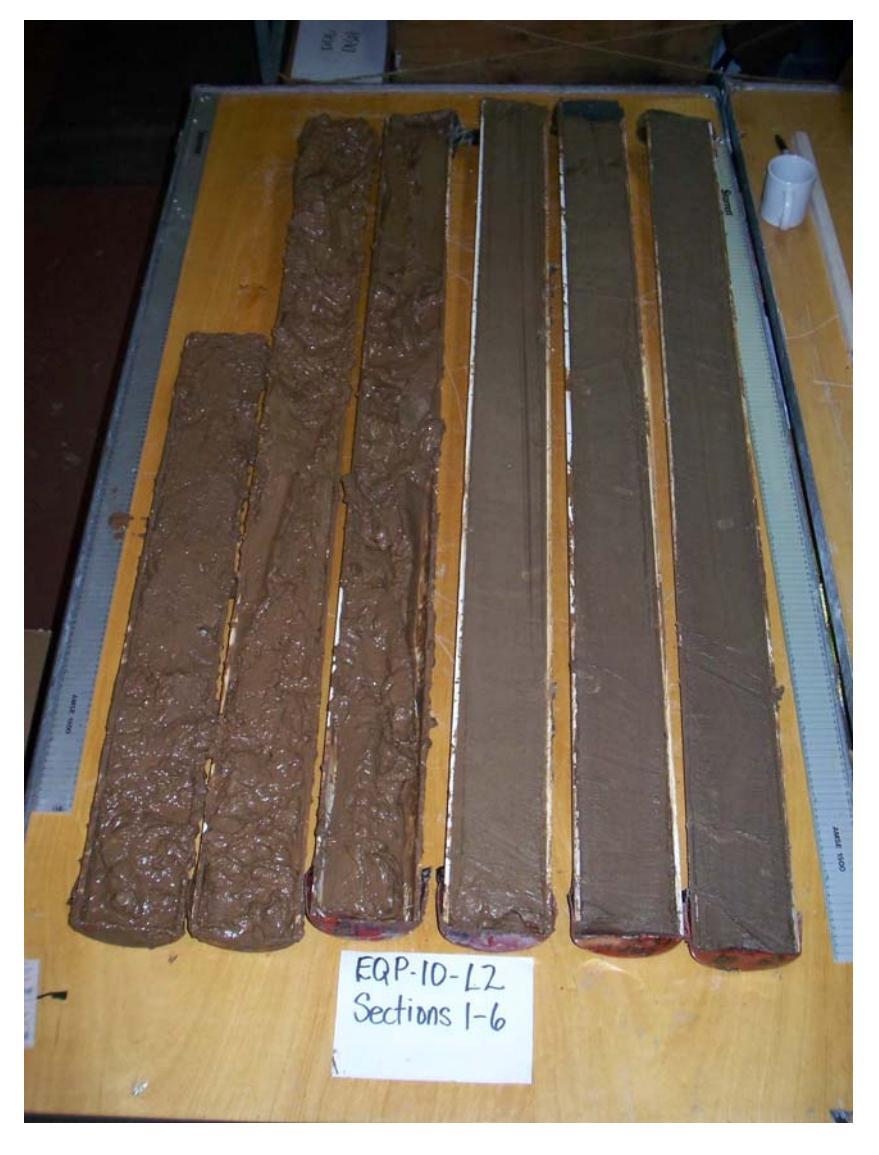
1. Disruption of the upper several meters of core occurred in at least 5 of 13 long piston cores, due to `blow-ins' of the core liner at liner joints. The blowins result in water jetting into the core through the liner wall. This problem precludes all studies of the upper sediment column in these cores and greatly complicates attempts to correlate the piston cores to each other and to co-located gravity cores (which are usually shorter than the interval of disturbed sediment). This problem is routinely minimized with other piston coring systems. It might be better avoided with stronger core liner. During the expedition, blow-ins were eventually minimized by gluing and taping all liner joints, appropriately orienting the direction of the joints, and offsetting the liner joints from the pipe joints. These actions must become standard practices; when the coring group reverted to not gluing and taping the joints at site 10 (after doing so at site 8), the problem returned. See image from site 10; the blow-in occurred at the joint between section 3 and section 4.

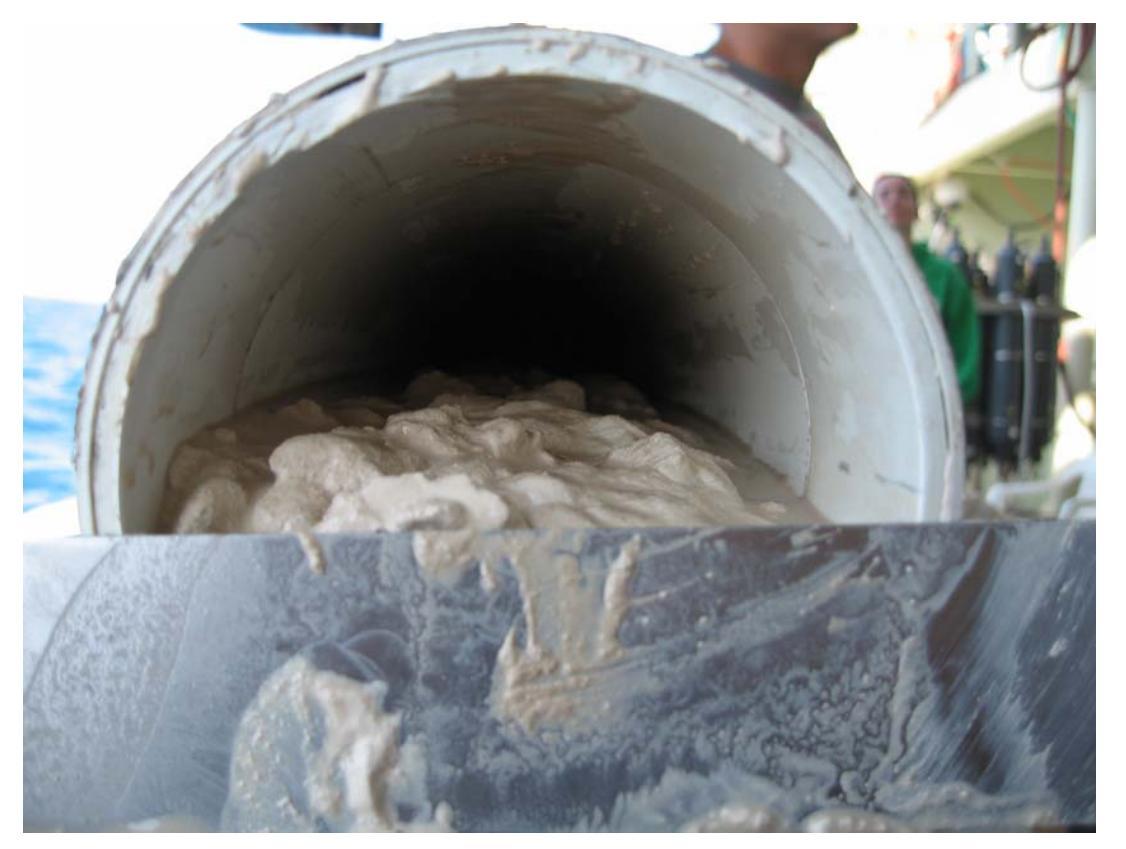
3. Up to five sections (several meters) of the upper core were disturbed in multiple long piston cores, due to sediment flow as the cores were brought from vertical to horizontal and the cores were removed from the pipe. See image below from site 8. This problem precludes all studies of the upper sediment column in these cores and it also greatly complicates attempts to correlate the piston cores to each other and to co-located gravity cores (which were typically no longer than the interval of disturbance in the piston cores). It is typically minimized with other coring systems by blocking the sediment from flow, e.g., by leaving the piston in place throughout the operation or by placing a sediment `stop' in the core liner at the sediment/water interface prior to bringing the core horizontal.
