Troubleshooting RDI Vessel Mounted ADCPs

What can go wrong with workhorse or ocean surveyor vessel-mounted instrument and how to troubleshoot it. This breakout is at the instrument level, not SOP for operations.

Teledyne RDI

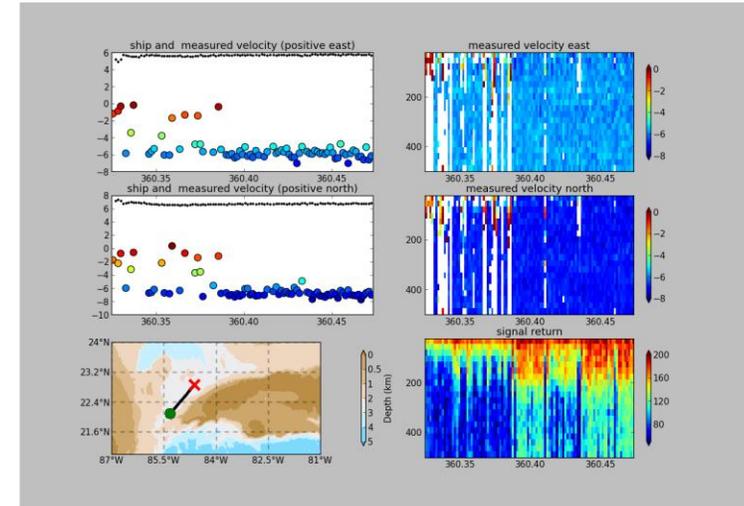
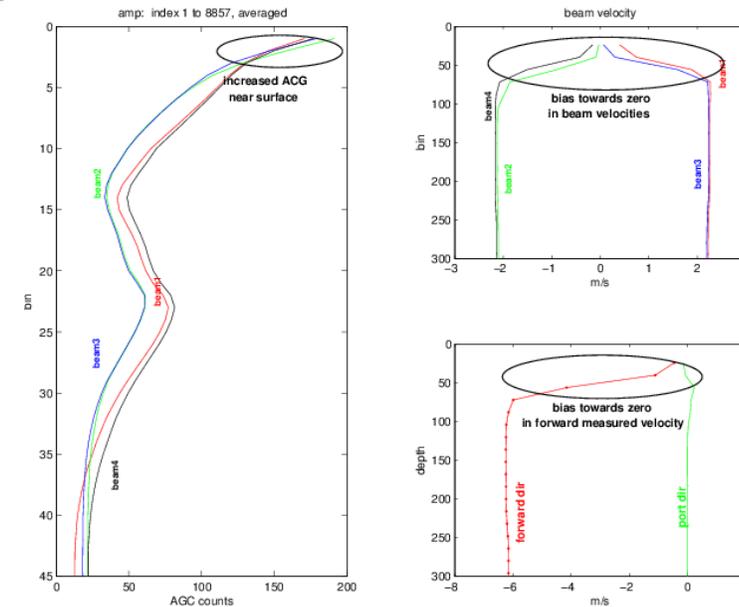
- Mechanical
 - Bubbles
 - Ringing
 - Well design
 - Dampening material
 - Lack of isolation
 - Use higher frequency ADCP
 - Change Blanking Distance
- Transducer failure

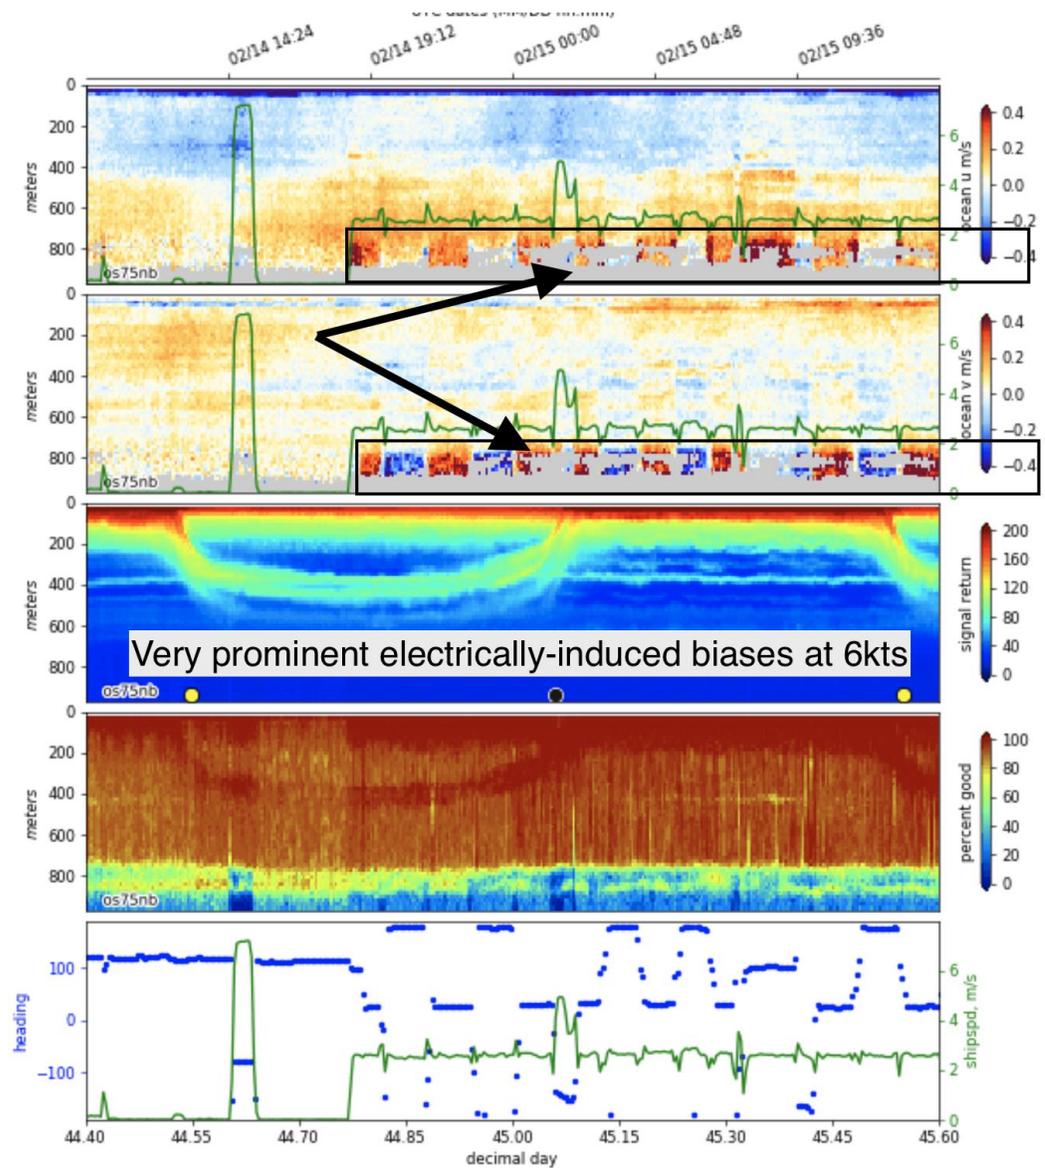
- EMF generators near the deck unit
 - Eg. Knudsen, CRT monitor
- EMF near Ocean Surveyor cable
 - other power lines
 - other transducers cables
- WH300 bad power supply

44.4 to 45.6 (1.20 days)

2021/02/14 09:42 to 2021/02/15 14:27

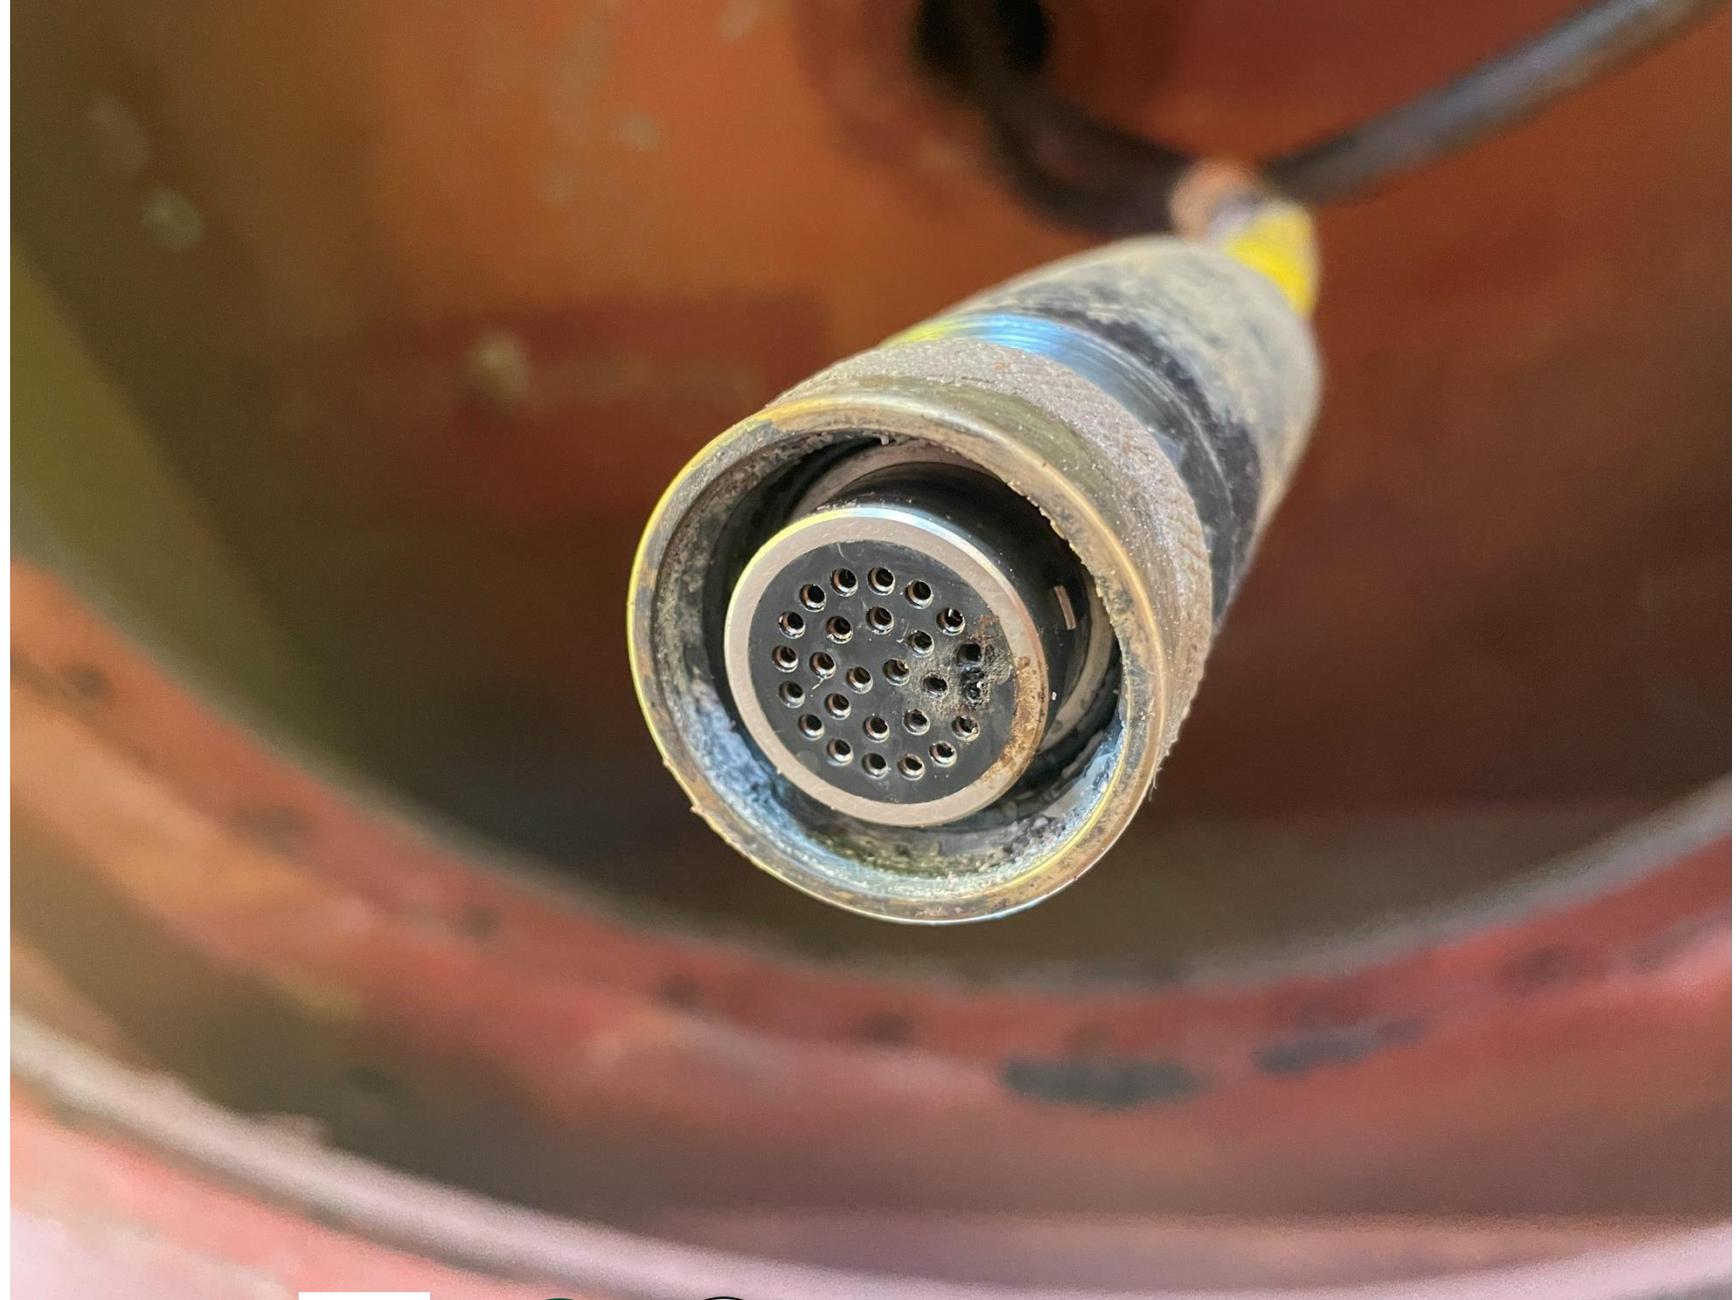
Things to look out for

Corrosion or evidence of flooding

Scorched pins or scorch marks on the connector plug

Cuts or abrasions on the wet end of the cable, they may lead to flooding

Cable fatigue or excessive cable wear

Crushed cable

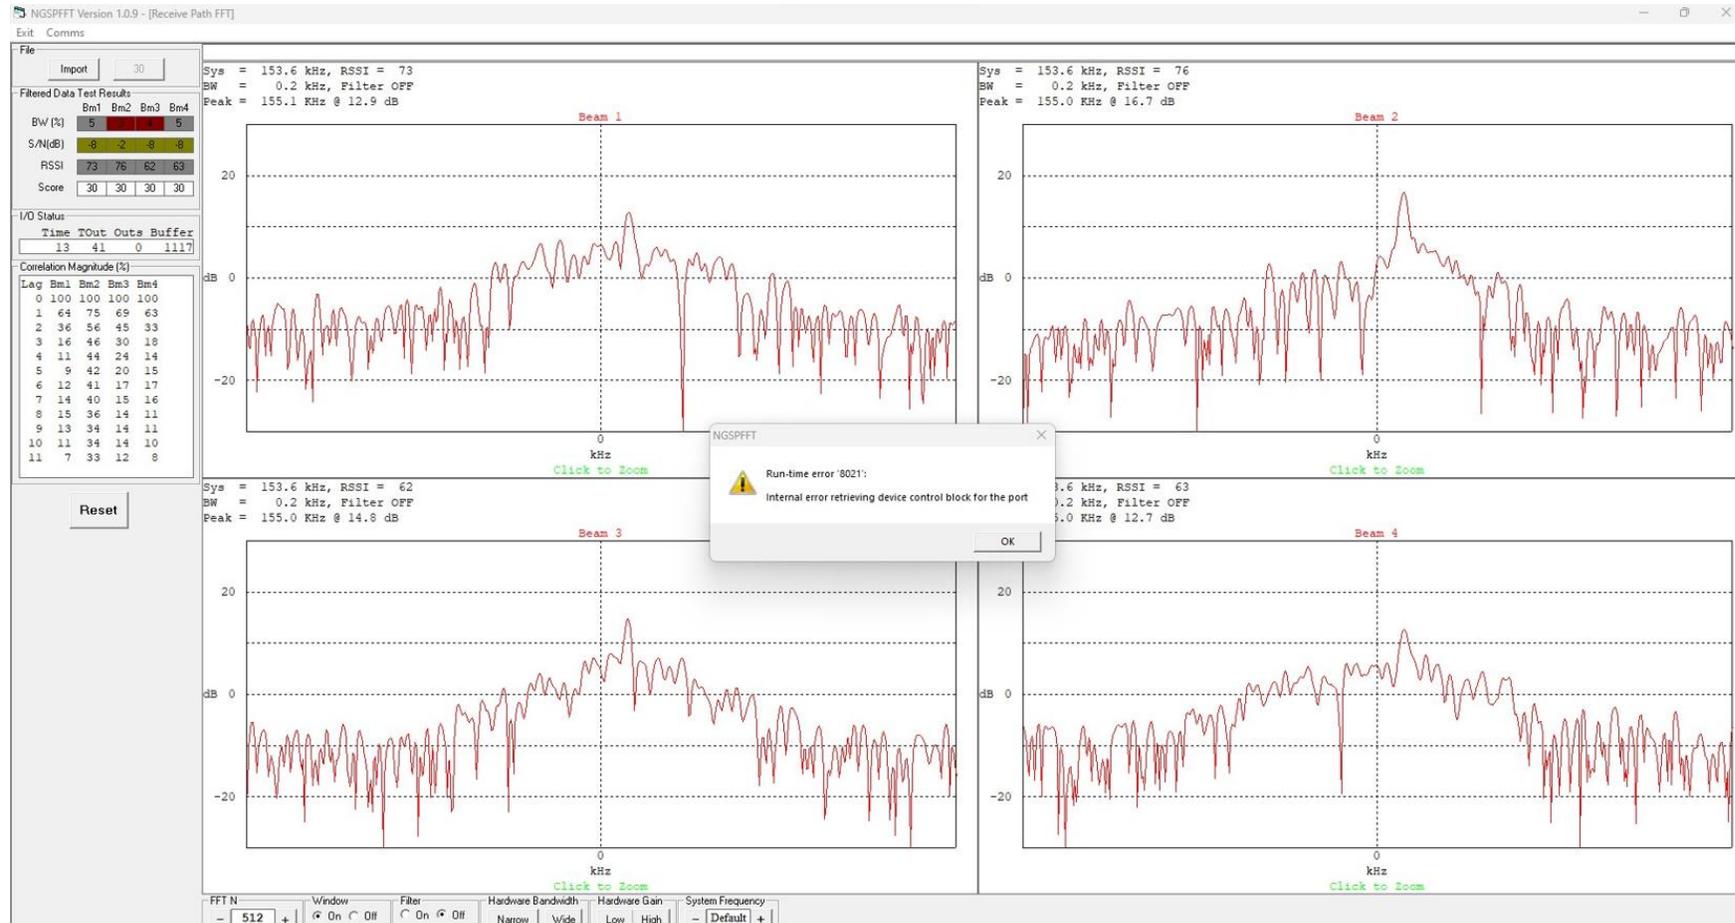
- FFT (Fast Fourier Transform)
 - Acoustic Interference

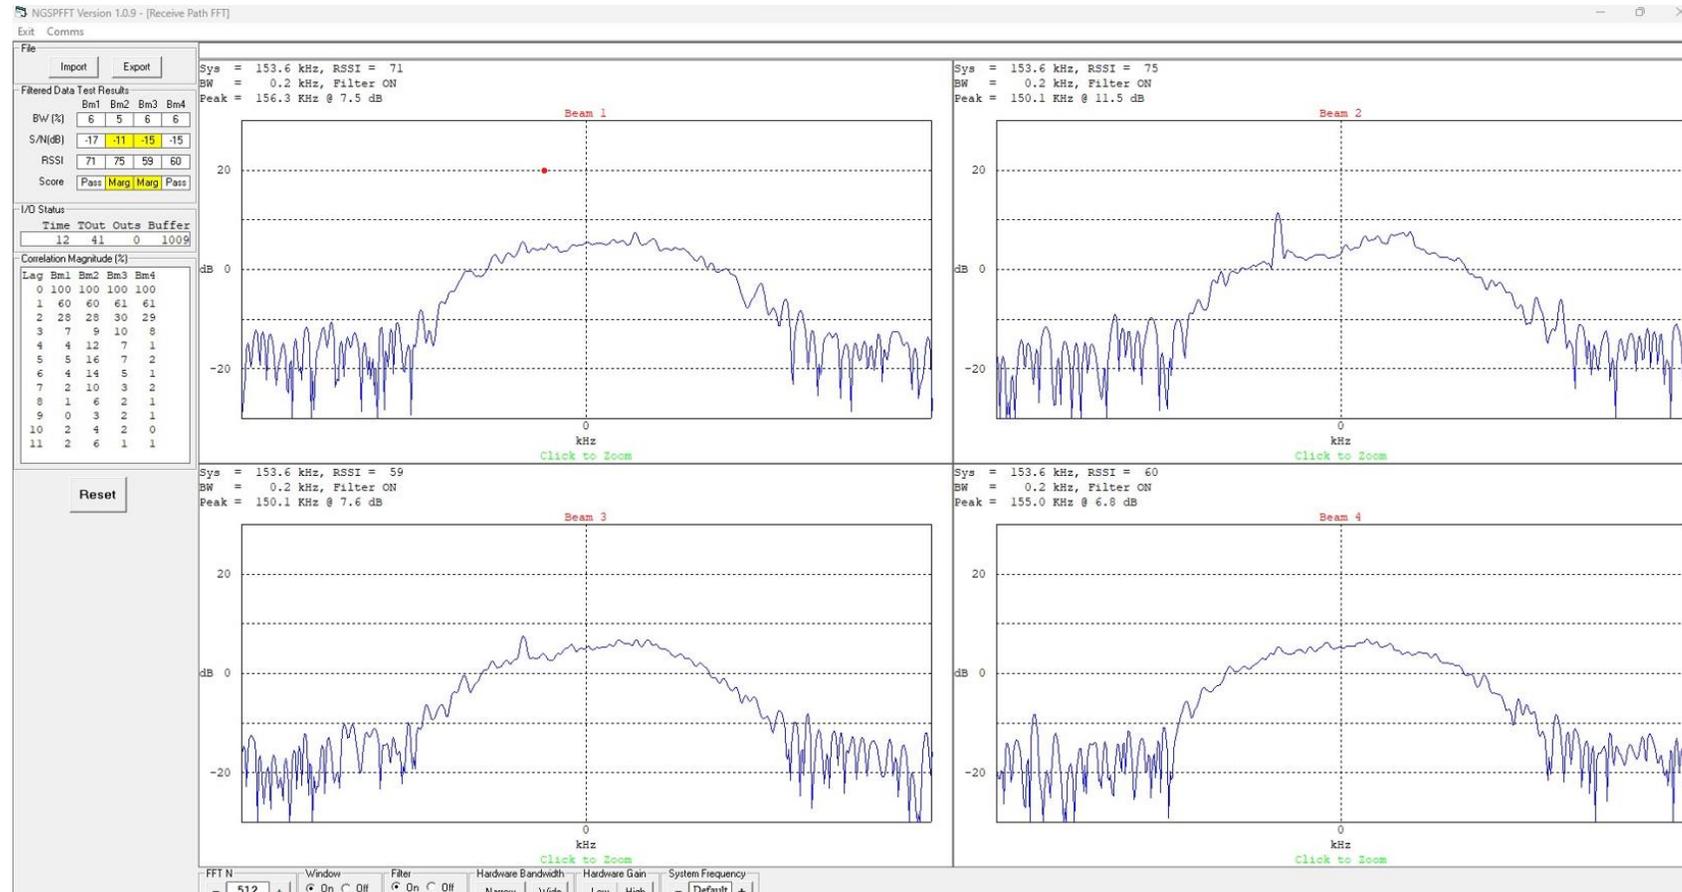
- FFT
 - EMI on Cable
