# STARC Report AICC – Technical Issues

# STARC Report AICC - Forward Jackstaff

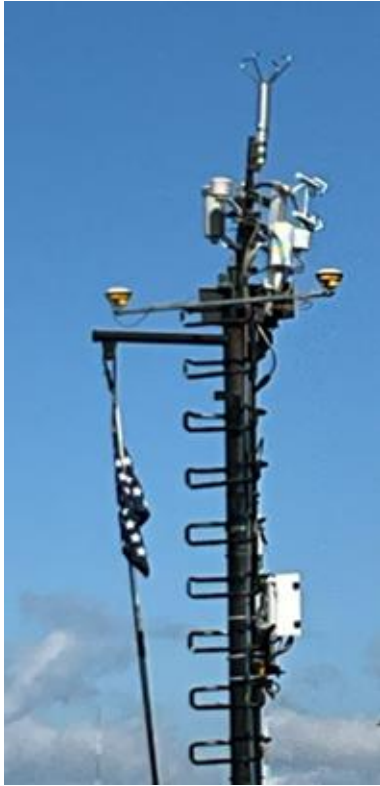
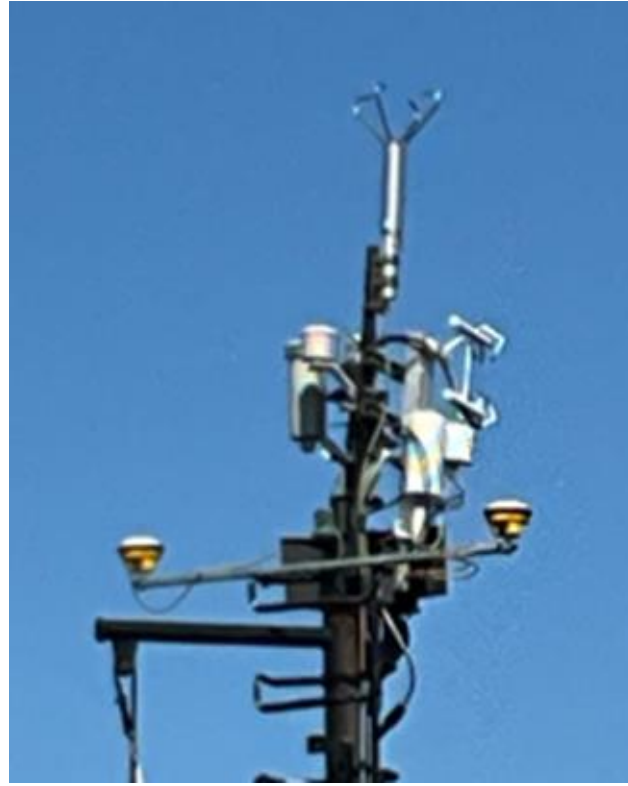
Multiple sensors and junction box on anemometer post

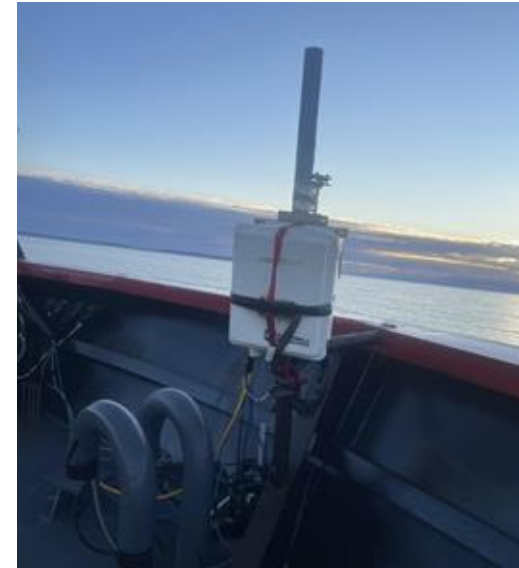
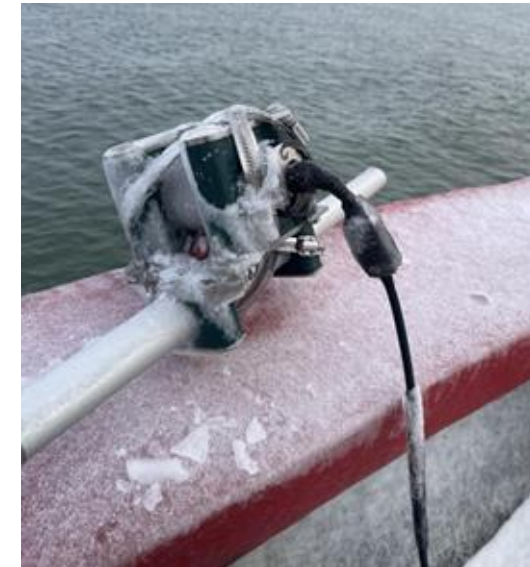
Additional junction box, and sea surface temperature sensor located on the bow.

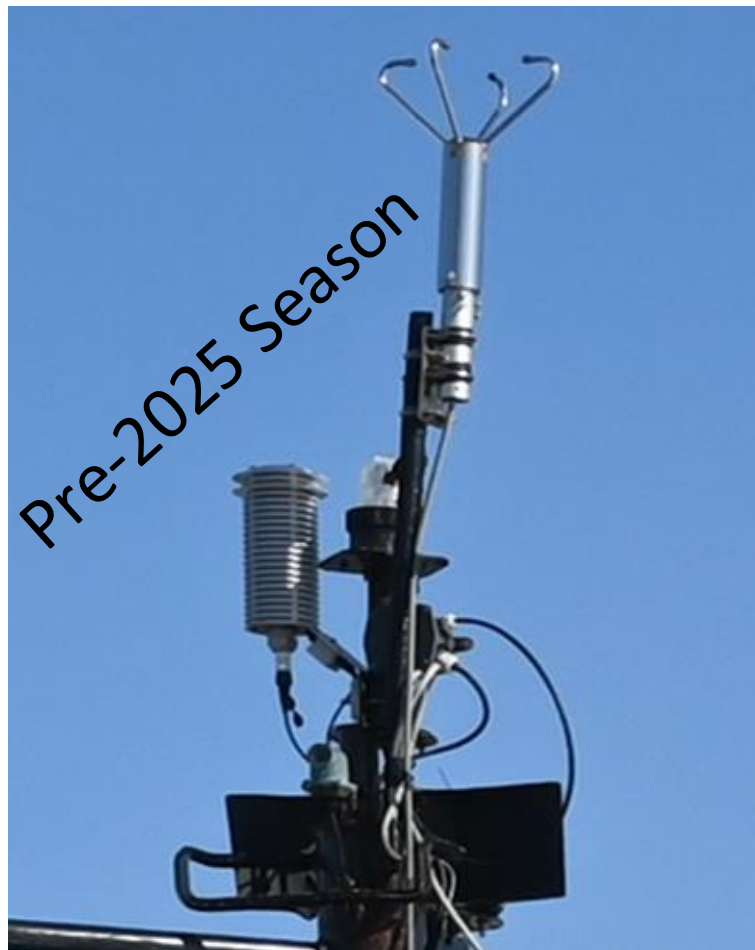
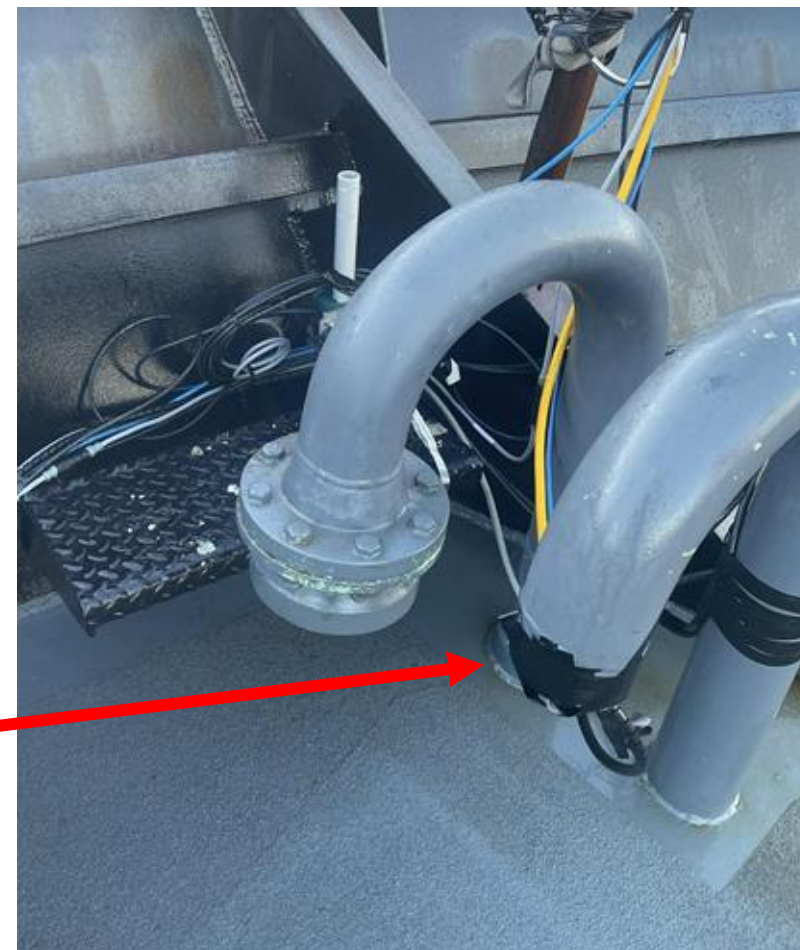
Current design

Limited space for additional sensors

Ship-induced vibration

Difficult cable management

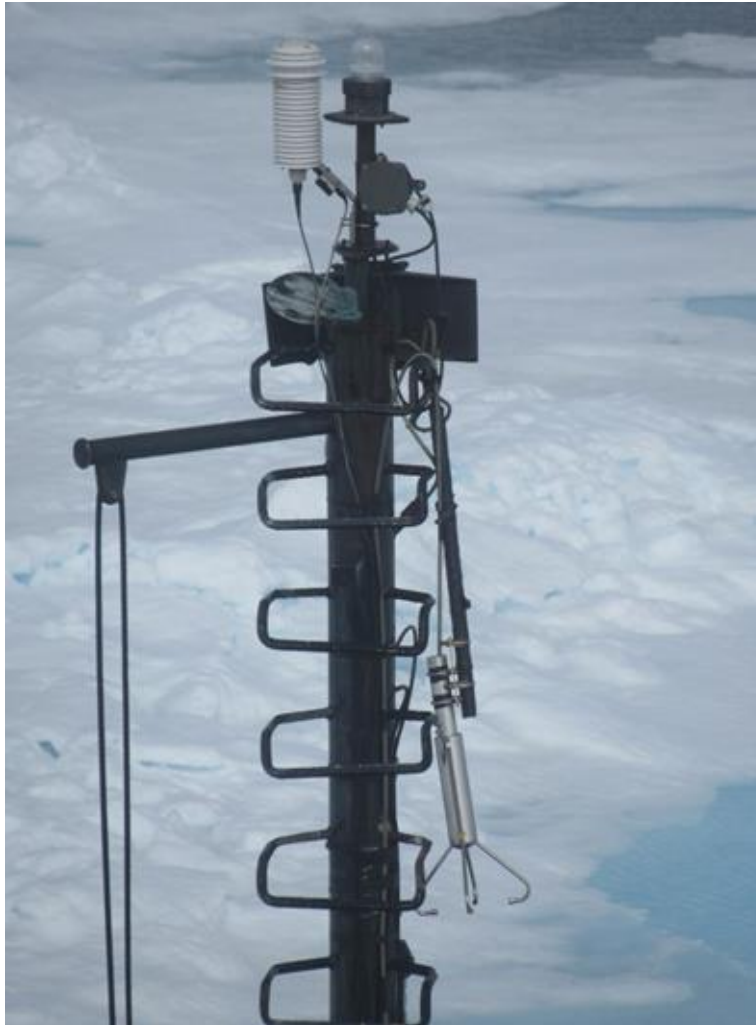
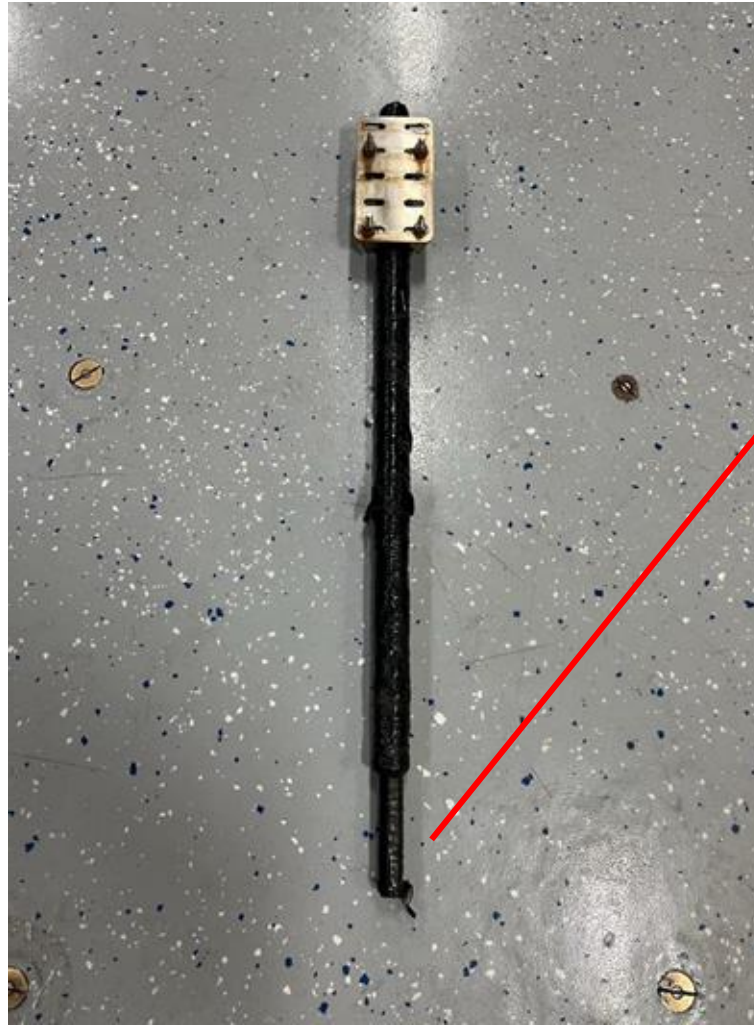
One inch rebar  
snapped from  
jackstaff

Poor design due to limited  
space.

Weakened by temporary  
sensors, vibration, corrosion
