Troubleshooting RDI Vessel Mounted ADCPs

What can go wrong with workhorse or ocean surveyor vessel-mounted instrument and how to troubleshoot it. This breakout is at the instrument level, not SOP for operations.

Teledyne RDI

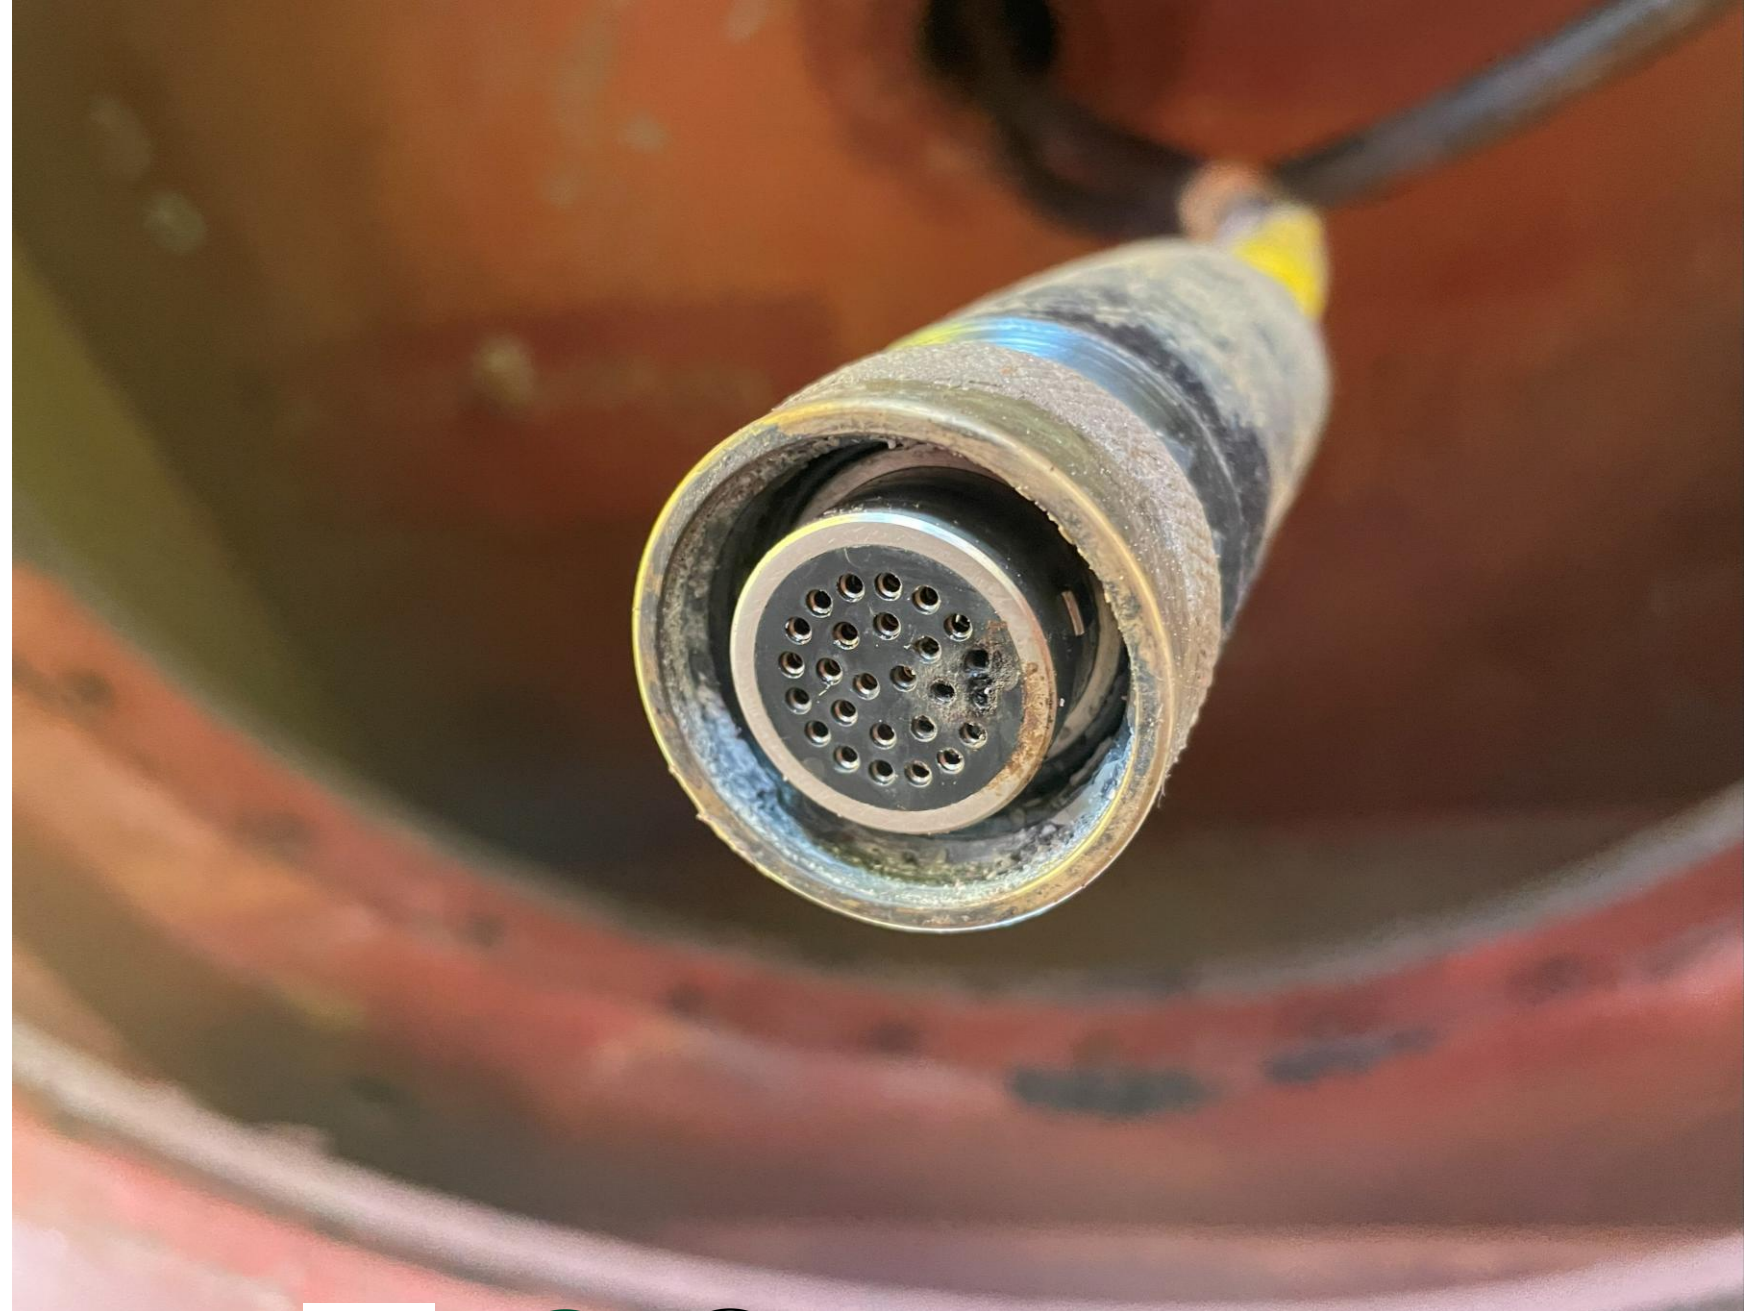
Things to look out for

Corrosion or evidence of flooding

Scorched pins or scorch marks on the connector plug

Cuts or abrasions on the wet end of the cable, they may lead to flooding

Cable fatigue or excessive cable wear

Crushed cable

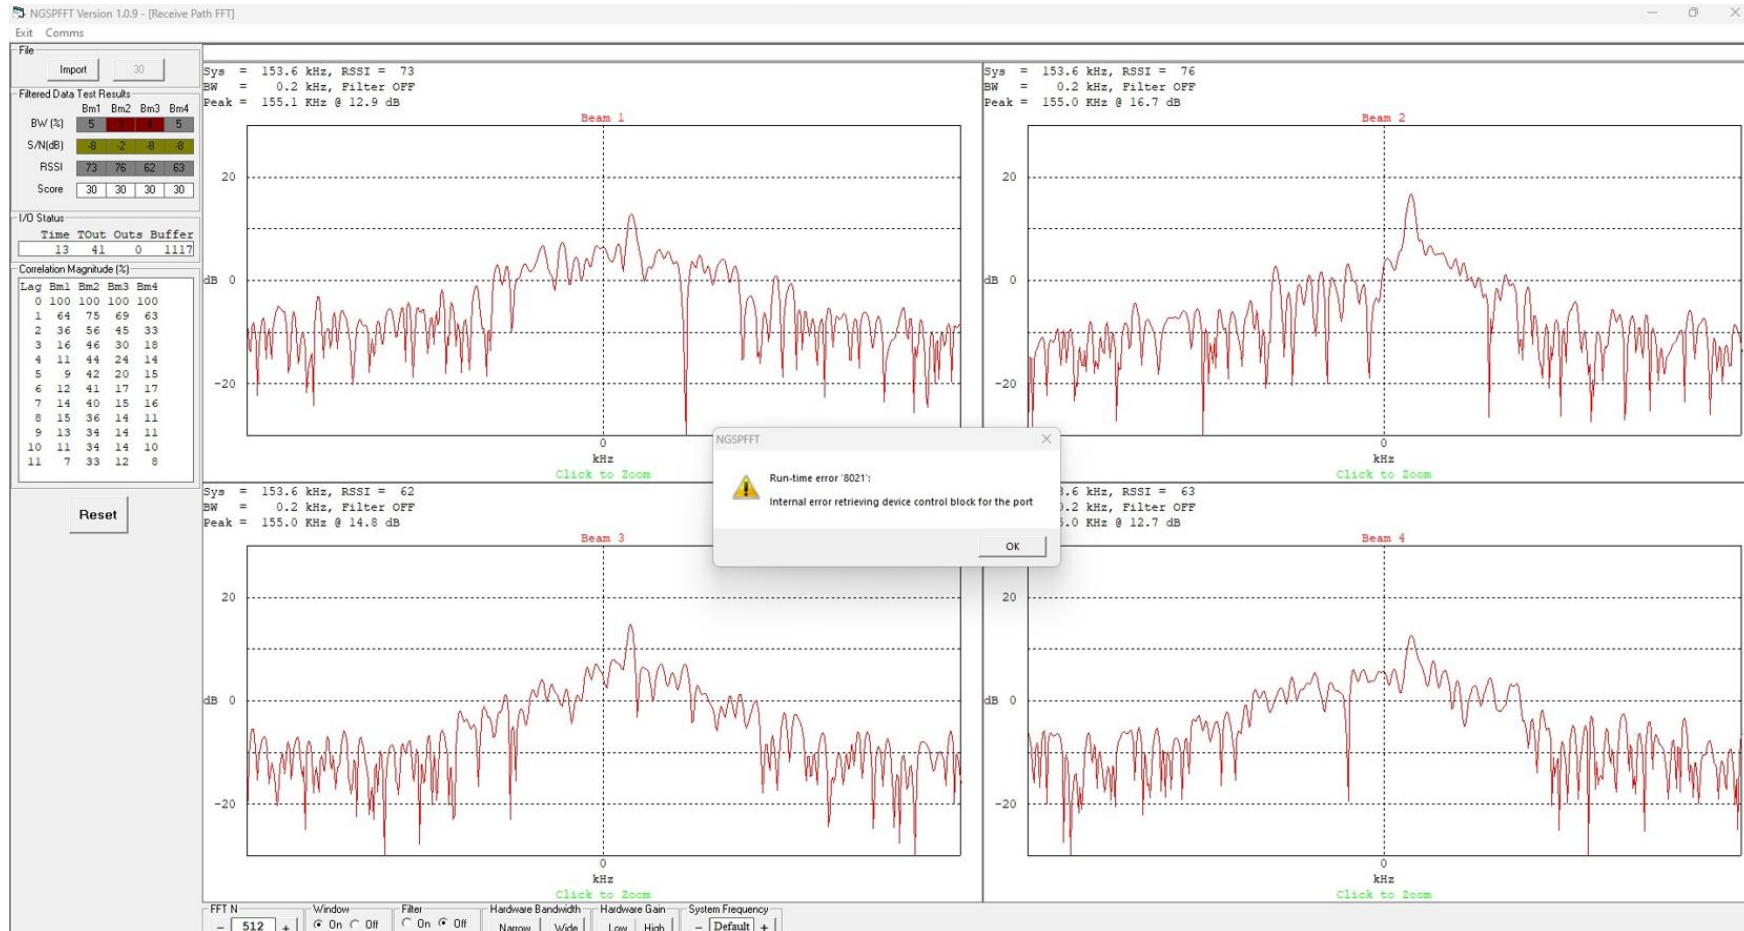
- FFT (Fast Fourier Transform)
 - Acoustic Interference

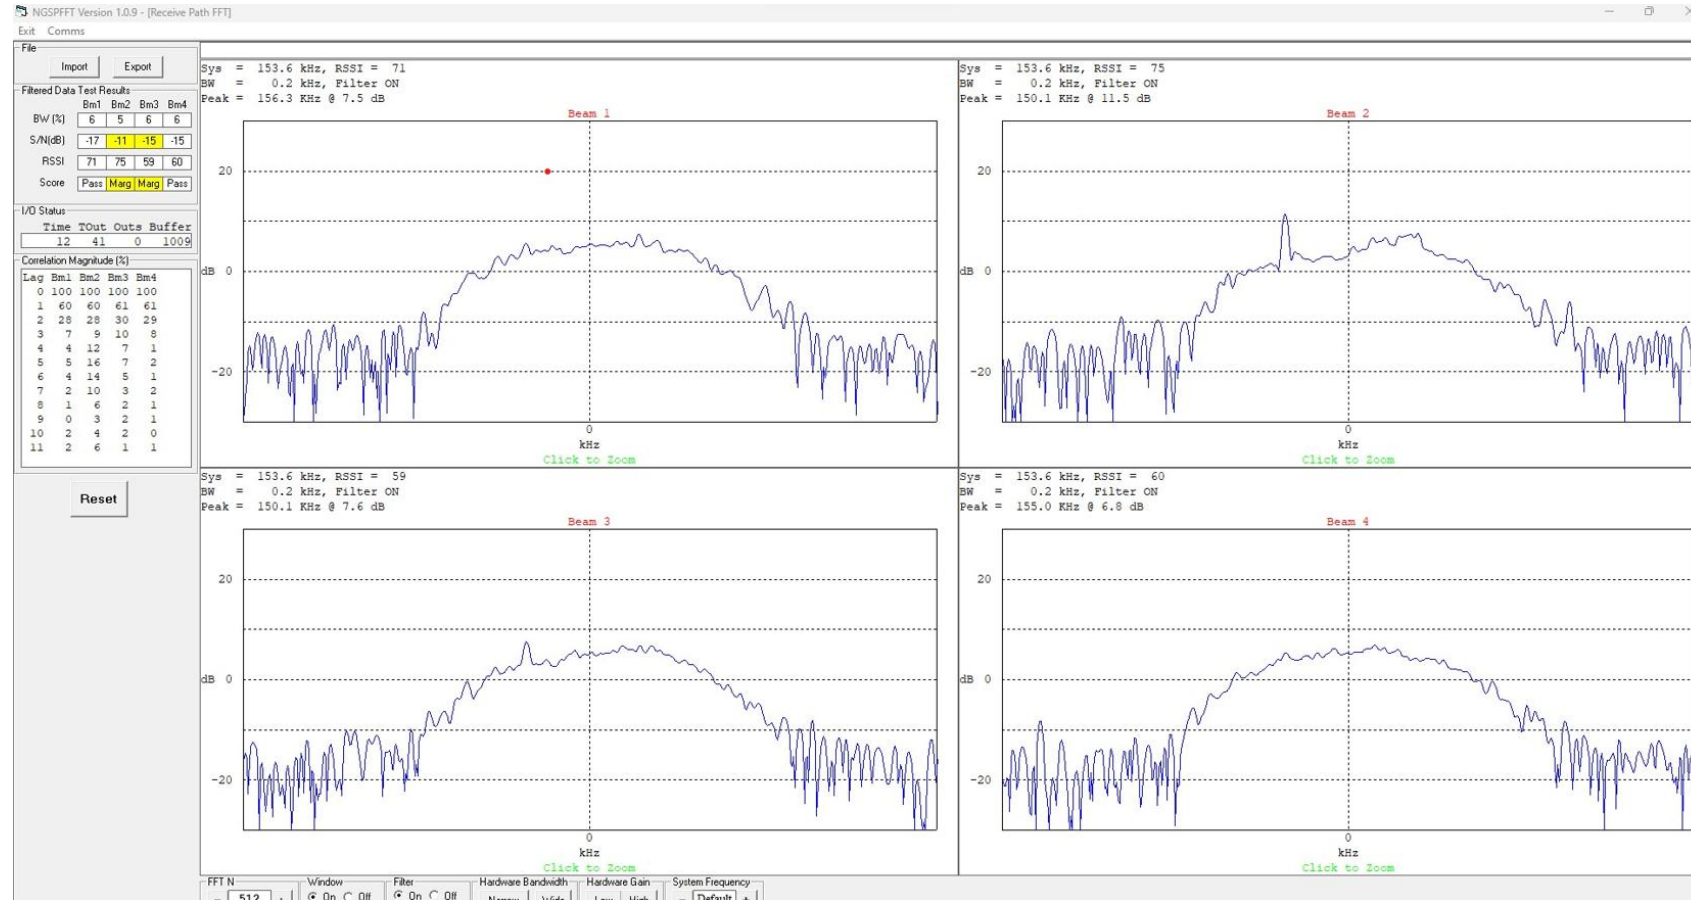
- FFT
 - EMI on Cable

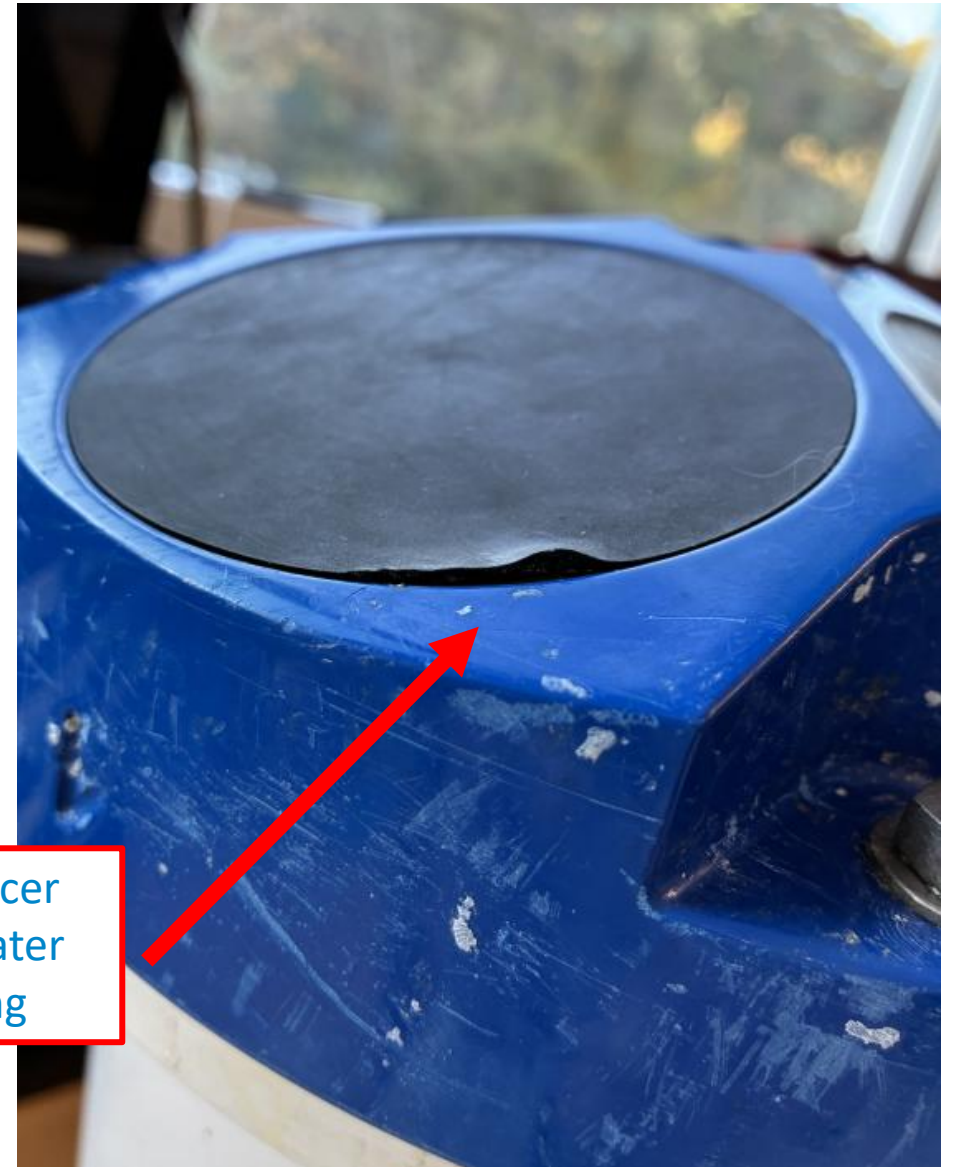
Peeling on transducer face can lead to water ingress and flooding
