SWAB REPORT # 1016

SWAB DATE: 15 October 2021

R/V Savannah

REPORT FOR SWAB # 1016

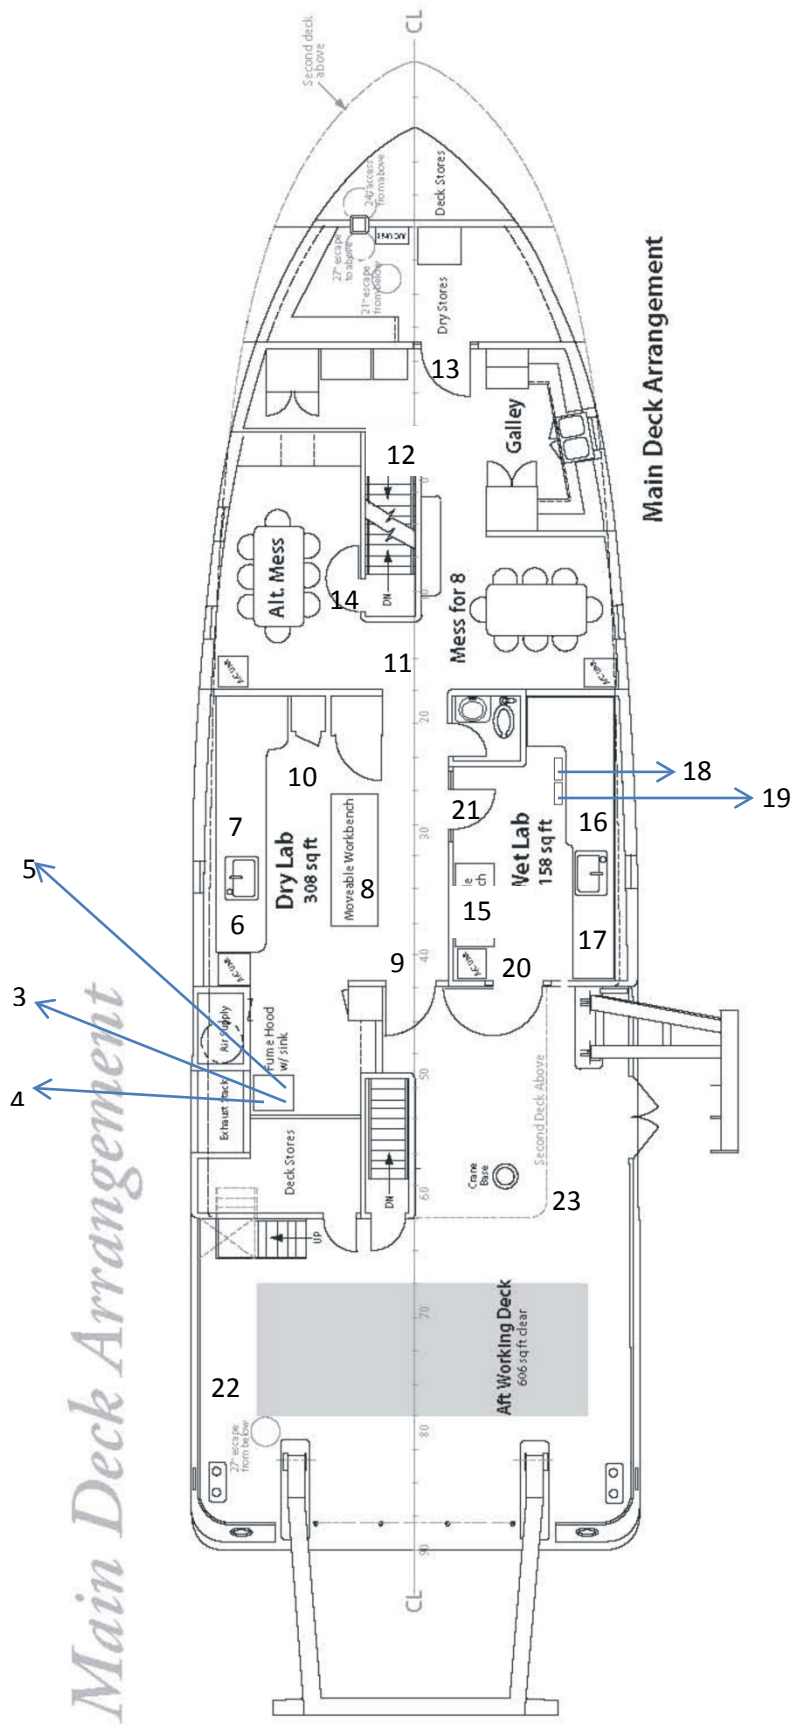
Figure 1
 SWAB #1016
 15 October 2021

Sample #	Sample Identification	³ H dpm/m ²		¹⁴ C dpm/m ²	
		activity	error	activity	error
1	1st Vial Bkgnd	0 ±	0	0 ±	0
2	Initial bucket blank	-50 ±	0	-7 ±	0
	<u>Dry Lab (Figure 1)</u>				
3	Inside fume hood	missing		missing	
4	Benchtop next to fume hood	*5125 ±	201	*80 ±	11
5	Deck in front of fume hood	192 ±	66	2 ±	6
6	Benchtop aft of sink	-26 ±	90	18 ±	40
7	Benchtop forward of sink	-89 ±	31	8 ±	94
8	Center benchtop	-59 ±	204	-9 ±	112
9	Deck at aft entrance	-58 ±	198	16 ±	45
10	Forward deck	-40 ±	139	11 ±	45
	<u>Miscellaneous Areas (Figure 1)</u>				
11	Deck under water fountain	-24 ±	83	-14 ±	37
12	Deck at bottom of stairs	-48 ±	165	25 ±	41
13	Deck inside forward door	-22 ±	76	-7 ±	82
14	Deck at top of stairs	-33 ±	114	-12 ±	51
	<u>Wet Lab (Figure 1)</u>				
15	Port benchtop	-30 ±	102	15 ±	41
16	Benchtop forward of sink	-42 ±	143	20 ±	41
17	Benchtop aft of sink	-18 ±	63	11 ±	40
18	Inside Thermo refrigerator	-26 ±	91	6 ±	47

19	Inside Isotemp freezer	-22 ±	75	-10 ±	117
20	Deck at aft entrance	-18 ±	64	-12 ±	52
21	Deck inside port entrance	18 ±	63	-9 ±	108
	<u>Aft Deck (Figure 1)</u>				
22	Deck near incubator	-33 ±	114	20 ±	40
23	Deck near CTD	-2 ±	9	-23 ±	37
24	Final bucket blank	-30 ±	103	3 ±	70

Category	^3H (dpm/m^2)	^{14}C (dpm m^2)	Recommendations
A	<500	<50	No action
B*	500-10,000	50-10,000	Needs cleaning before any natural tracer work. Decks in radiation vans with activities above $1000 \text{ dpm}/\text{m}^2$ should be cleaned.
C**	10,000-100,000	10,000-50,000	Must be cleaned before any use.
D***	>100,000	>50,000	May be a health hazard. Notify local radiation safety official.
