SWAB REPORT #1054

R/V Kilo Moana & OTG Rad Van

REPORT FOR SWAB # 1054

LOCATION: Honolulu, HI
VESSEL/LAB: R/V Kilo Moana

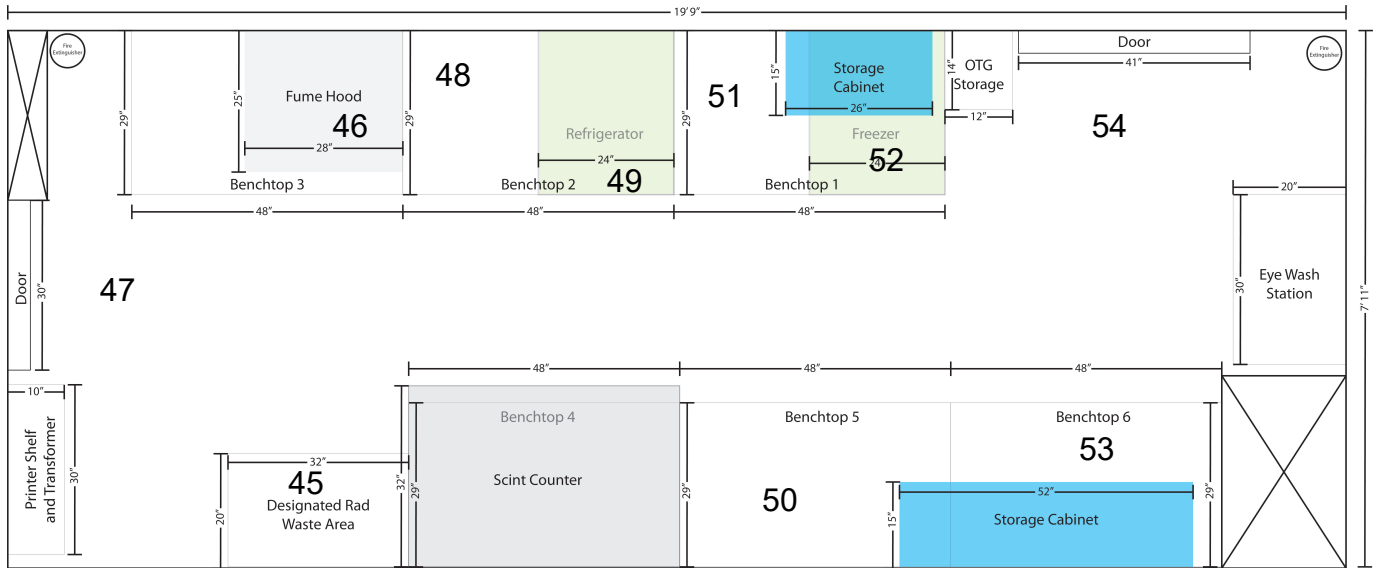
Figure #2
SWAB #1054
15 February 2023

43	Deck in front of foward sink	21	± 21	-39	± 43
44	Intermediate bucket blank	57	± 37	-32	± 36
<u>OTG Rad Van, Ser#592.2.01 (Figure 2)</u>					
45	Designated Rad waste area	*653	± 95	28	± 9
46	Inside fume hood	108	± 32	-38	± 42
47	Deck inside entrance near fume hood	*702	± 102	6	± 3
48	Benchtop next to fume hood	*1395	± 139	24	± 26
49	Inside refrigerator near fume hood	104	± 31	-22	± 24
50	Benchtop next to LSC	88	± 32	-18	± 20
51	Benchtop next to entrance	96	± 35	-4	± 199
52	Inside refrigerator near entrance	46	± 24	-1	± 15
53	Benchtop across from entrance	128	± 38	-17	± 19
54	Deck inside front entrance	146	± 44	-15	± 17
55	Final bucket blank	27	± 28	-16	± 17

values to zero. Values are only significantly above background when they are positive and larger than the error. Please note that we are now using a Quantulus 6220 LSC which counts very near natural background. While the cleanup standards have not changed all values above background will now be in bold. All areas on the ship were free from isotope contamination requiring cleaning. The Rad Van had minor ^3H contamination. No action is necessary
