The Use of Synthetic Tension Members

per Appendix A of the UNOLS
Research Vessel Safety Standard
January 17, 2024

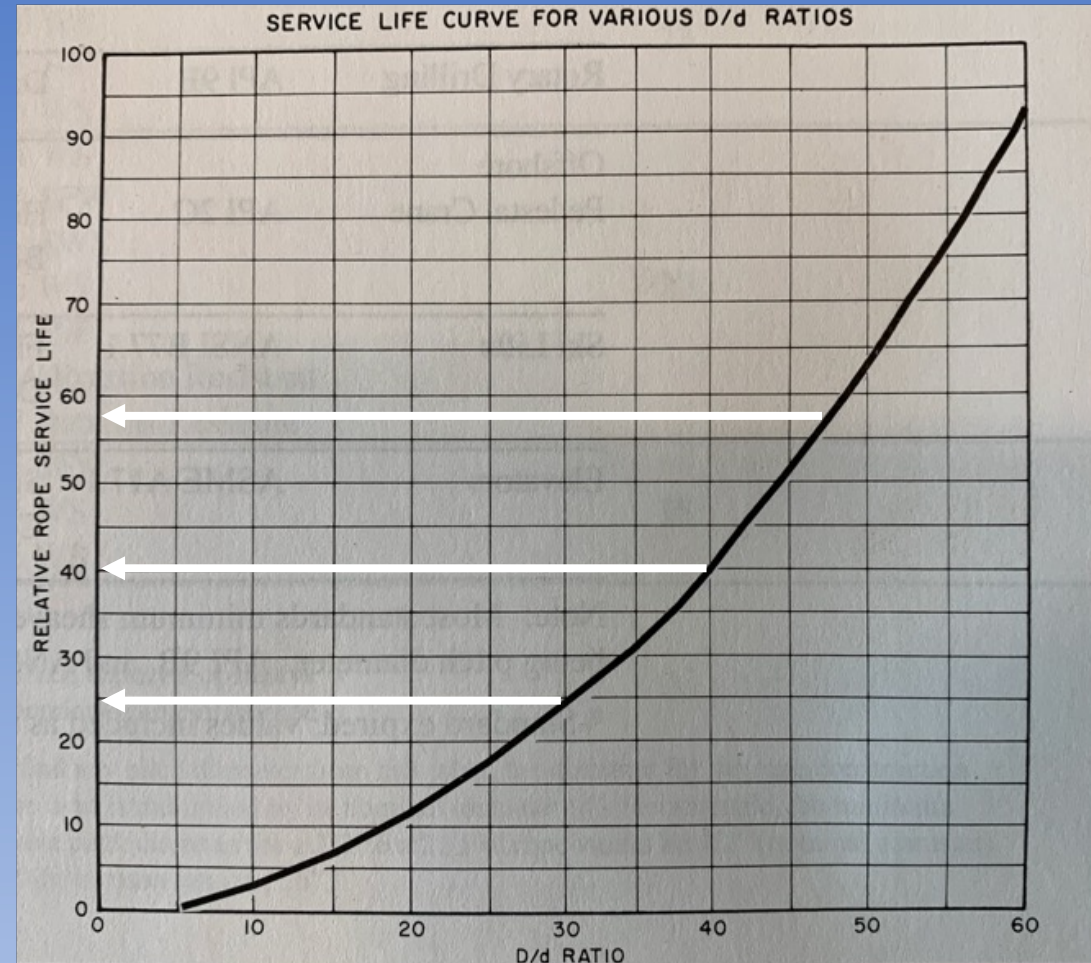
Impact of Sheave Size on Rope Service Life

$D/d = 30$ to $D/d = 40$ 66% increase in the bend service life of the rope

Doubles the service life compared to $D/d=30$

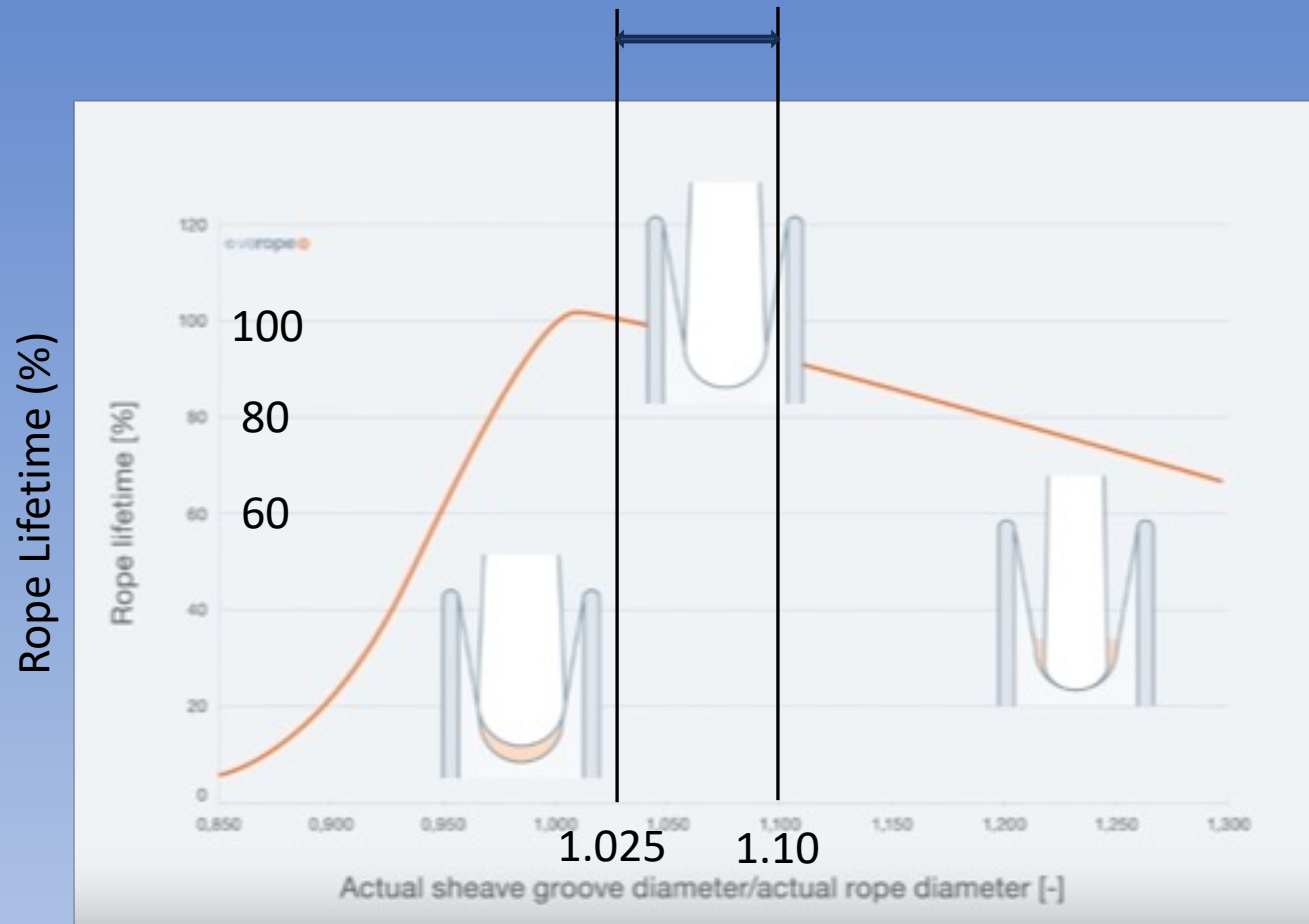
Impact of Groove Diameter On Rope Life

$\frac{\text{Sheave groove diameter}}{\text{Rope diameter}}$

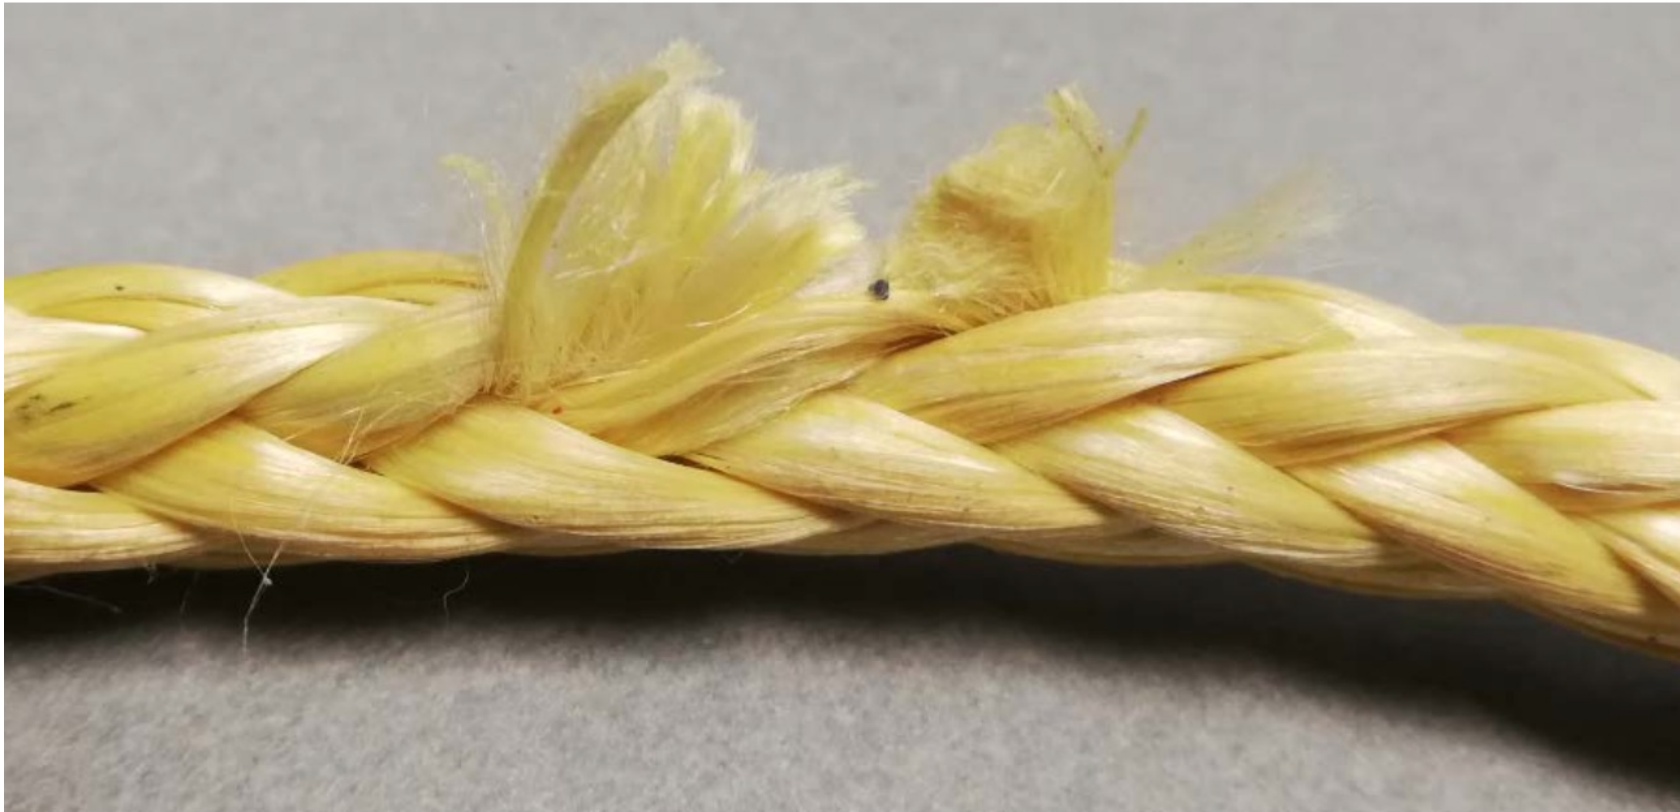
Cuts

Even squared off fiber ends at point of damage

Extent of damage depends on depth, will reduce strength, rope may become unbalanced.

Partially cut strand

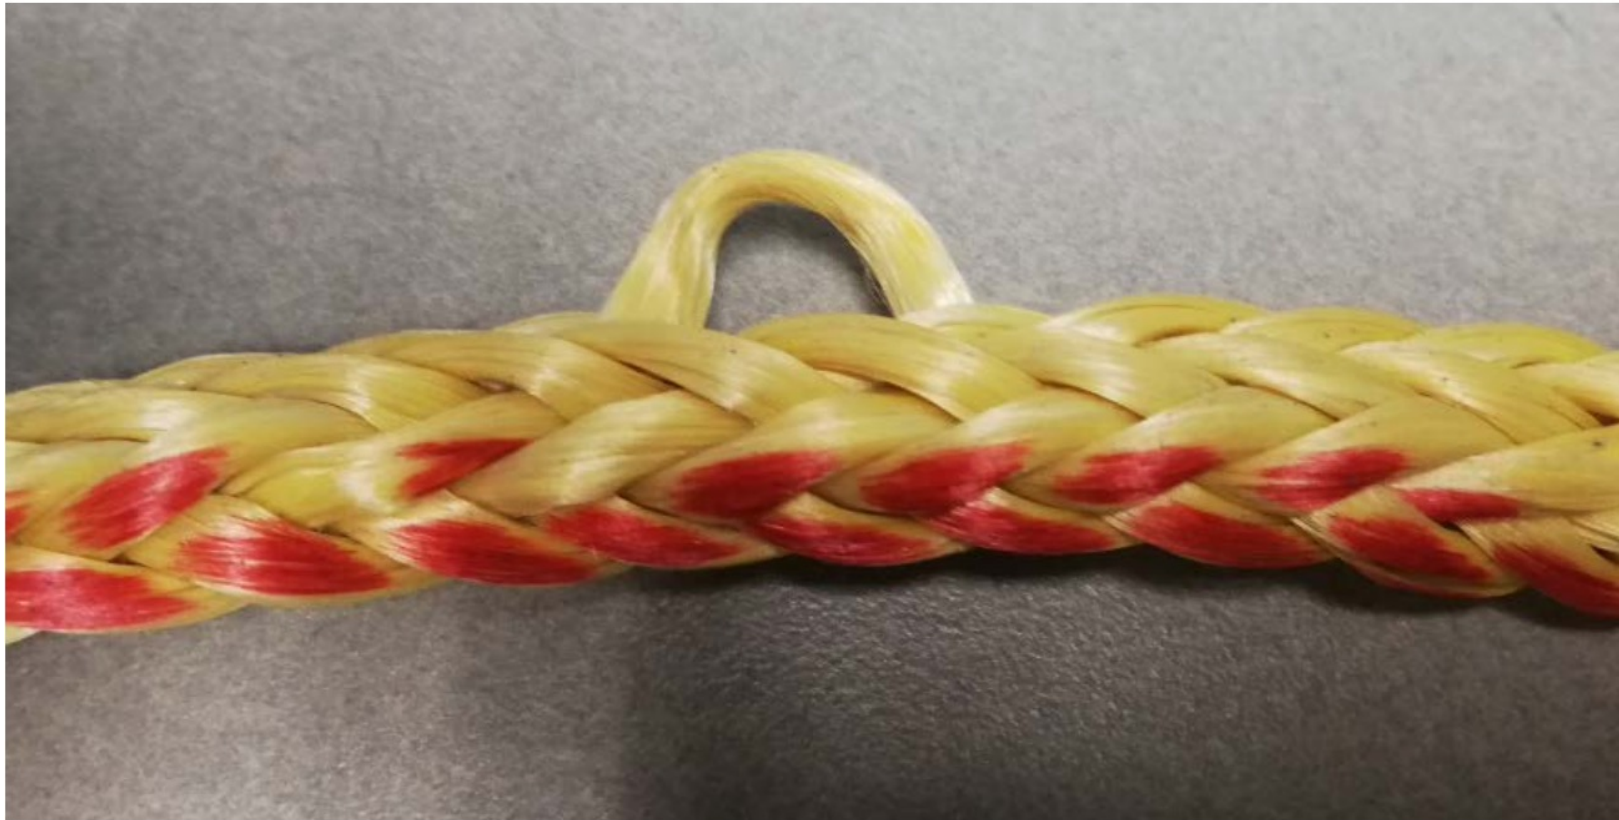
Pulls

Object snags a yarn or strand and pulls it away from rope surface forming a loop.
Attempt to work the pulled strand back

Pulled strand

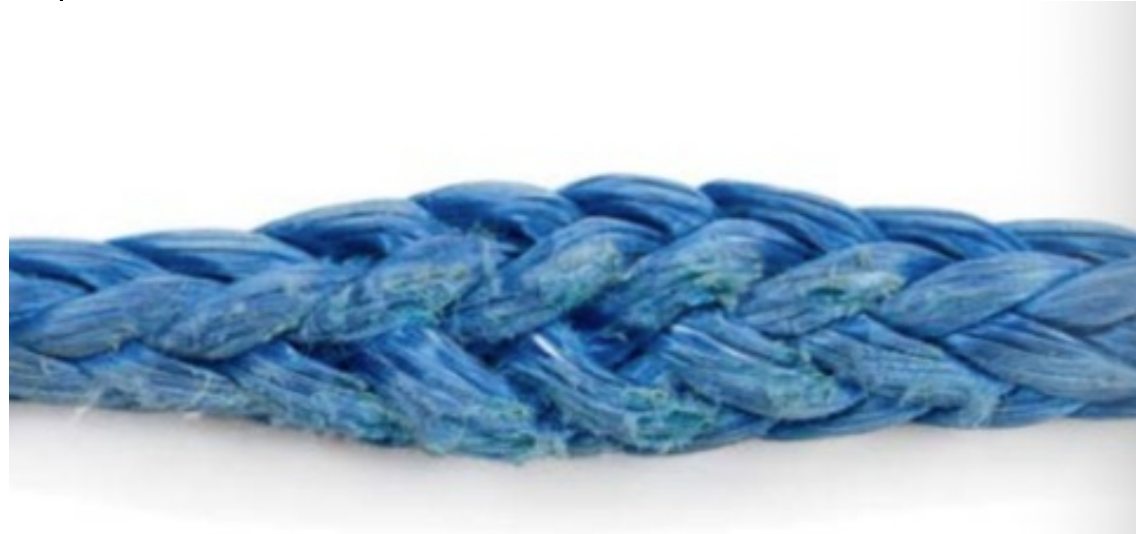
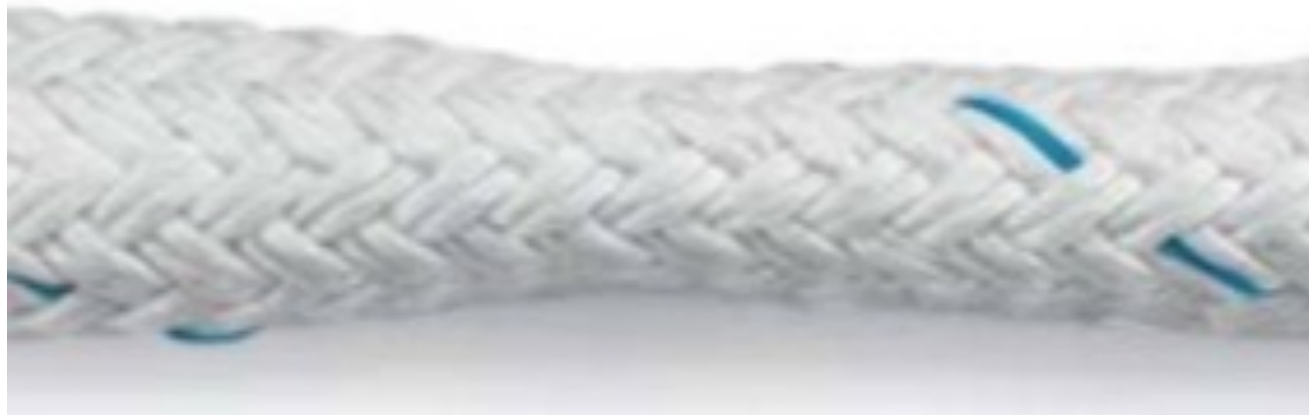
Uneven diameter

Distortion, significant diameter change, inconsistency in overall measurements will decrease the performance of the rope.

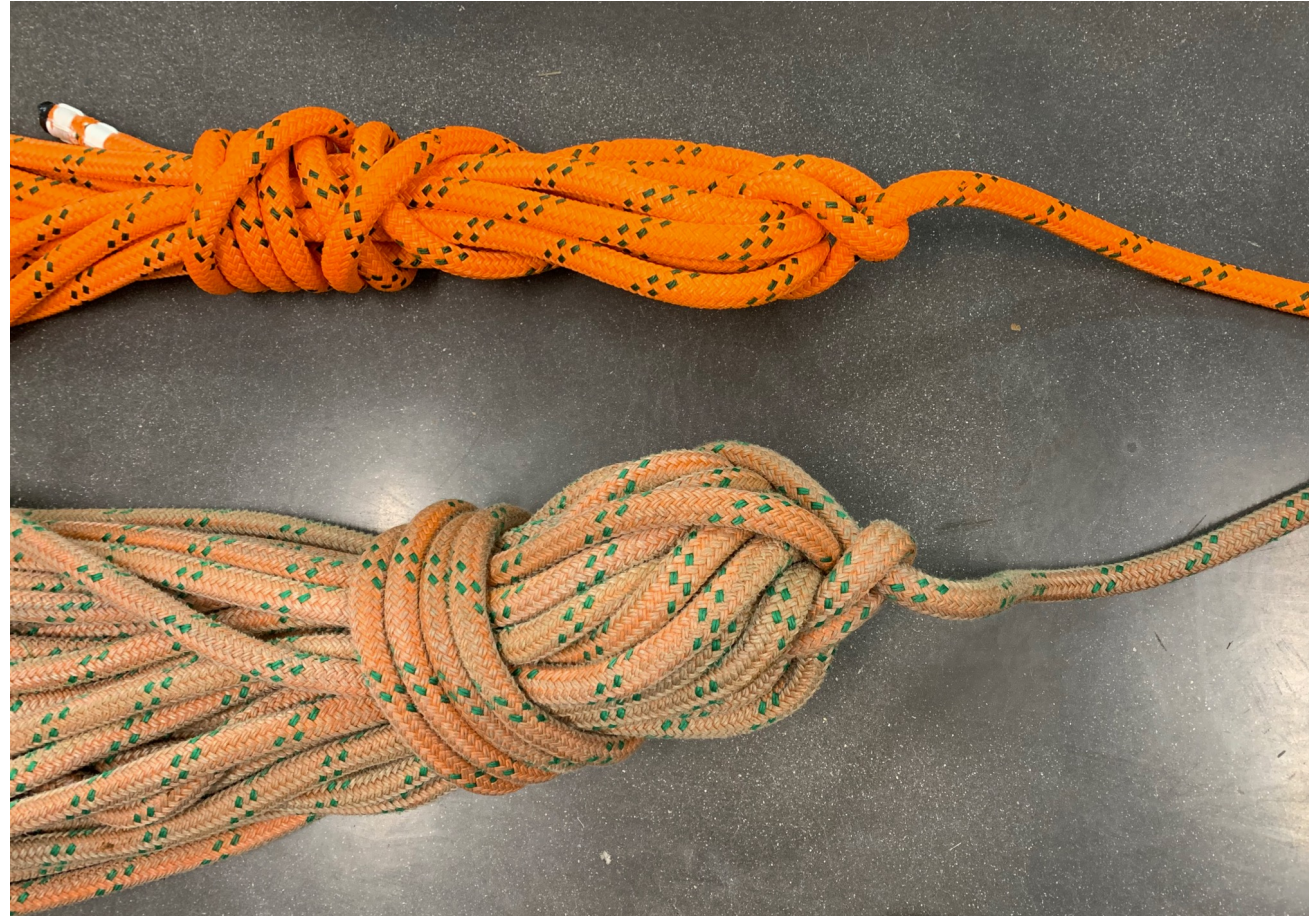
Discoloration

UV exposure tends to cause discoloration. Long periods of exposure will decrease the overall strength. Chemicals may cause discoloration
