SWAB REPORT #1020

R/V Kilo Moana & OTC Rad Van

LOCATION: Honolulu, HI
VESSEL/LAB: *R/V Kilo Moana*

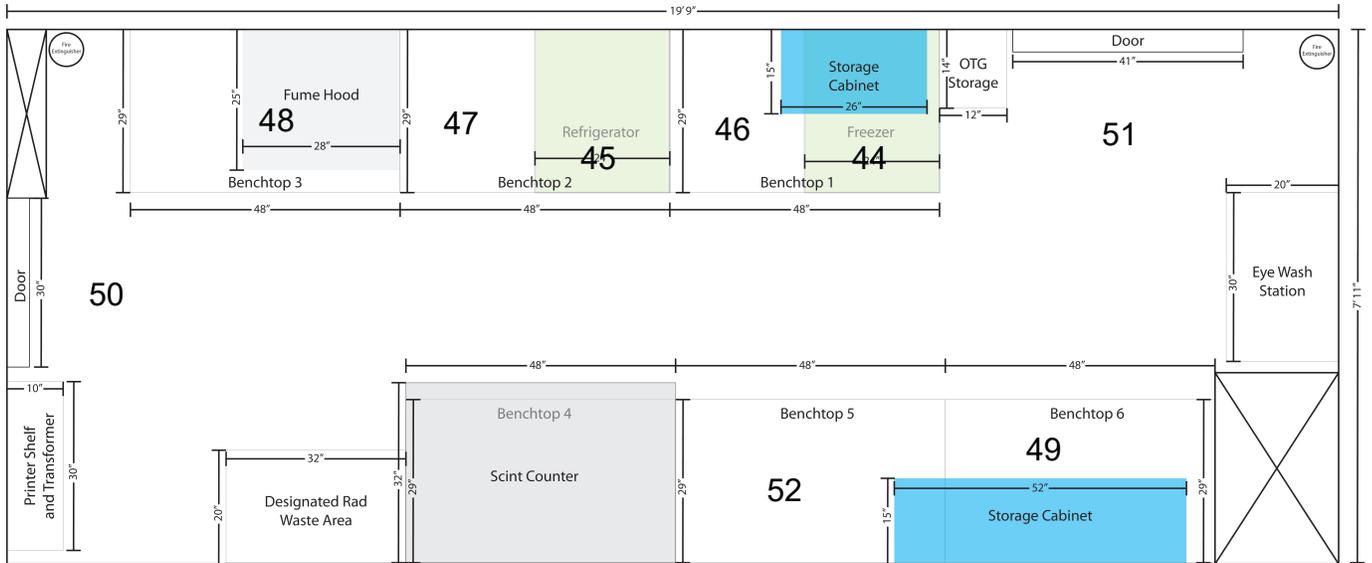
Figure #2
SWAB #1020
12 December 2021

43	Aft sink area with bench in starboard lab	-20	± 45	-7	± 18
<u>OTG Rad Van, Ser#592.2.01 (Figure 2)</u>					
44	Inside refrigerator near entrance	204	± 43	16	± 7
45	Inside refrigerator near fume hood	396	± 57	25	± 7
46	Benchtop next to entrance	325	± 51	14	± 6
47	Benchtop next to fume hood	*8653	± 255	*116	± 7
48	Inside fume hood	487	± 69	12	± 4
49	Benchtop across from entrance	303	± 54	20	± 7
50	Deck inside entrance near fume hood	*2977	± 180	*304	± 21
51	Deck inside front entrance	714	± 81	45	± 9
52	Benchtop next to LSC	271	± 48	18	± 7
53	Final bucket blank CO #2	34	± 24	4	± 7

Please note that the error reported for each isotope is the two-standard deviation counting error. Reports may now contain values less than zero. Decay counting background samples will be distributed about the background vial, which means that negative values are possible. In the past we rounded the negative values to zero. Values are only significantly above background when they are positive and larger than the error. Please note that we are now using a Quantulus 6220 LSC which counts very near natural background. While the cleanup standards have not changed all values above background will now be in bold. All areas on the ship were free from isotope contamination requiring cleaning. The Rad Van had ^3H and ^{14}C contamination, and while no action is necessary we recommend cleaning the deck to help prevent tracking of ^3H out of the van.
