SWAP  
and other things  
on a two icebreaker cruise  
USCGC Healy  
CGC Louis S. St-Laurant

a very brief report of work done  
by Steve Roberts, Val Schmidt and Dale Chayes

RVTEC October 30, 2008

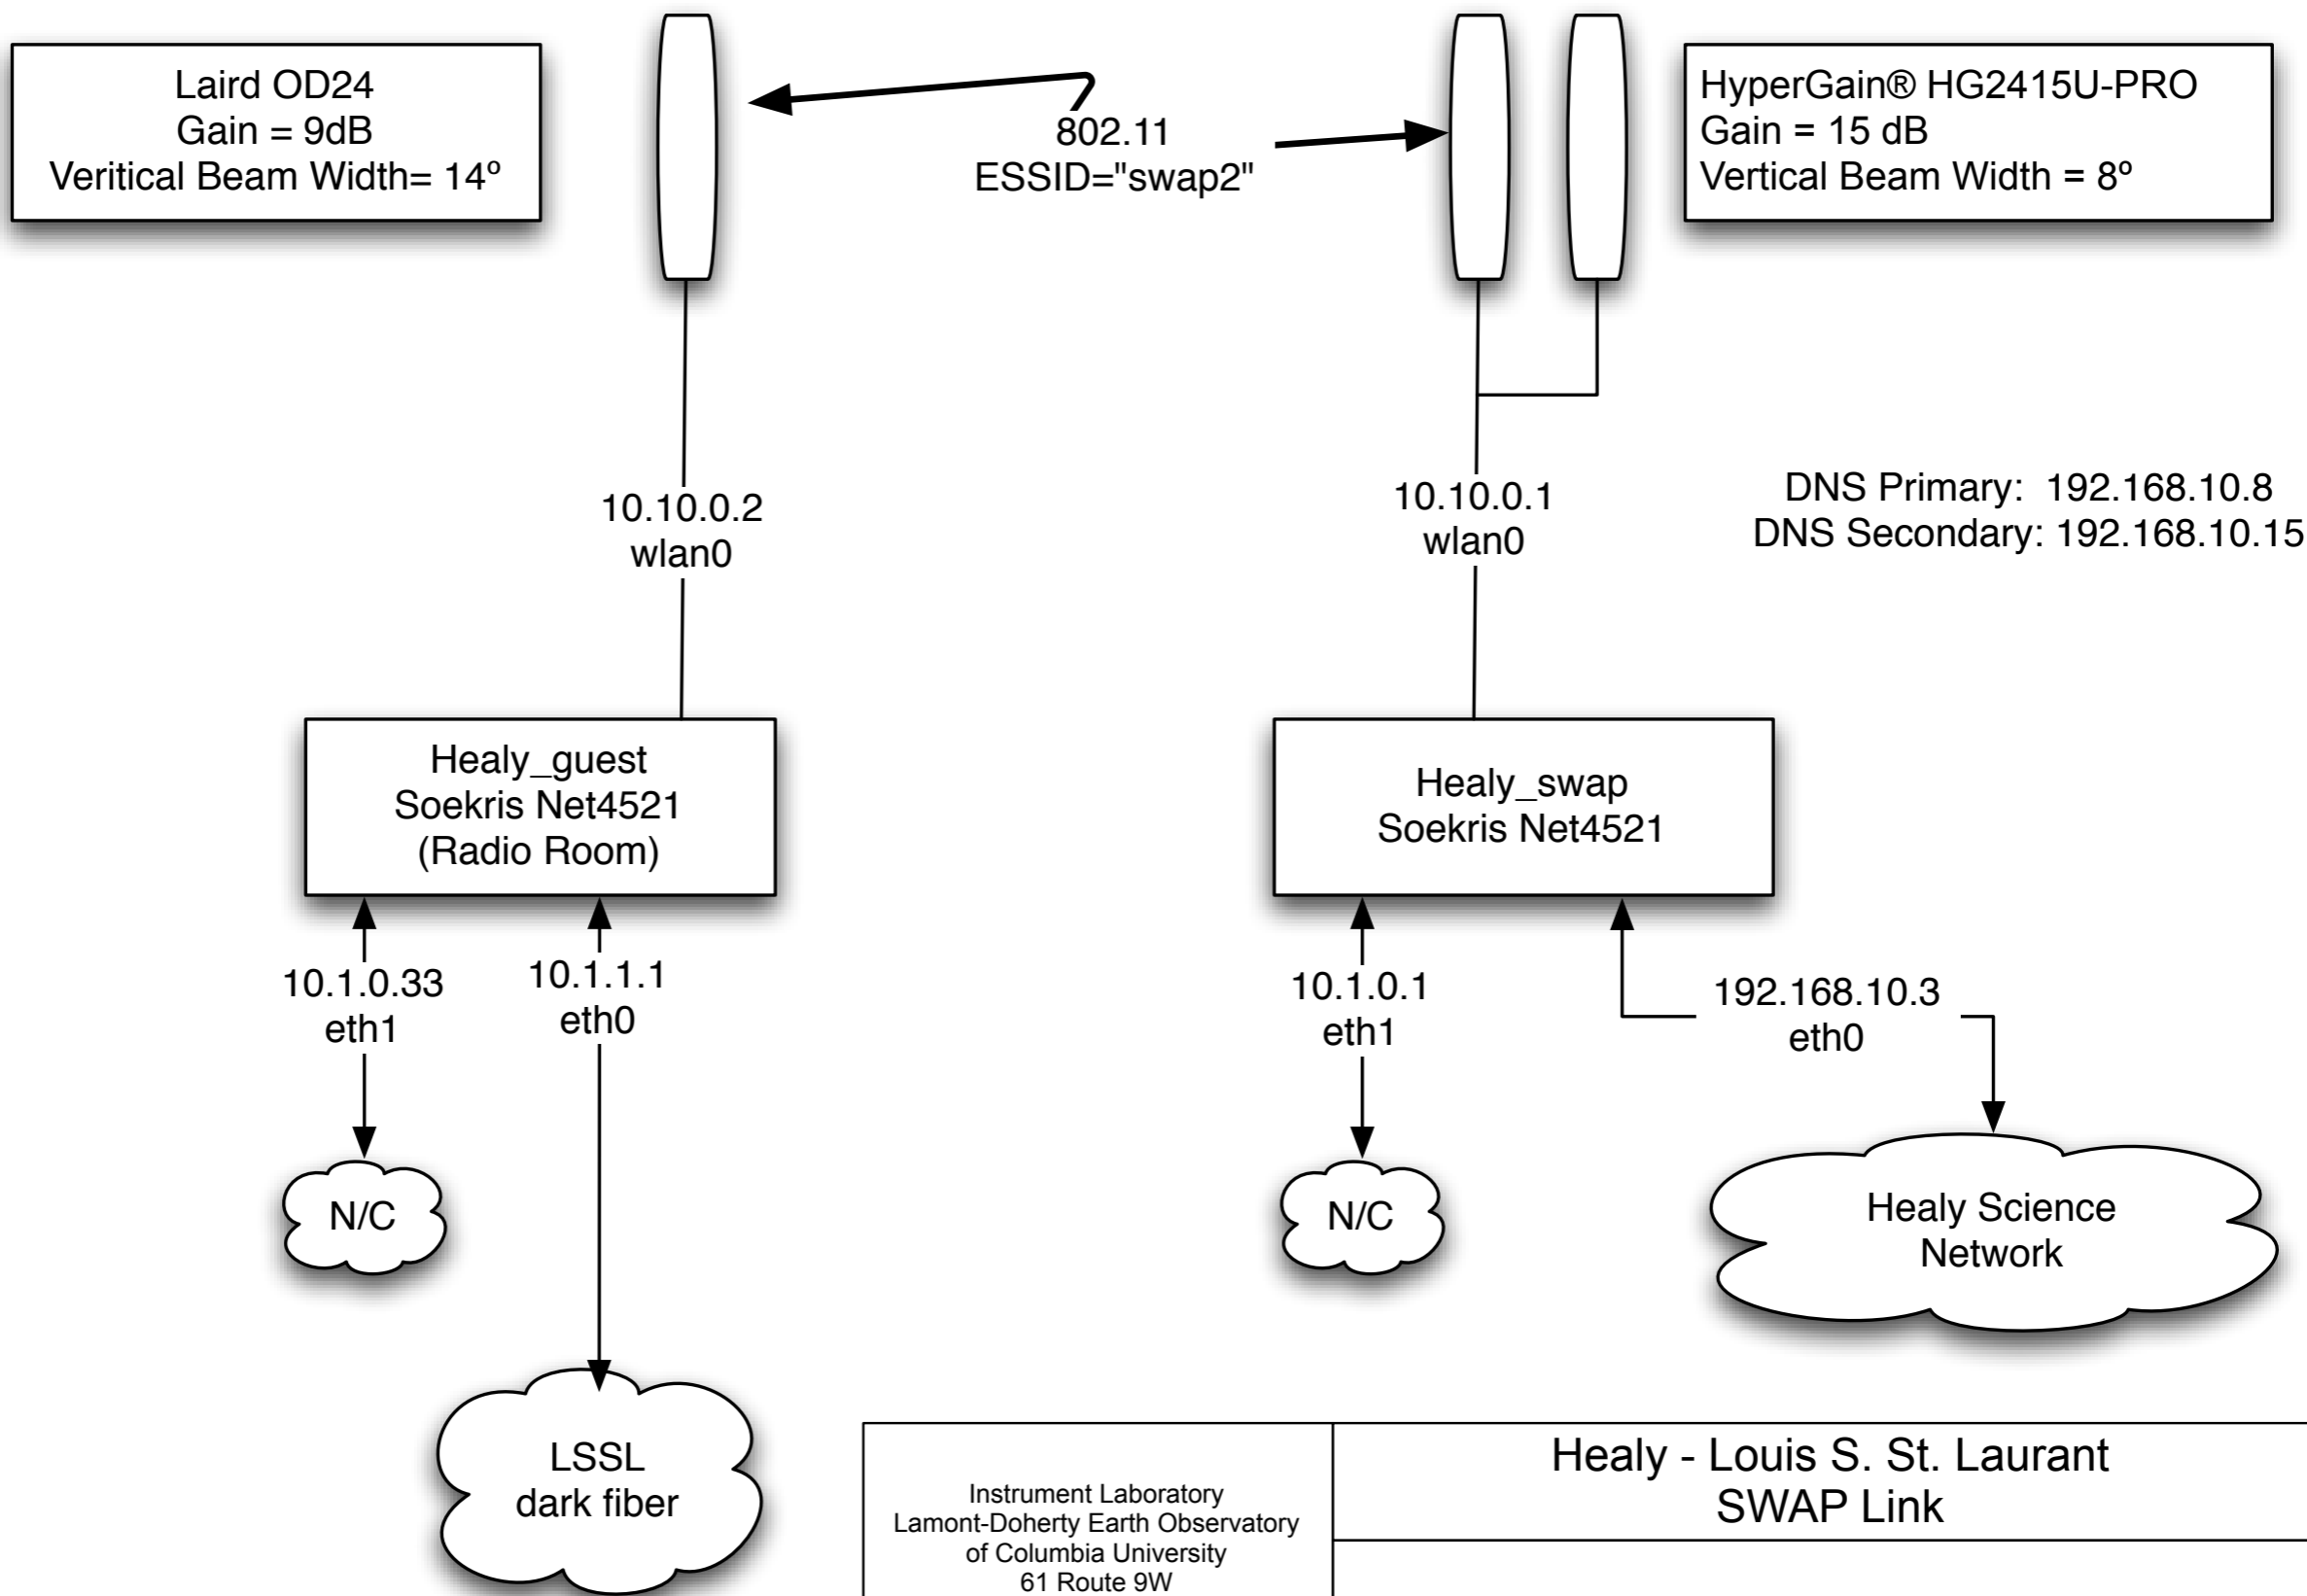
- Continuous connection between ship's (science) working in close proximity
- ssh & http
- VOIP phones

Instrument Laboratory Lamont-Doherty Earth Observatory of Columbia University 61 Route 9W Palisades, NY 10964	<b>Healy - Louis S. St. Laurant          SWAP Link</b>			
	Drawn 2008-09-11 Updated: 2008-09-25	SIZE -	FSCM NO	DWG NO
Dale Chayes dale@ldeo.columbia.edu	SCALE	None	SHEET	10F 2

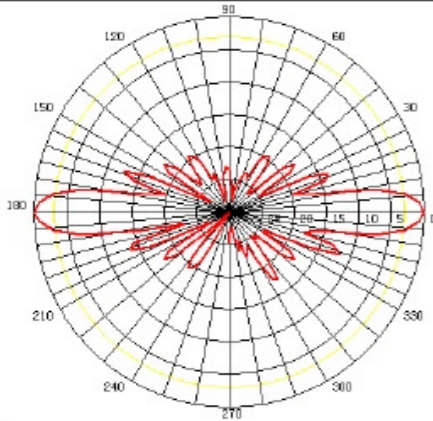
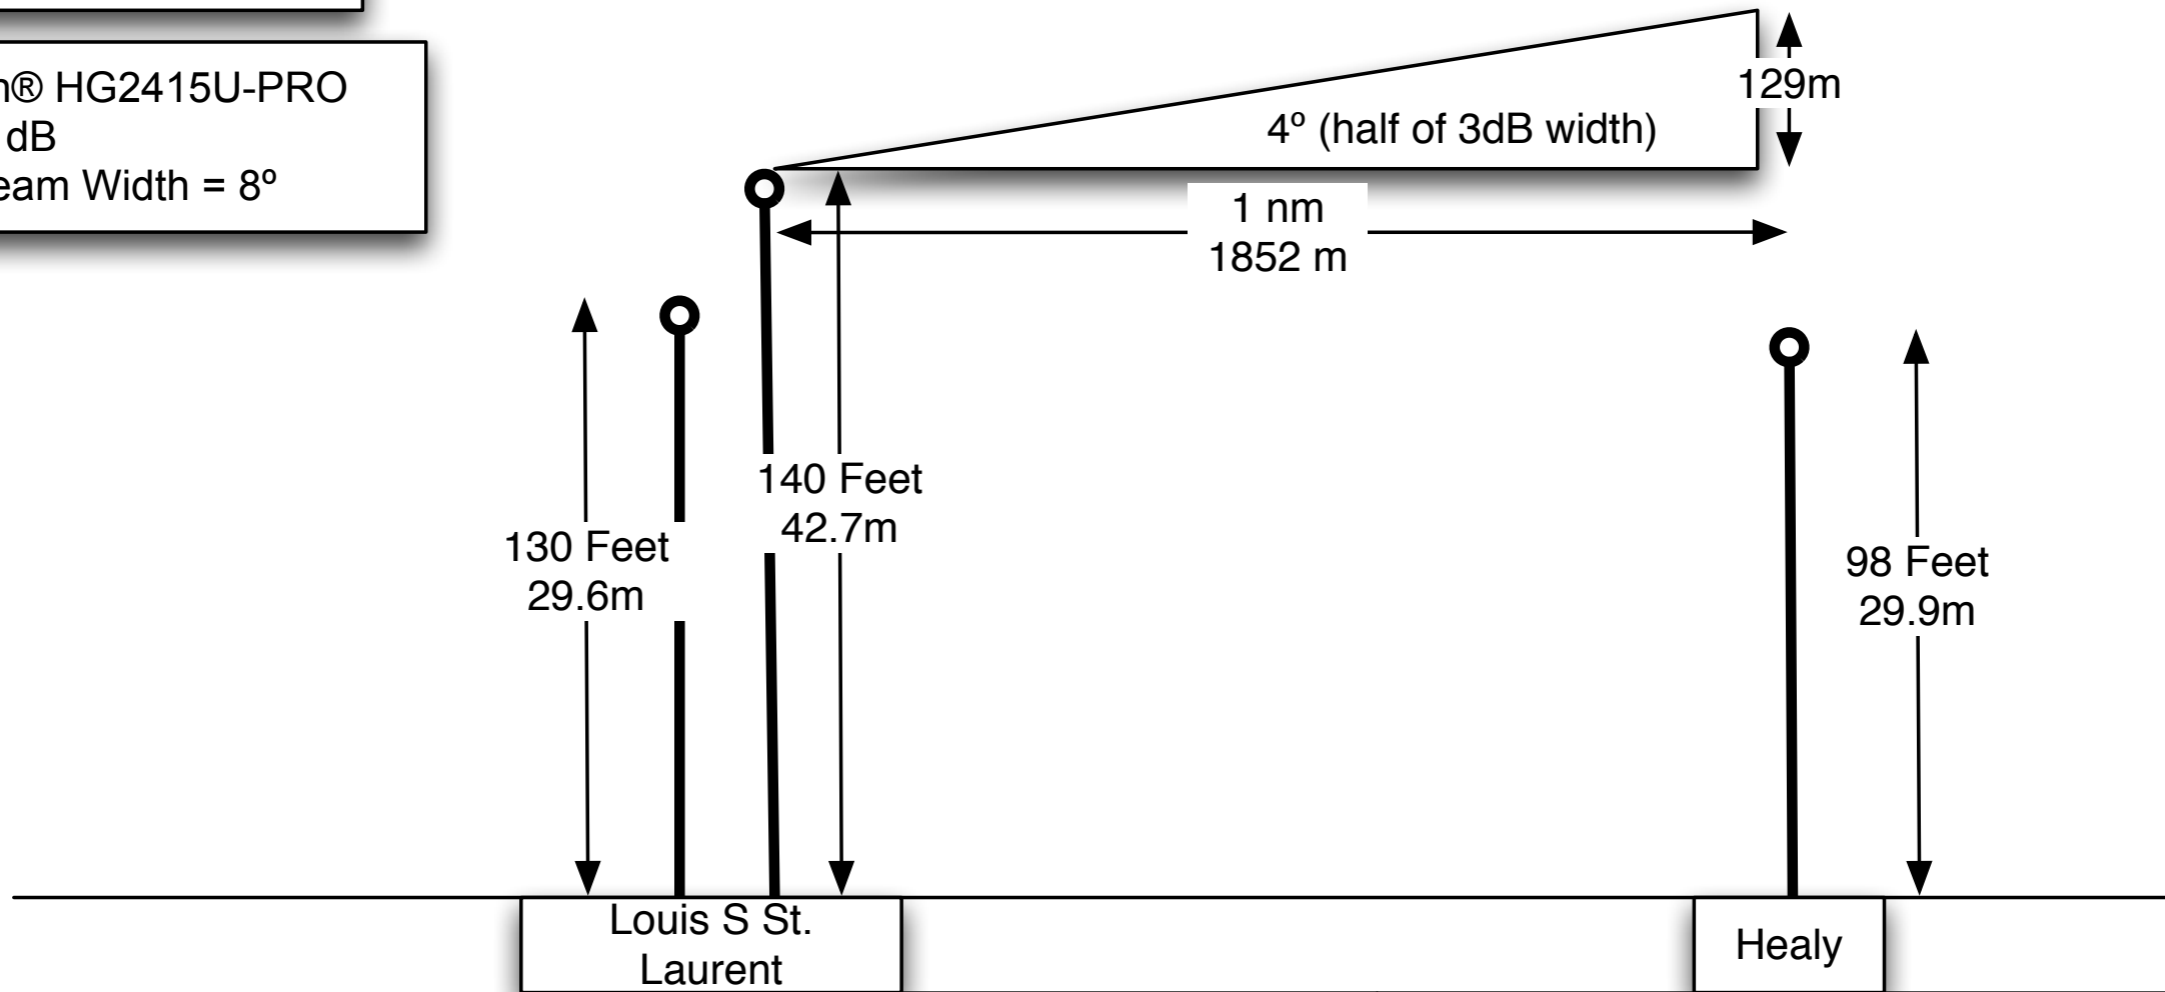
HLY0806 SWAP Antenna Beam Patterns

HyperGain® HG2415U-PRO  
 Gain = 15 dB  
 Vertical Beam Width = 8°

Laird OD24  
 Gain = 9dB  
 Vertical Beam Width = 14°

Note:  
 1) Drawing not to scale  
 2) Worst case is a pair of HG2415Us with 8° vertical beam width. Even with moderate rolling, the other ship should always be in the beam pattern.

- Multiple confounding start-up issues: connections, connectors, corrupt flash
- Range was less than expected (icing, ?)
- Link often did not "recover" itself
- Antenna field of view is (always) an issue?
- Keeping it running & helping users was labor intensive
- It was very effective for science

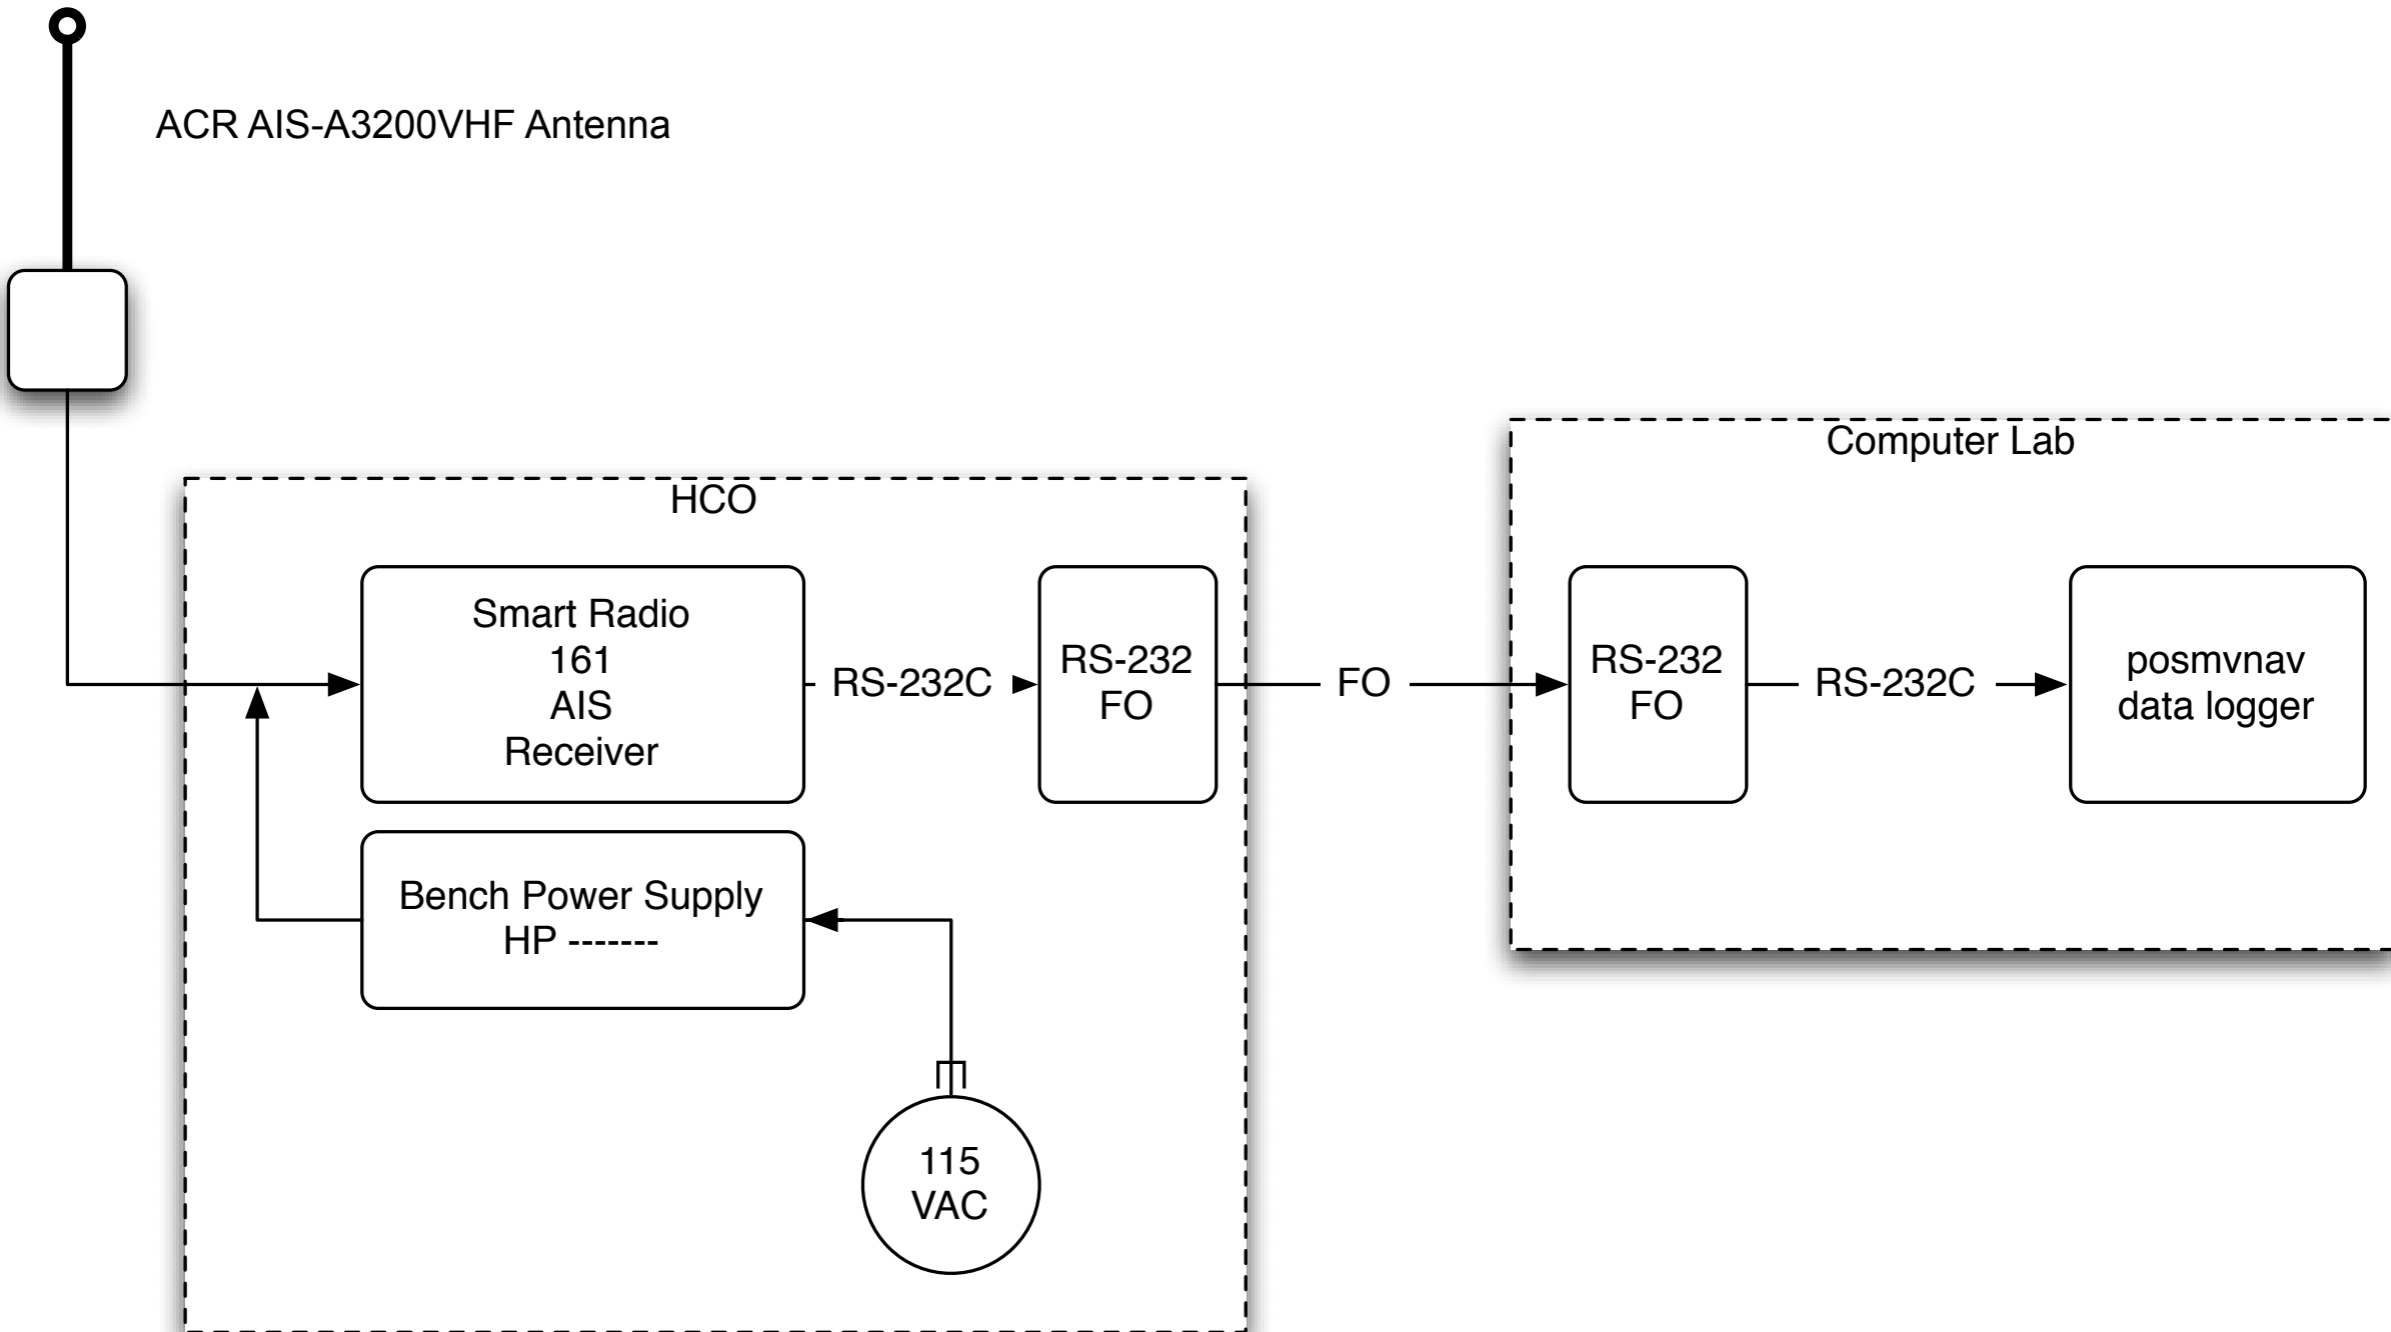
- We needed real-time position of the other ship (LSSL) in our real-time GIS
- Didn't want to depend on the wireless link due to range
- High "overhead" to connect to Healy's existing AIS system
- Purchased (\$250 + shipping) AIS receiver & antenna (only)
- Used existing code (Kurt Schwer, UNH/CCOM) <http://vislab-ccom.unh.edu/>

ACR AIS-A3200VHF Antenna

Instrument Laboratory Lamont-Doherty Earth Observatory of Columbia University 61 Route 9W Palisades, NY 10964	<b>Automatic Identification System Receiver (Science)</b>				
	Drawn 2008-09-27 Updated:	SIZE -	FSCM NO	DWG NO	REV -
Dale Chayes dale@ldeo.columbia.edu	SCALE	None		SHEET	3 OF 4

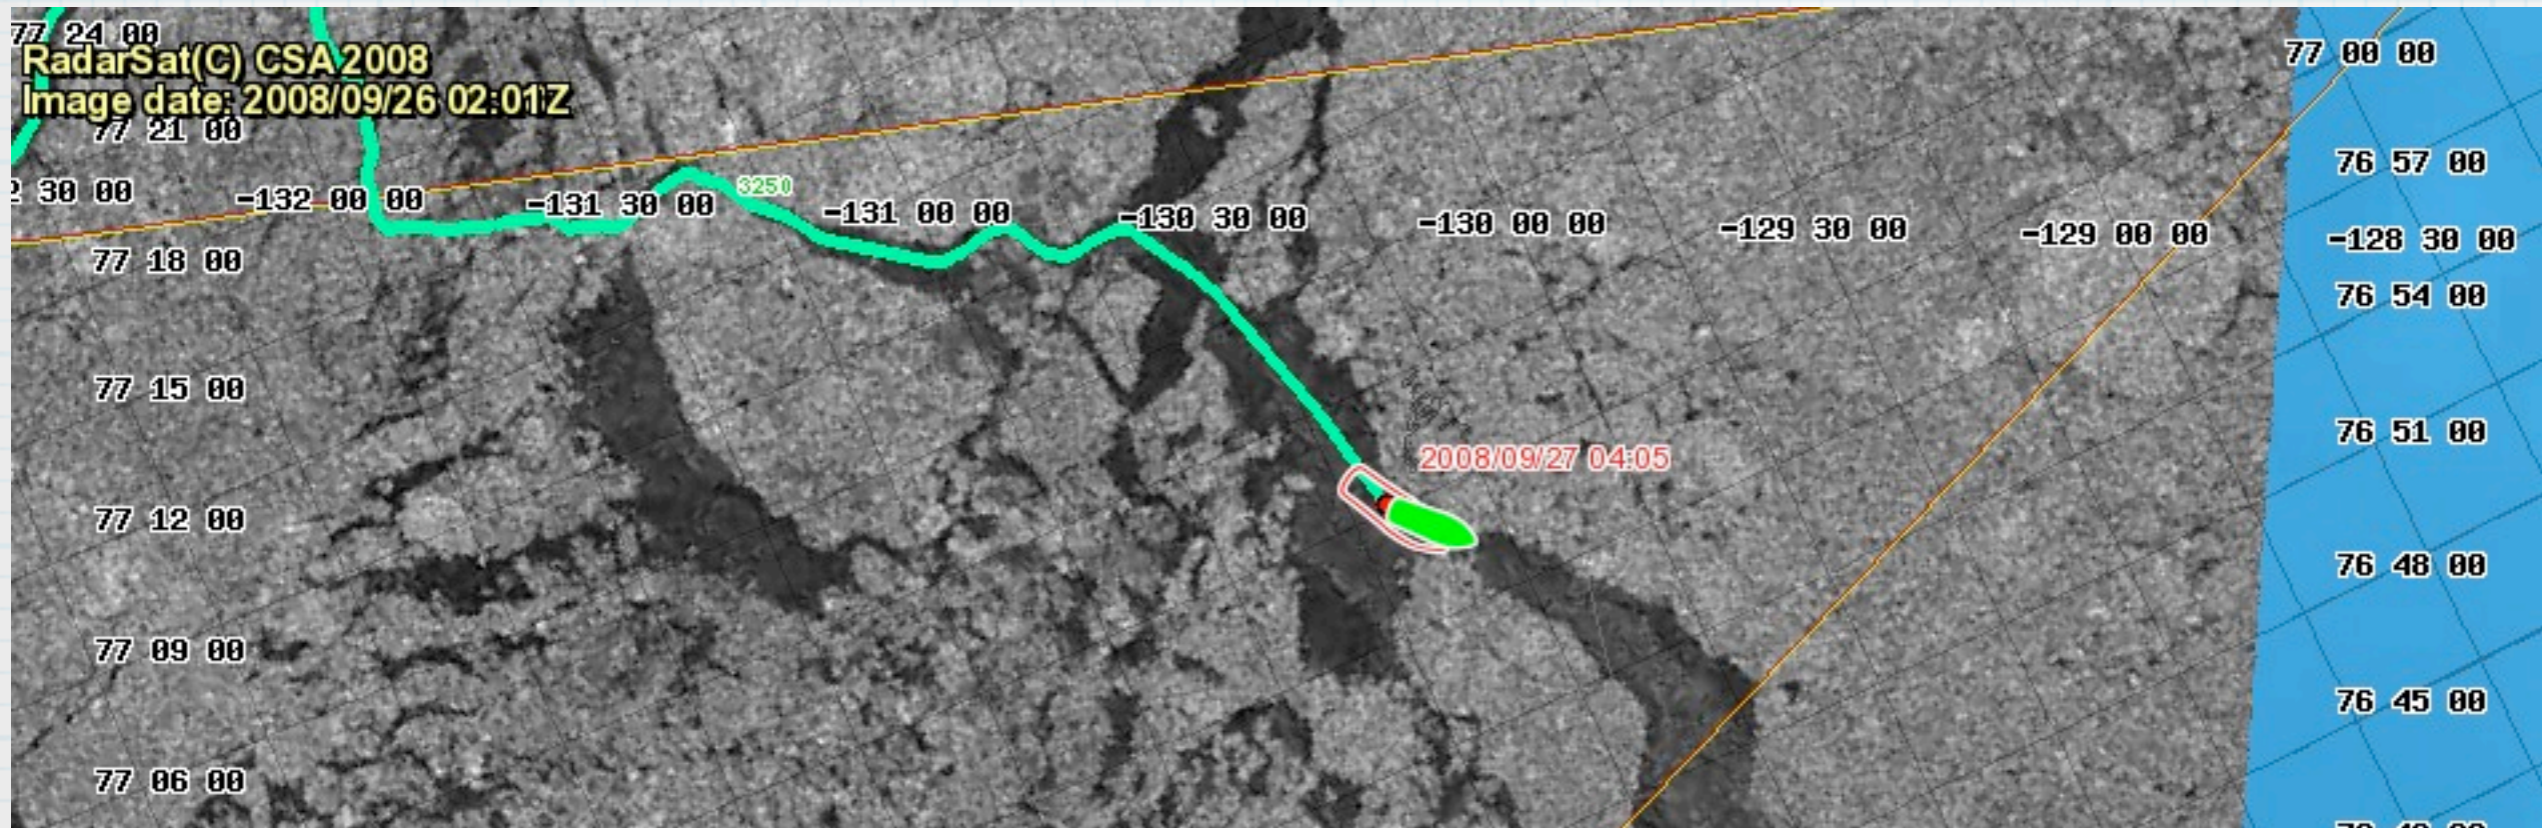
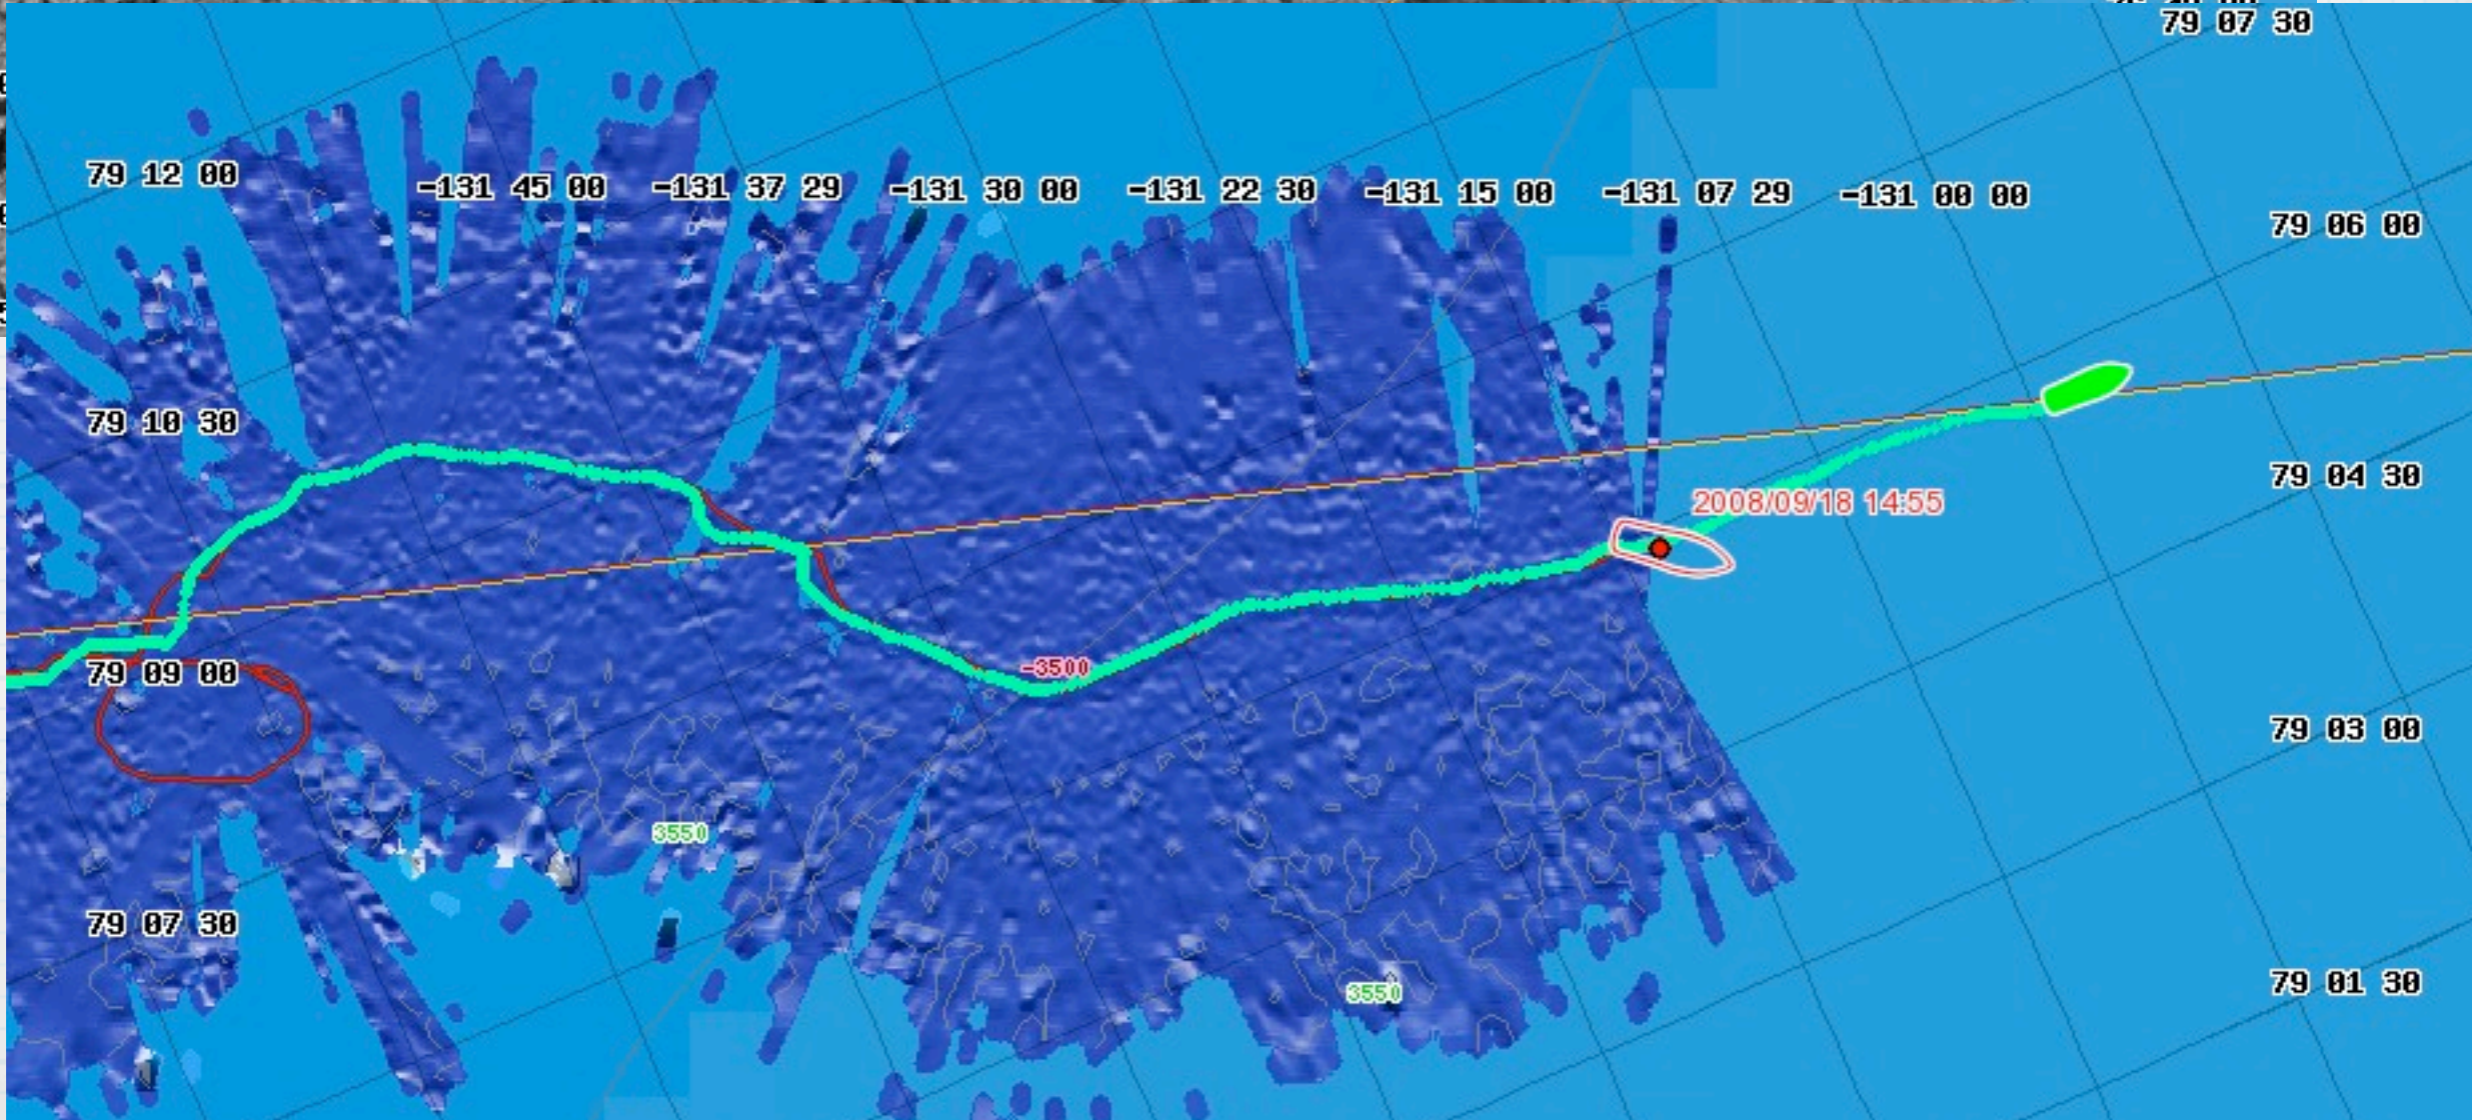
Screen shots from the Healy real-time GIS showing AIS data (green) for LSSL and Healy real-time navigation.

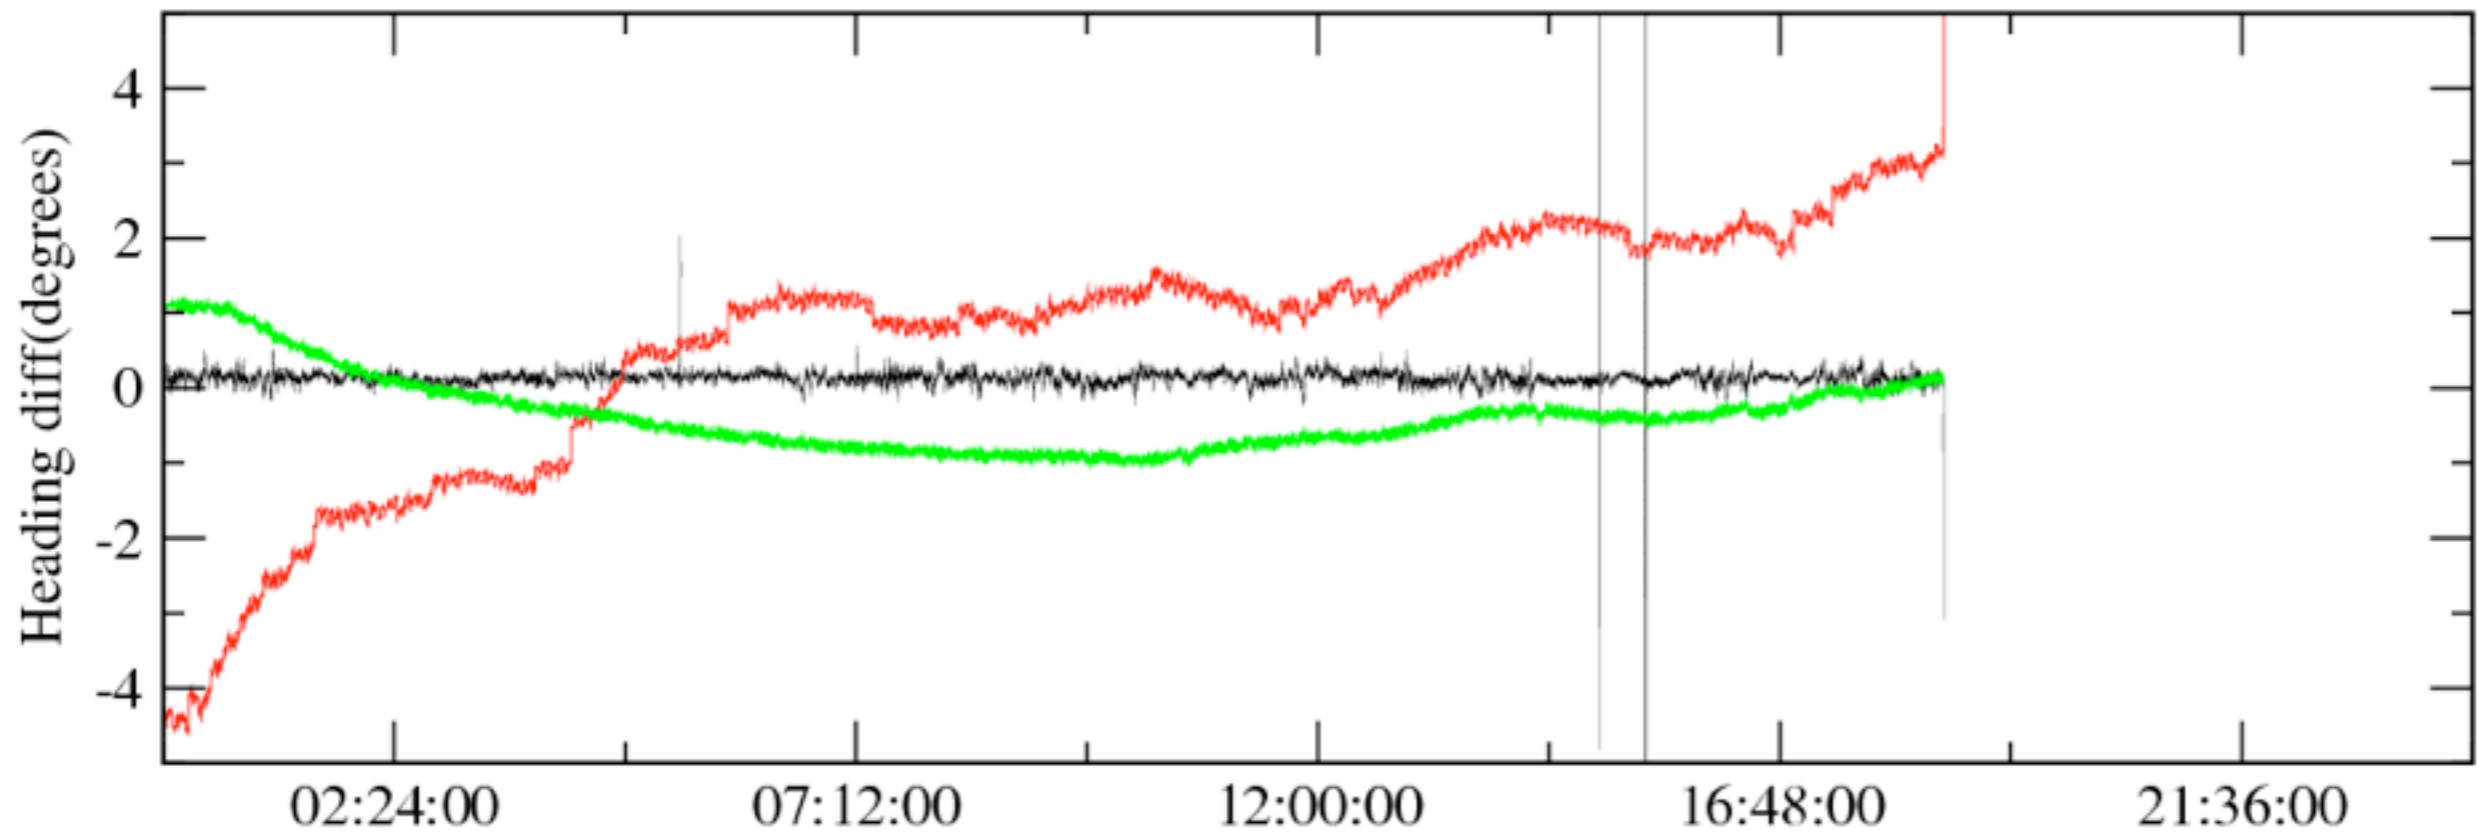
# Heading differences 2008/09/27

POSMV/ADU5(black) POSMV/MK27(red) POSMV/MK39(green)

- Applanix POS/MV-320
- Thales (Ashtech) ADU-5
- Sperry MK27
- Sperry MK39

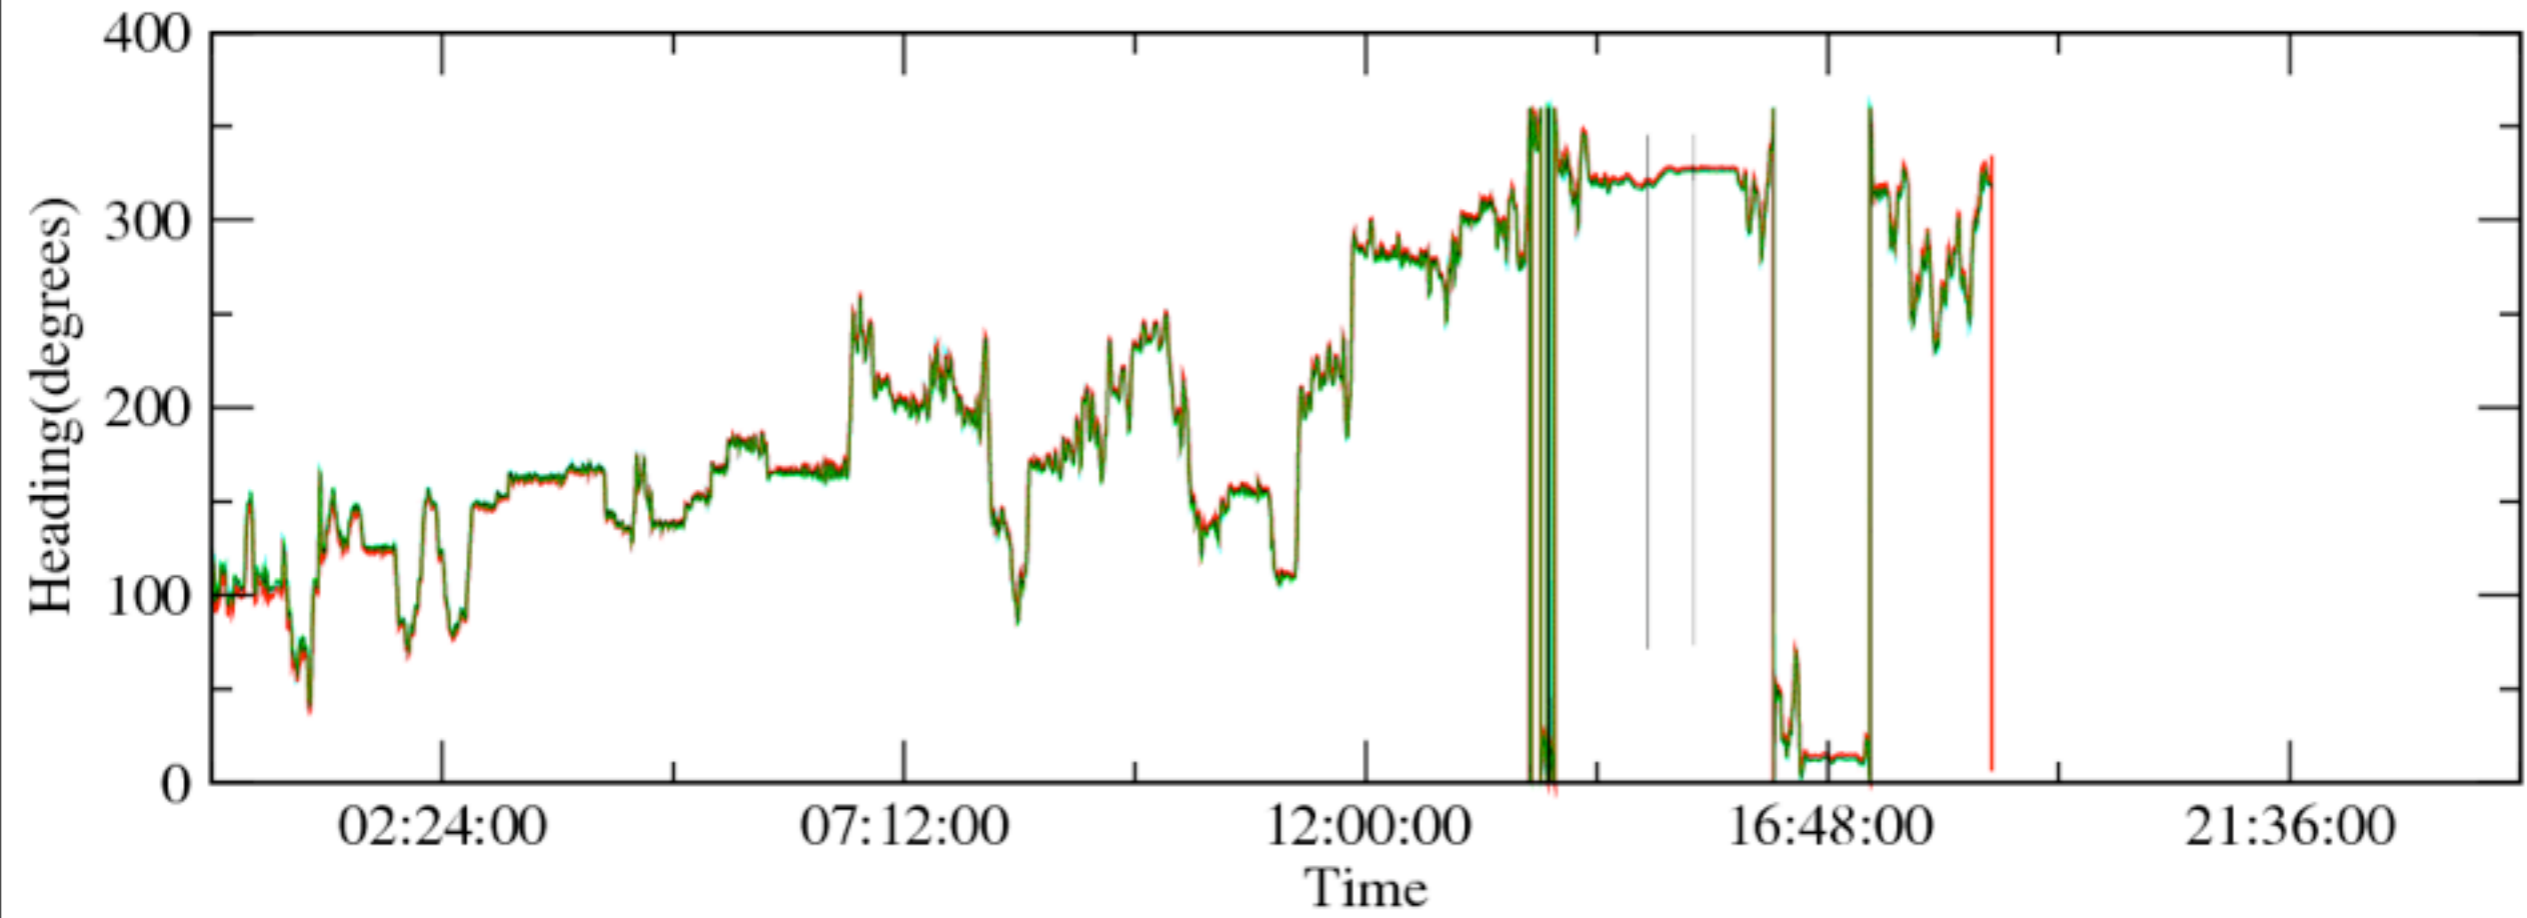
POSMV(cyan) ADU5(black) MK27(red) MK39(green)

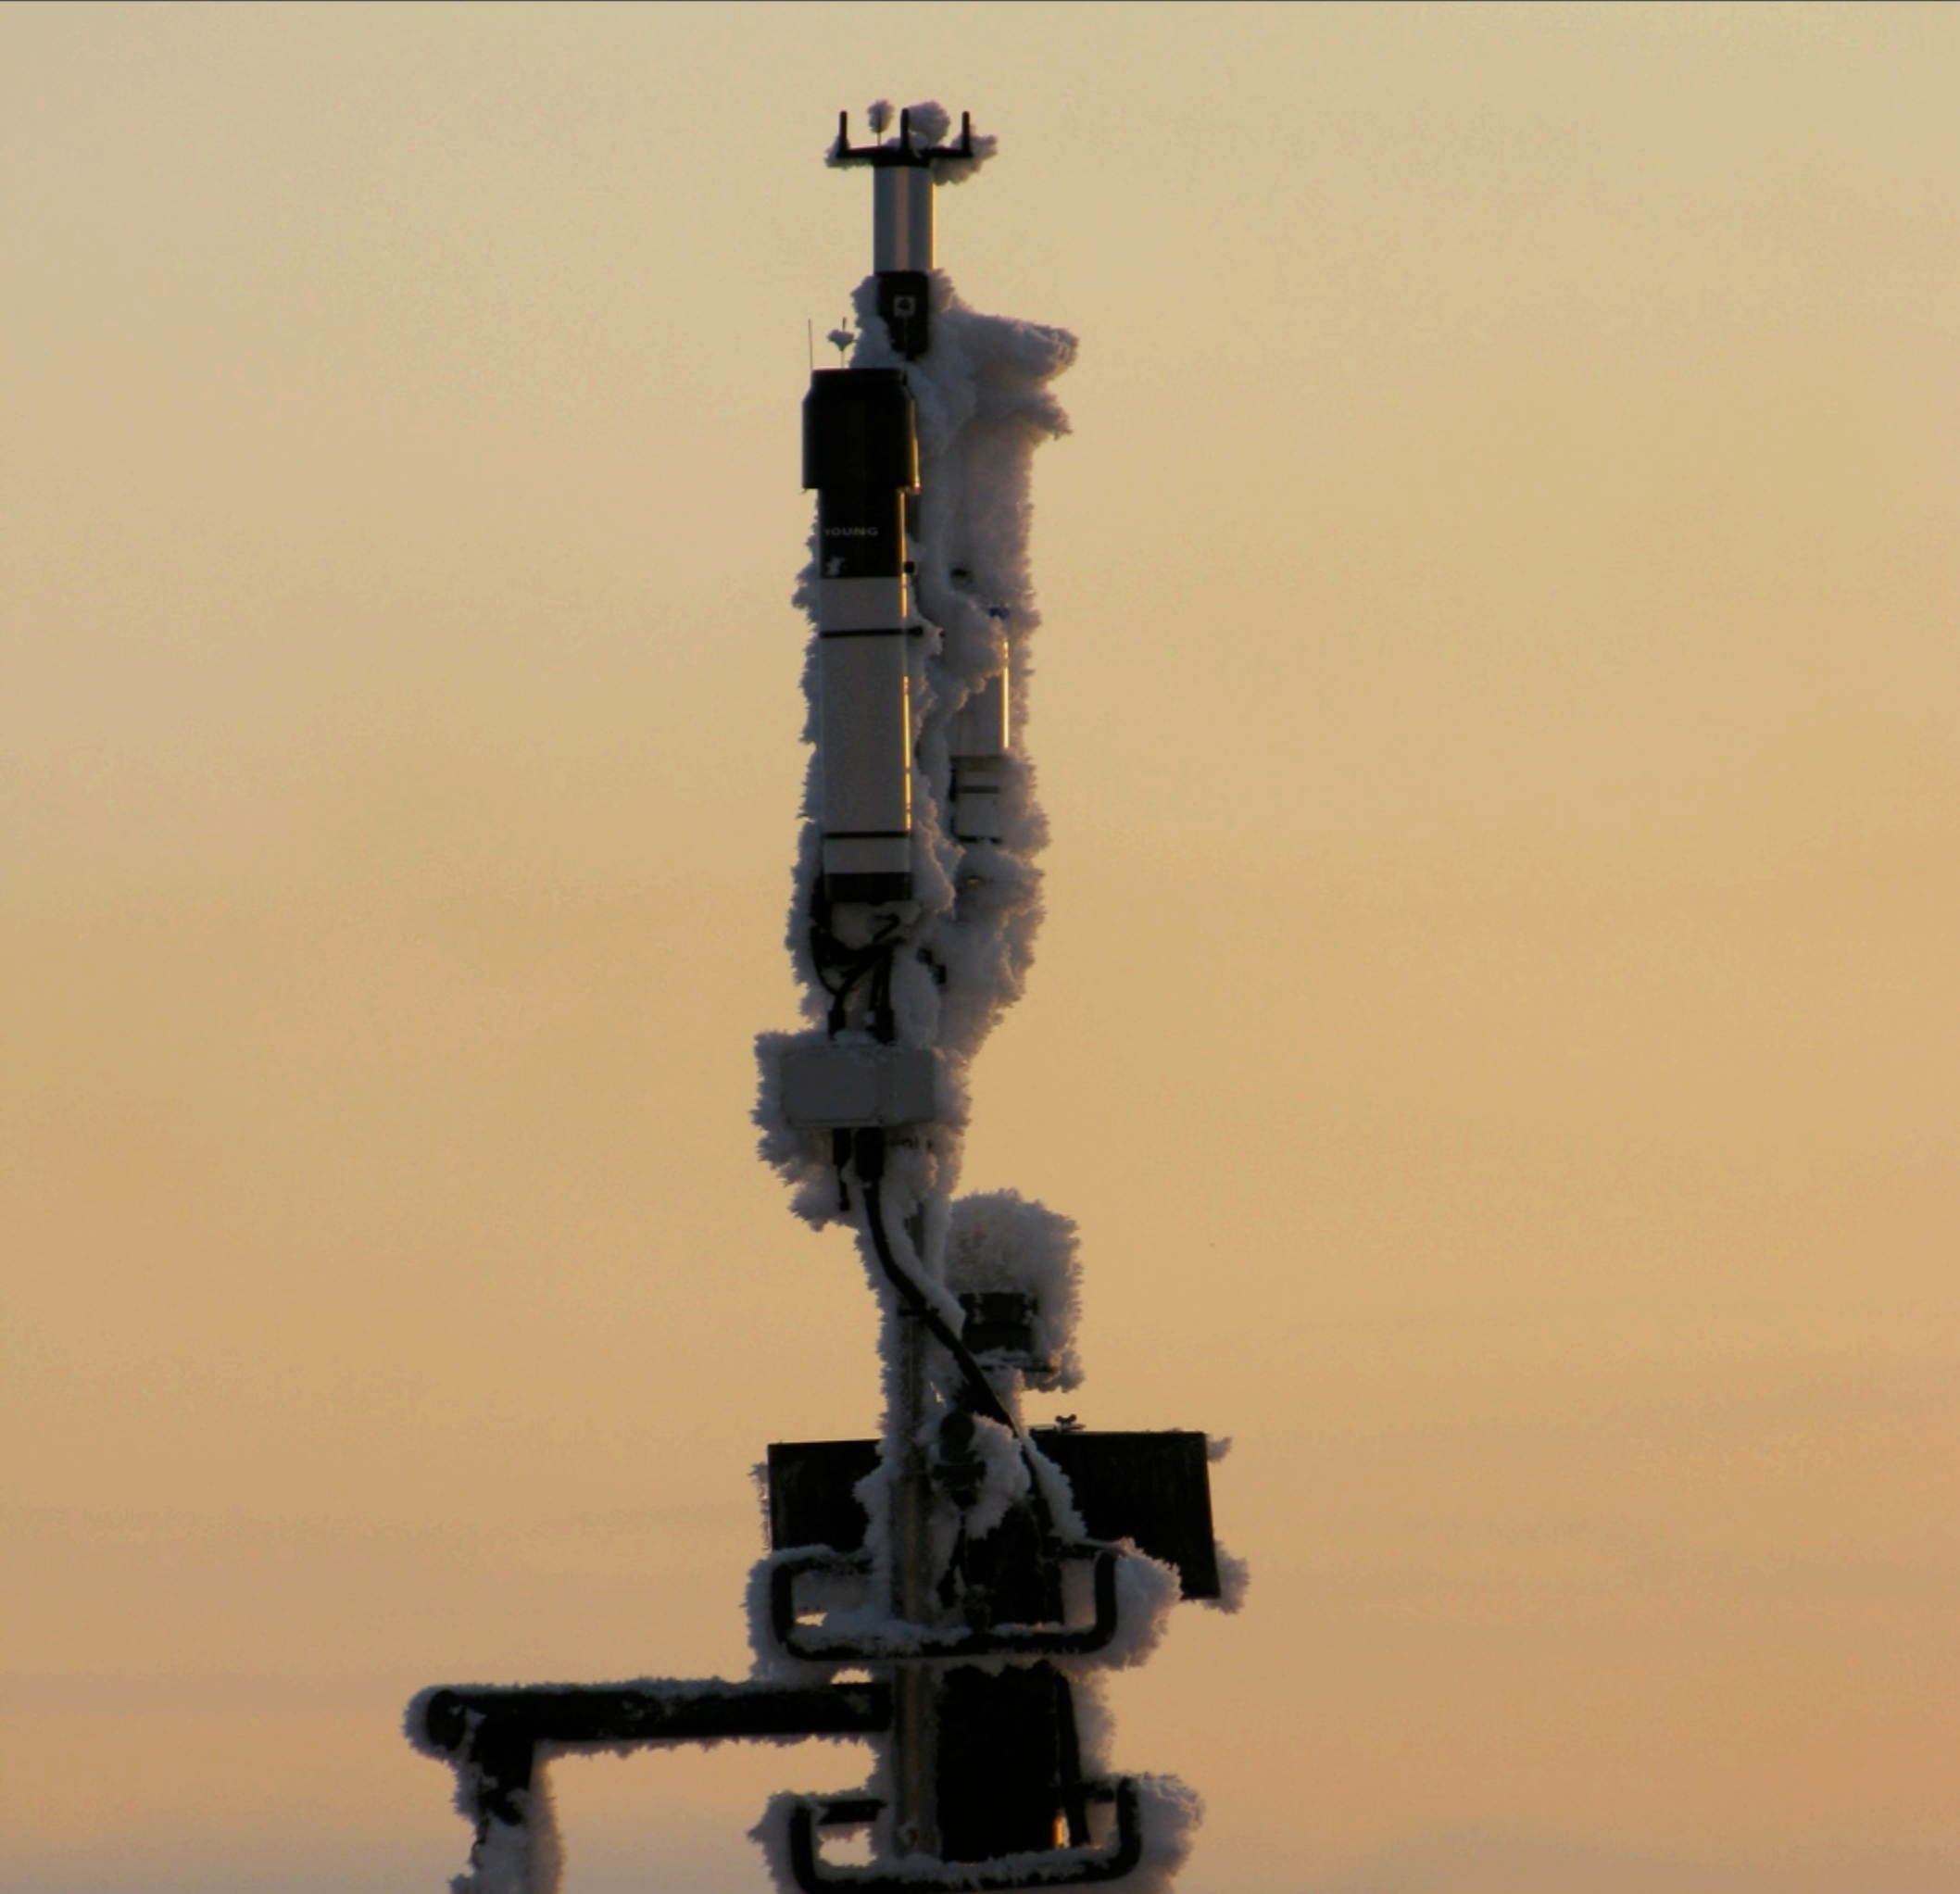
15

Met sensors, including heated ultrasonic anemometer, rain gauge, temperature, humidity sensors on the Healy's foremast.
