SWAP  
and other things  
on a two icebreaker cruise  
USCGC Healy  
CGC Louis S. St-Laurant

a very brief report of work done  
by Steve Roberts, Val Schmidt and Dale Chayes

RVTEC October 30, 2008

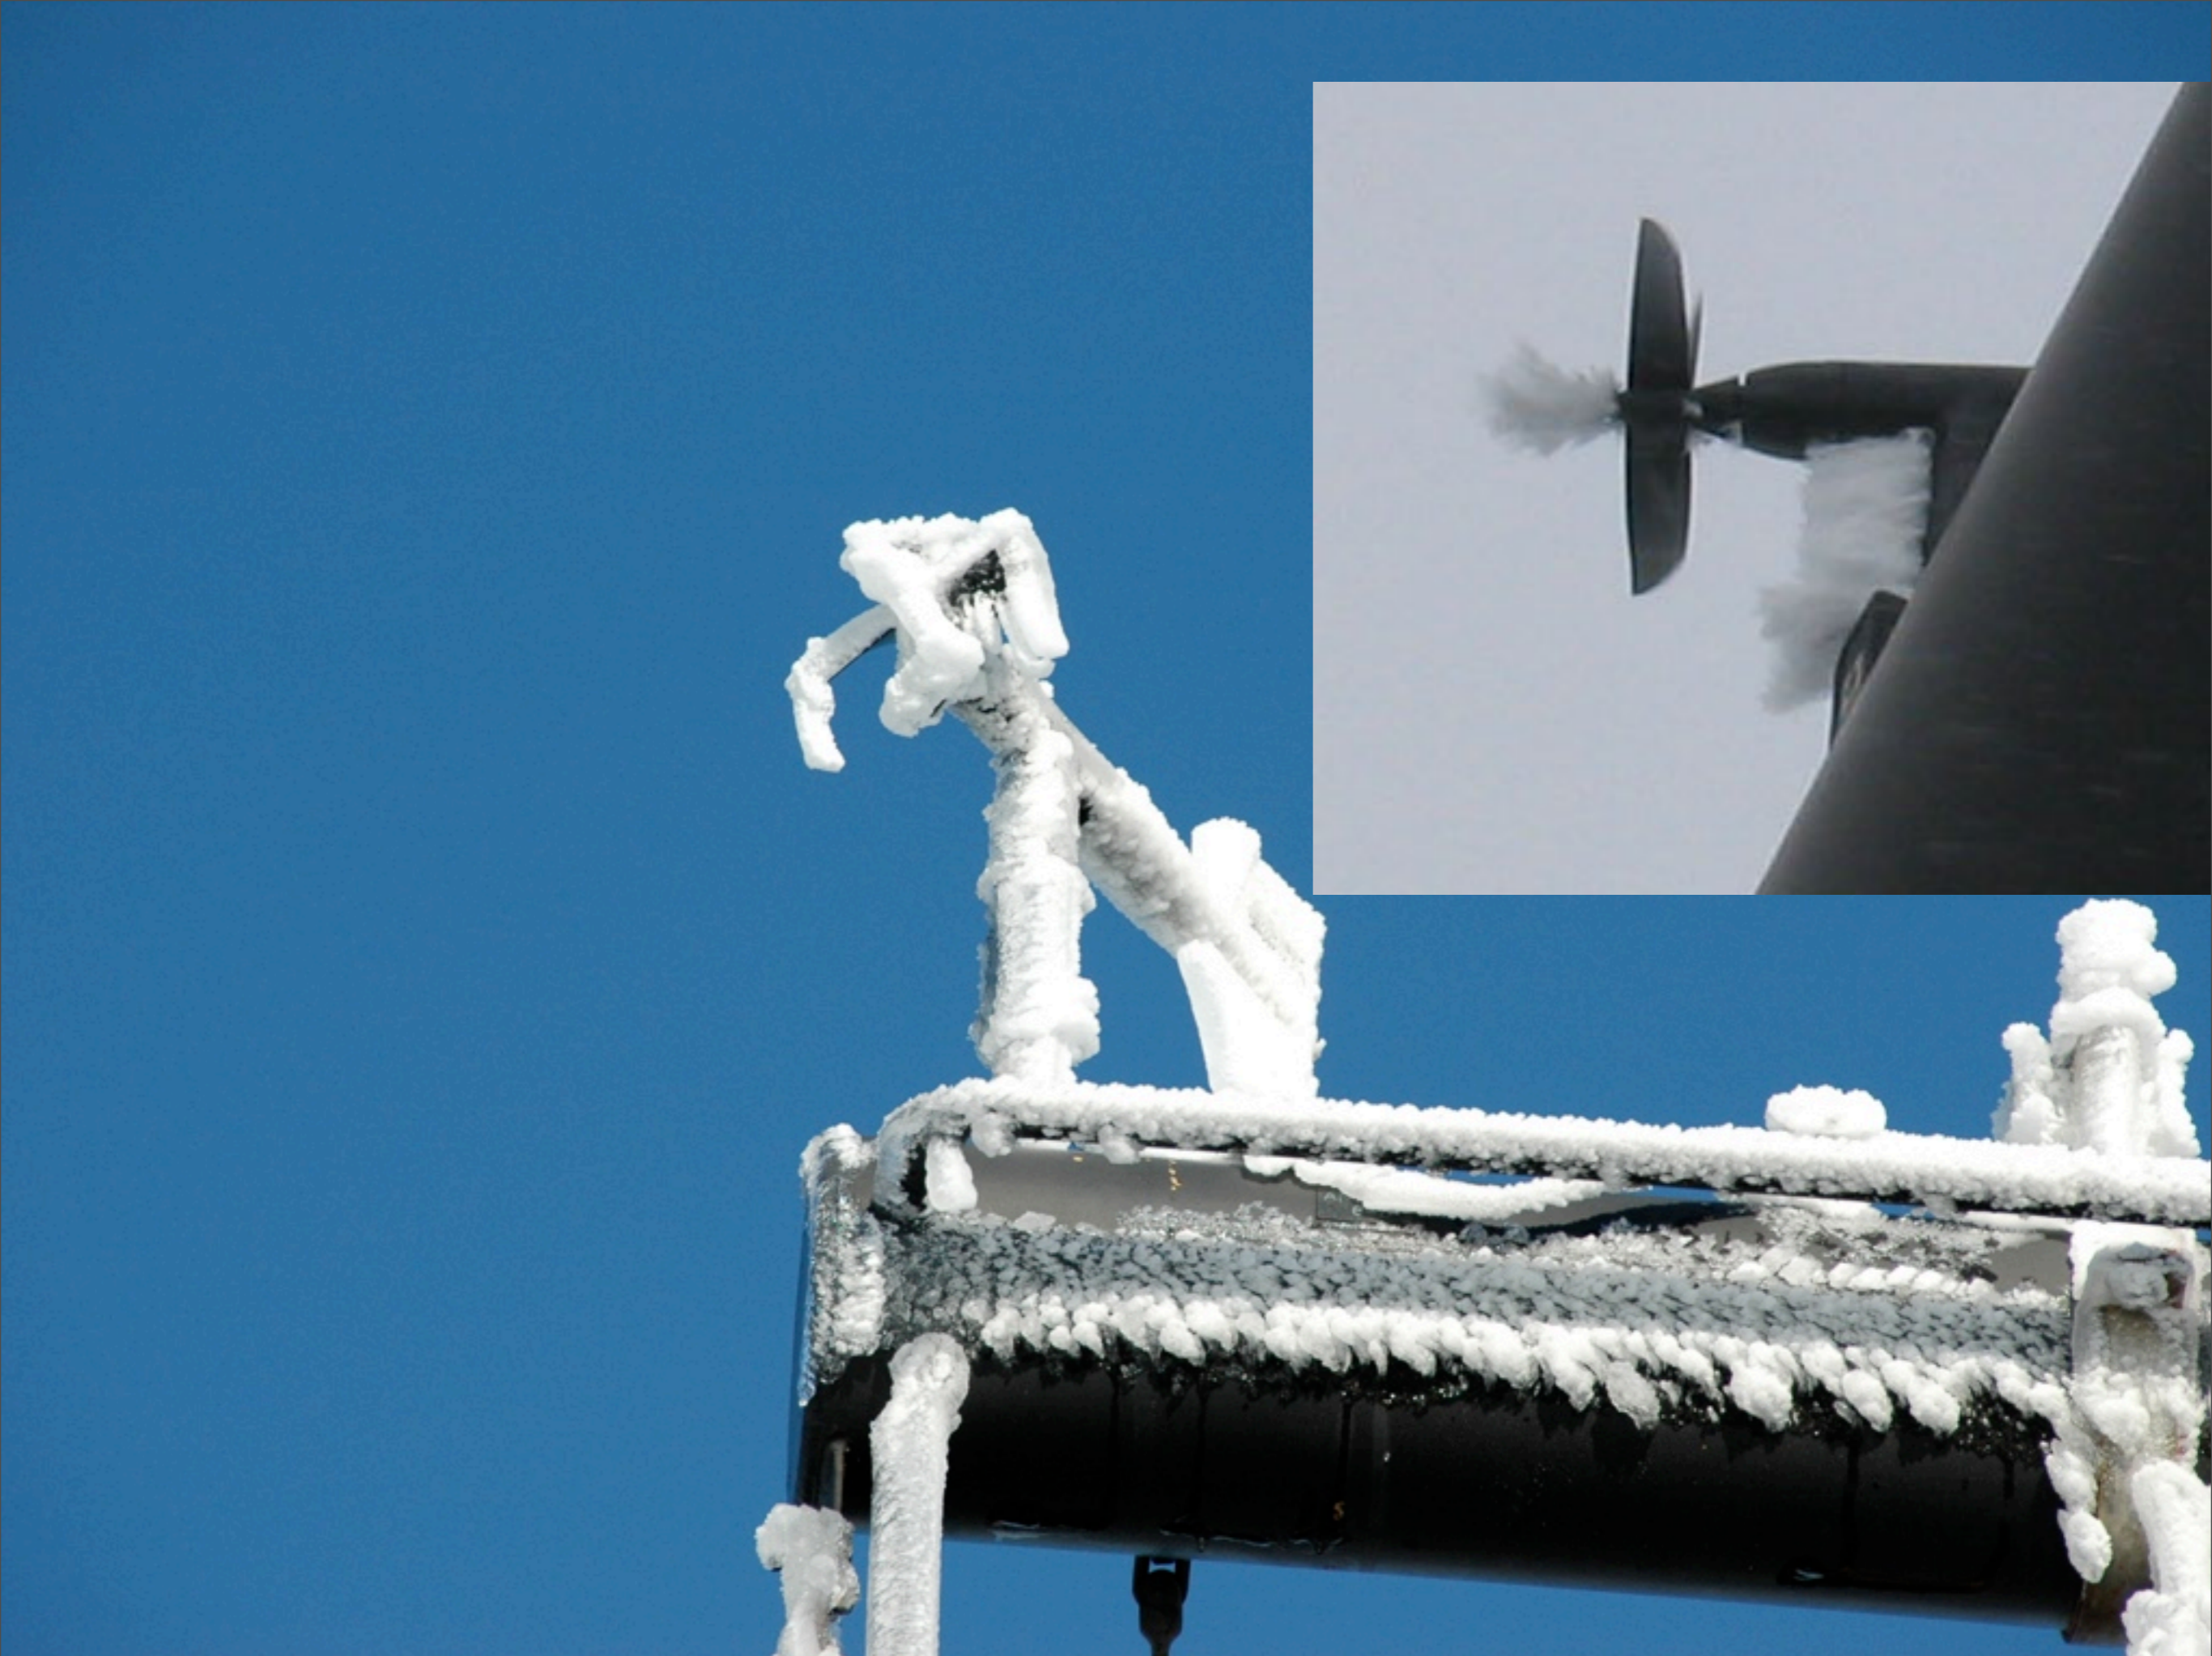
16

various kinds of icing cause

data quality problems

Icing of various severity on mechanical anemometers on Healy.

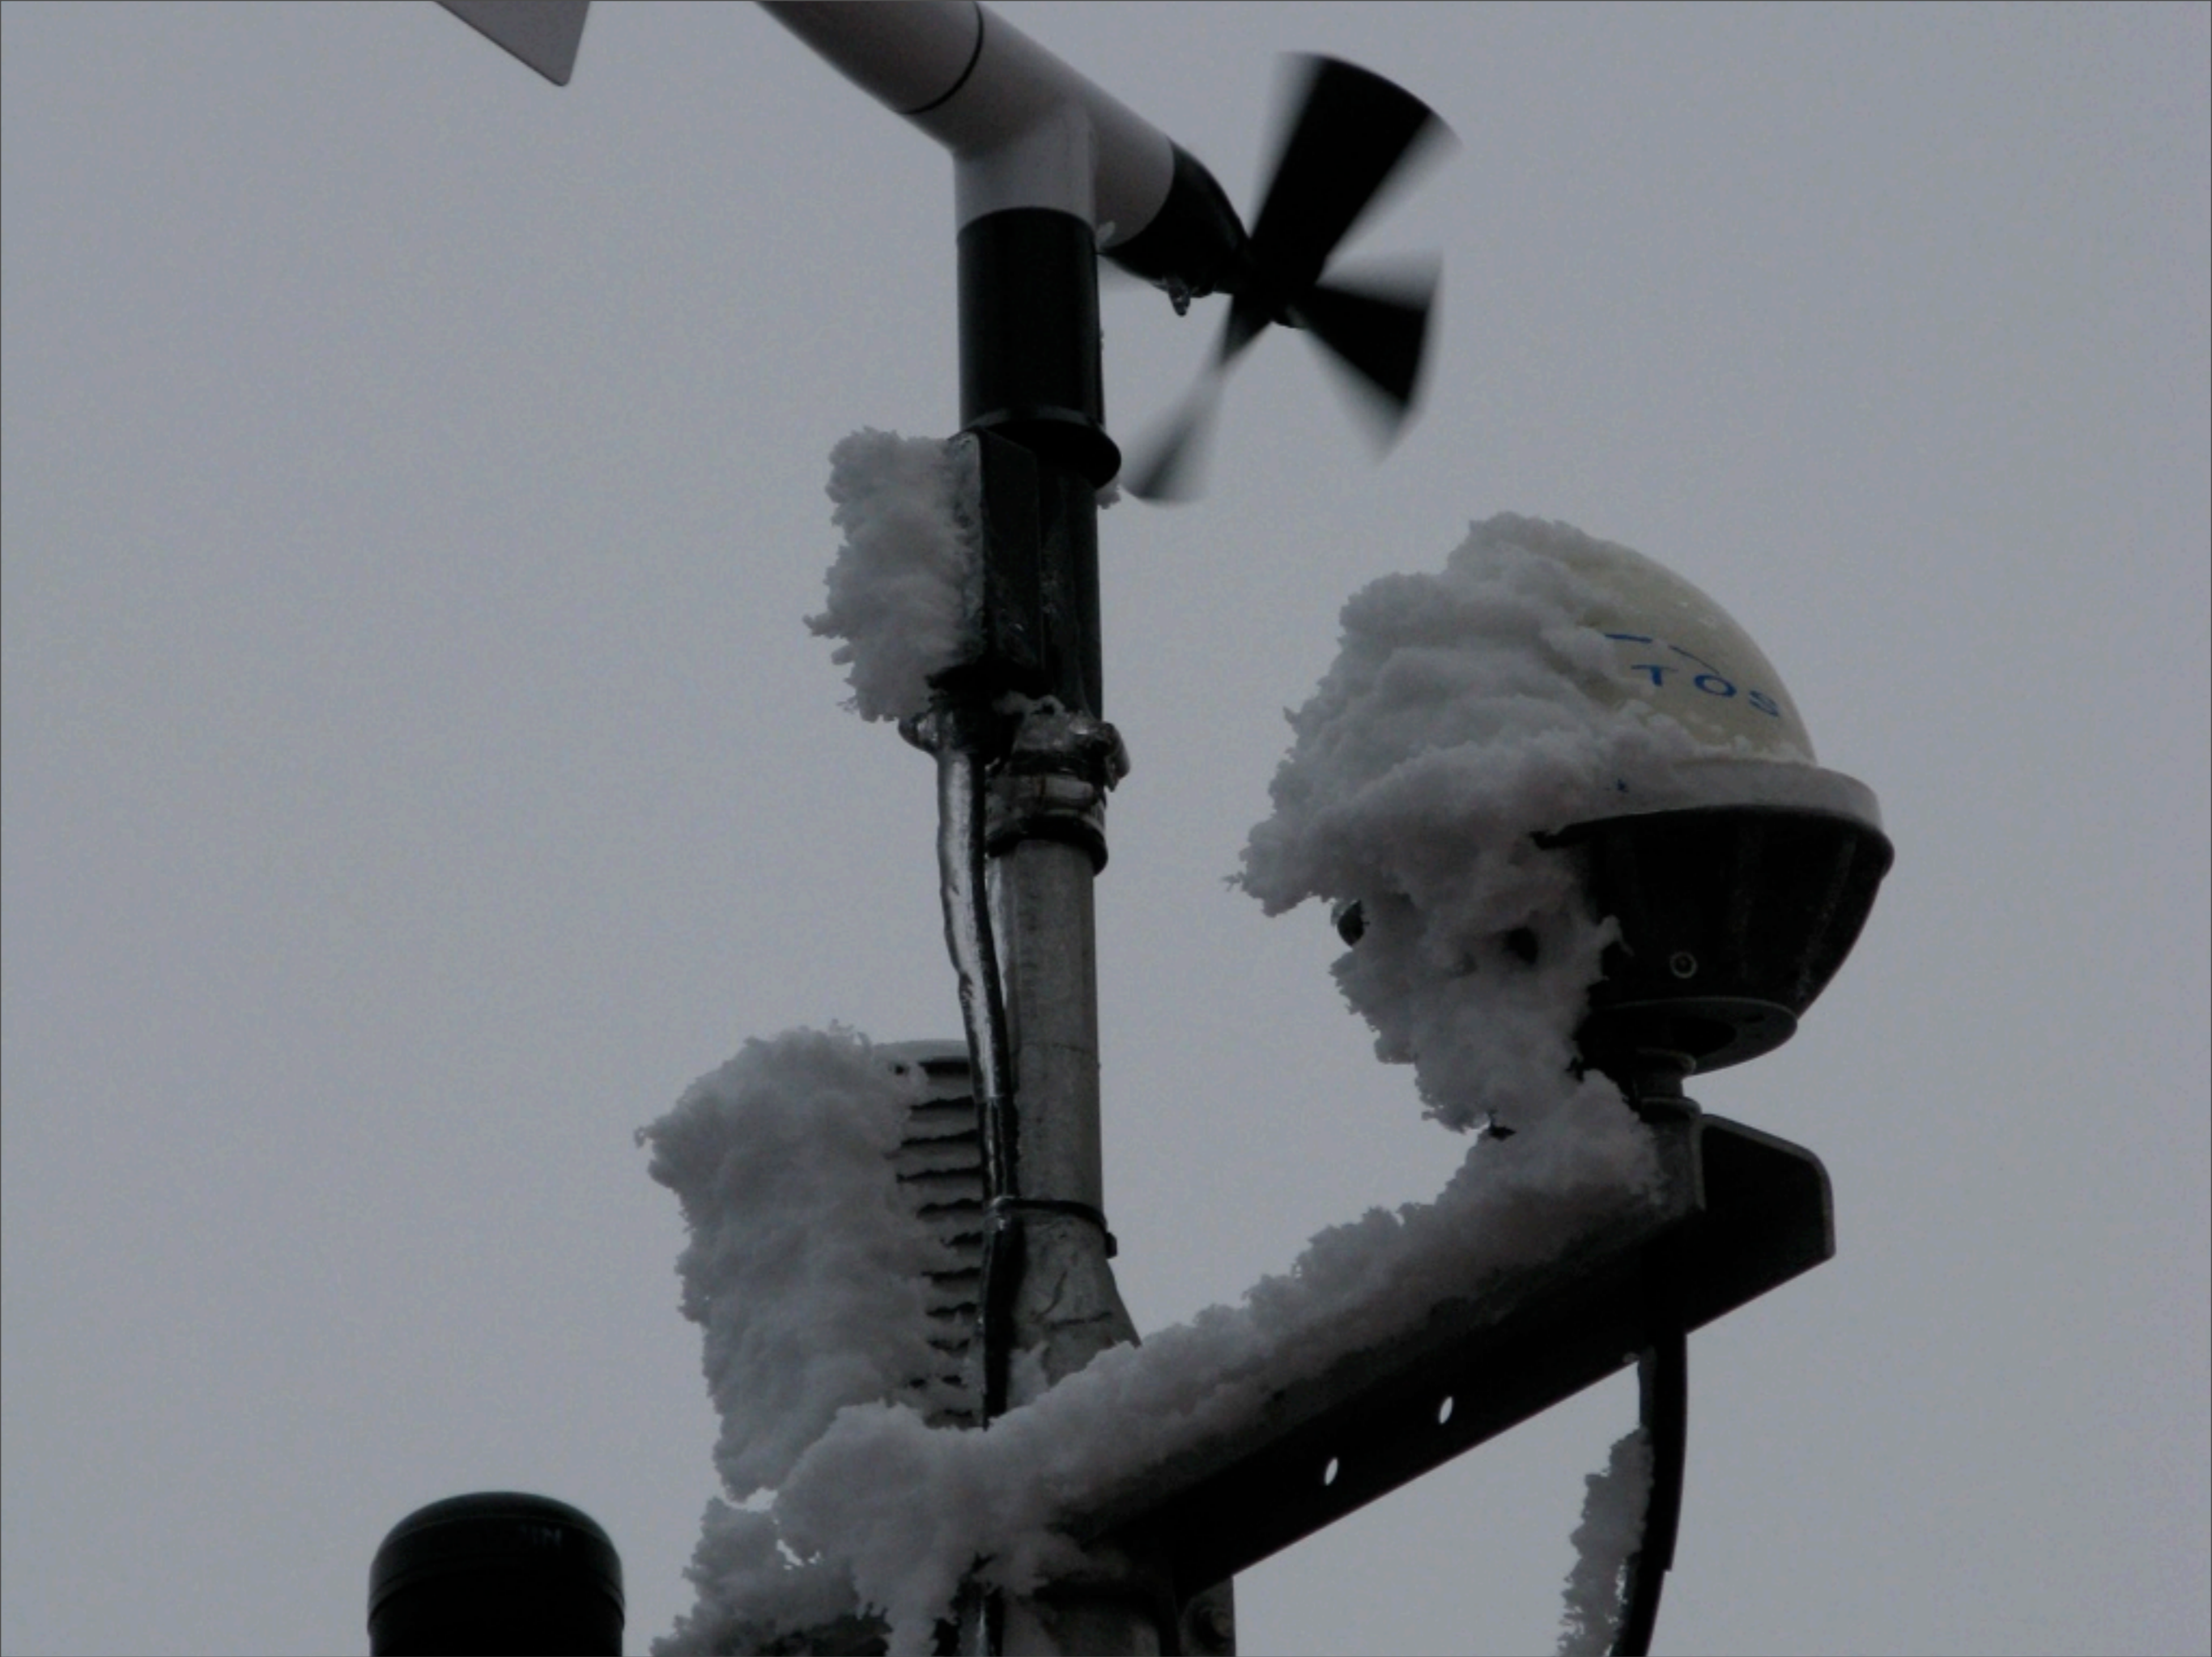
17

Icing of various met sensors on LSSL
