Shipboard Scientific Support Equipment: Oceanographic Cable NSF Grant No. 0555000

Presented by Rick Trask (WHOI)

Bending Fatigue Tests

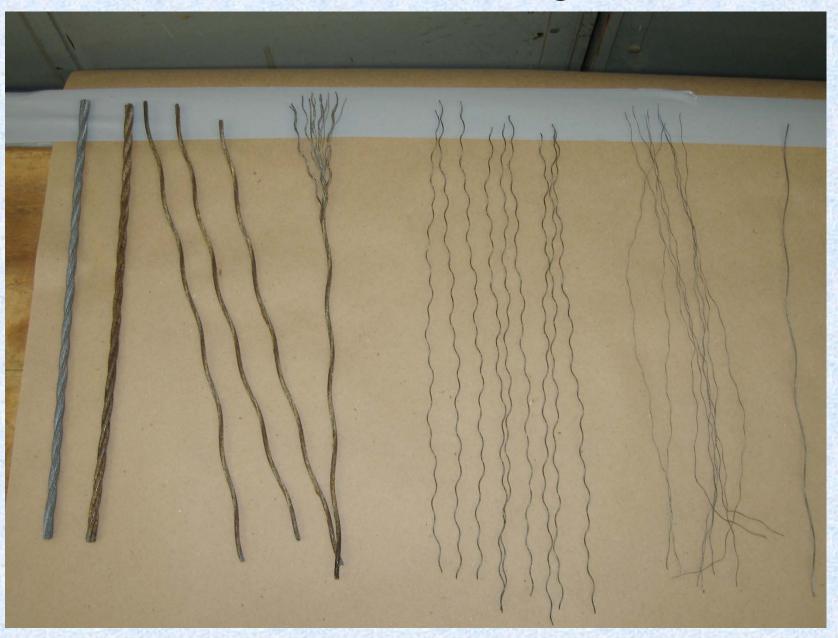
e-Kink Testing

- Technique suggested by The Rochester Corp.
- Simple test of all the individual wires that make up a cable.
- Take an 18 inch length, hold each end and form it into a loop.
- Pull the loop taught, forming the shape of a small letter "e".
- A wire break indicates that the material may be brittle and not fit for service.
- A failure rate of 30% or more is reason for taking the cable out of service.
