Healy Science Technical Support

Dale Chayes

2010-12-08/09 - UNOLS/AICC Meeting - USCG ISC Seattle

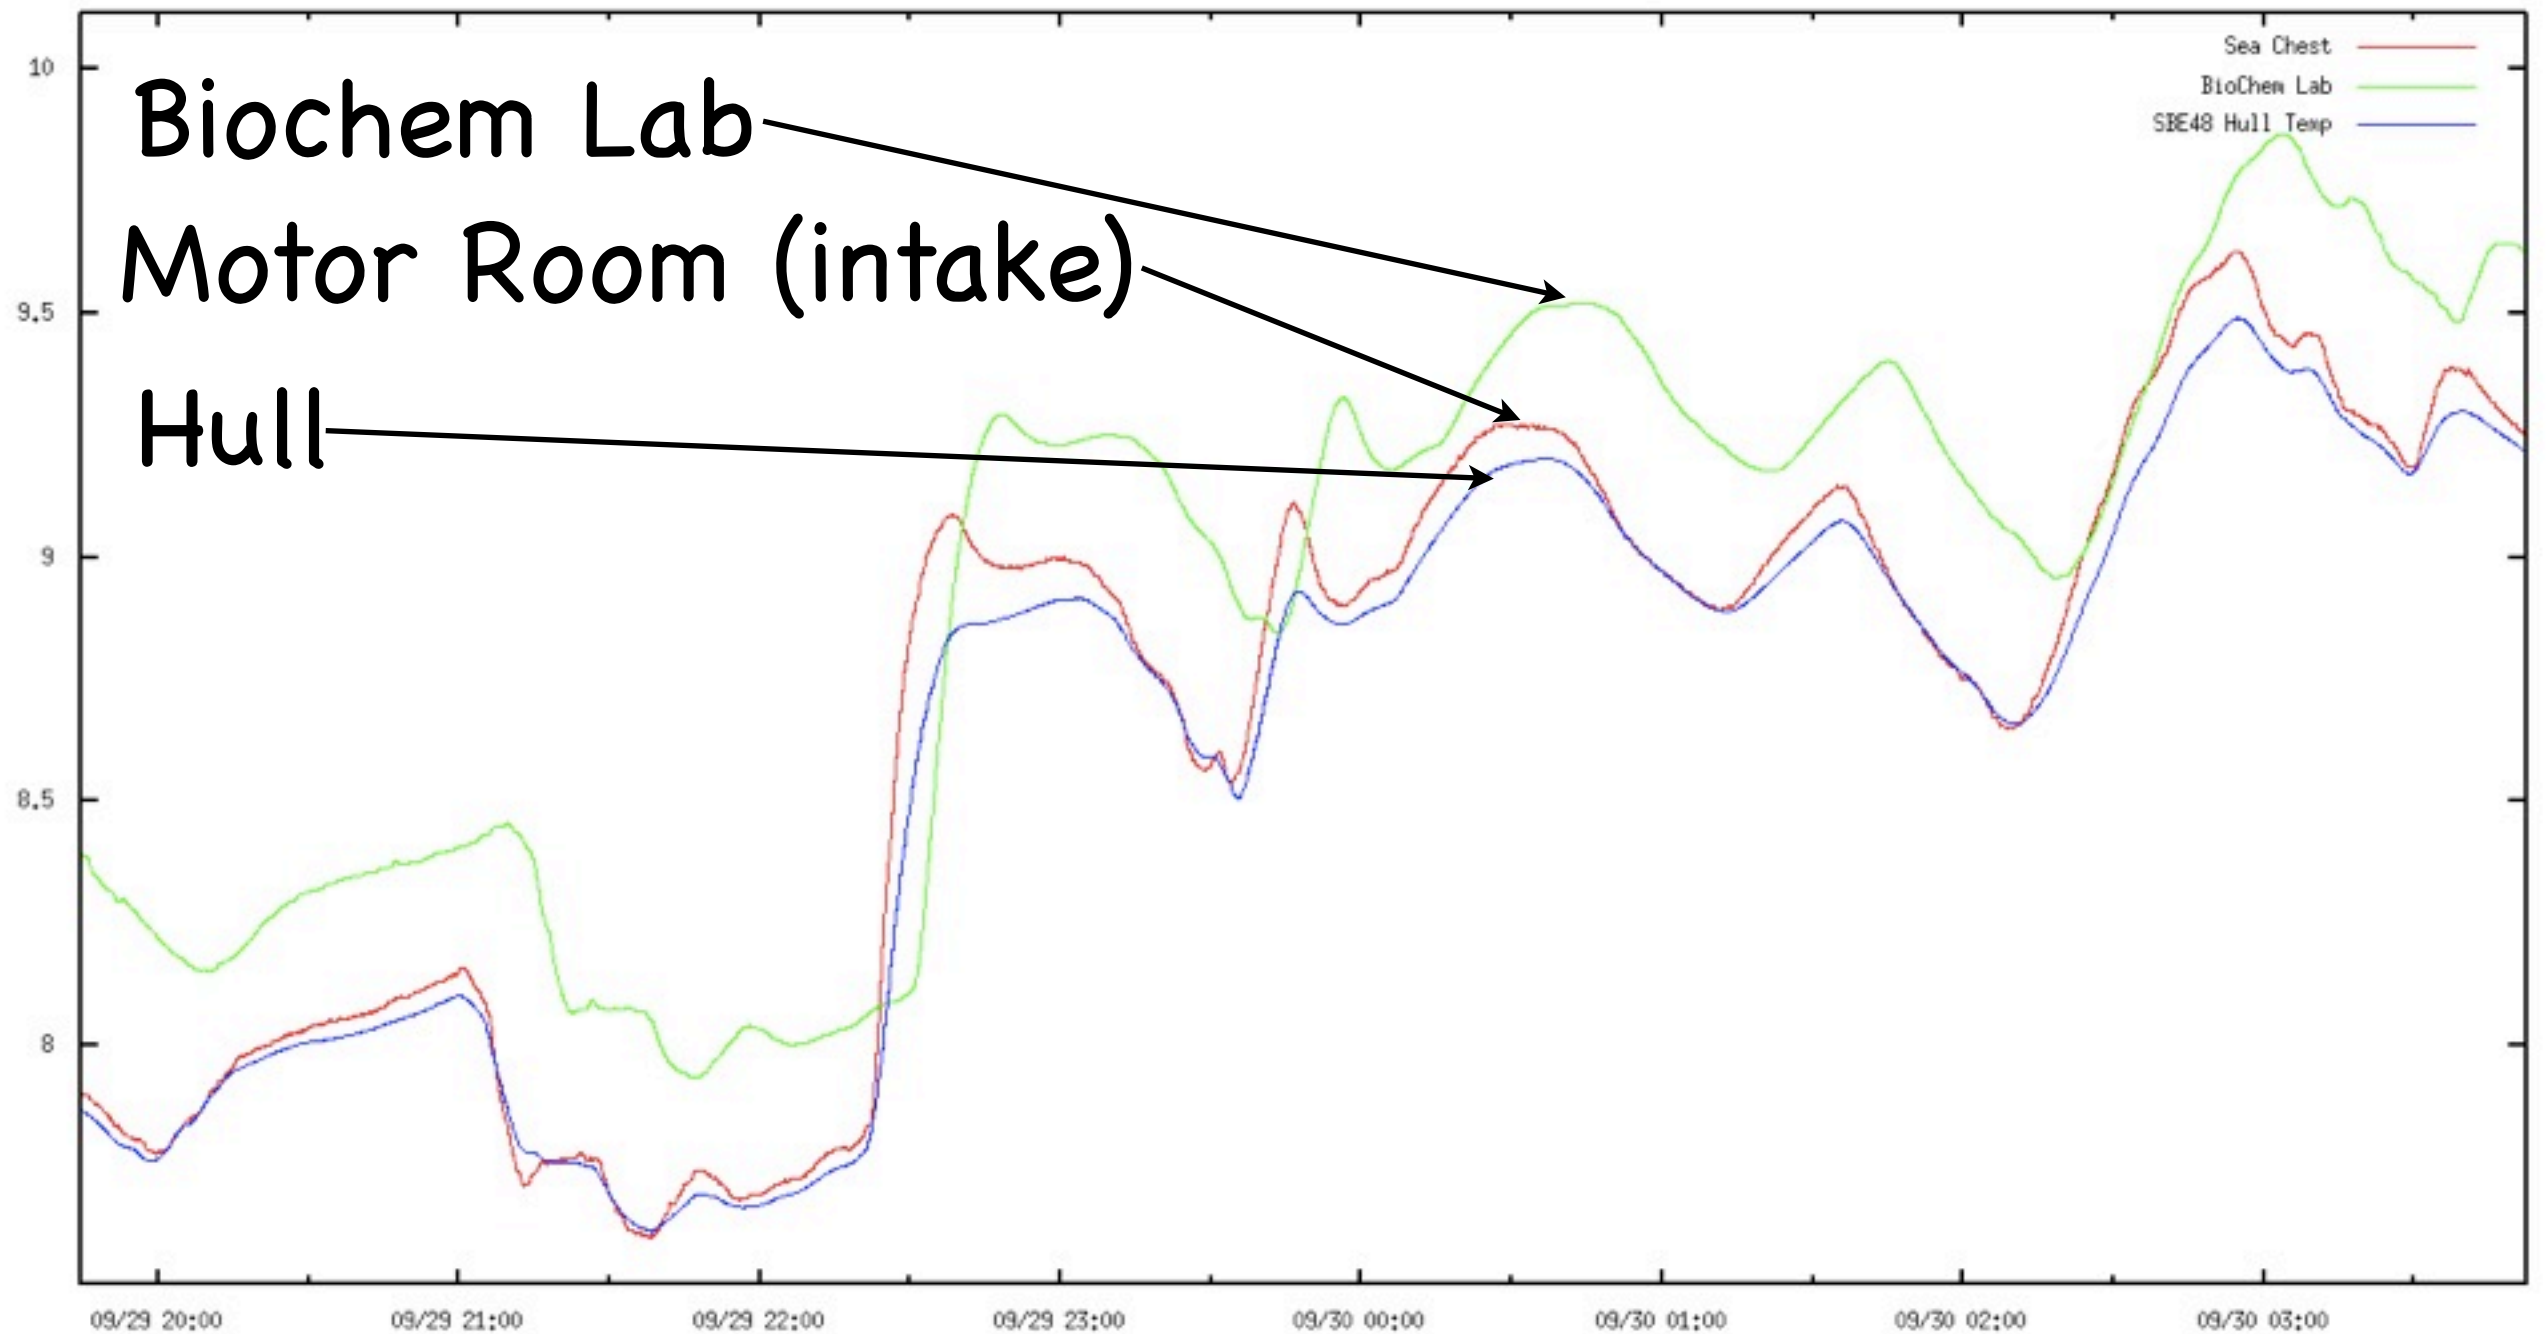
A robust proxy for sea surface temperature
Installed in fall of 2010

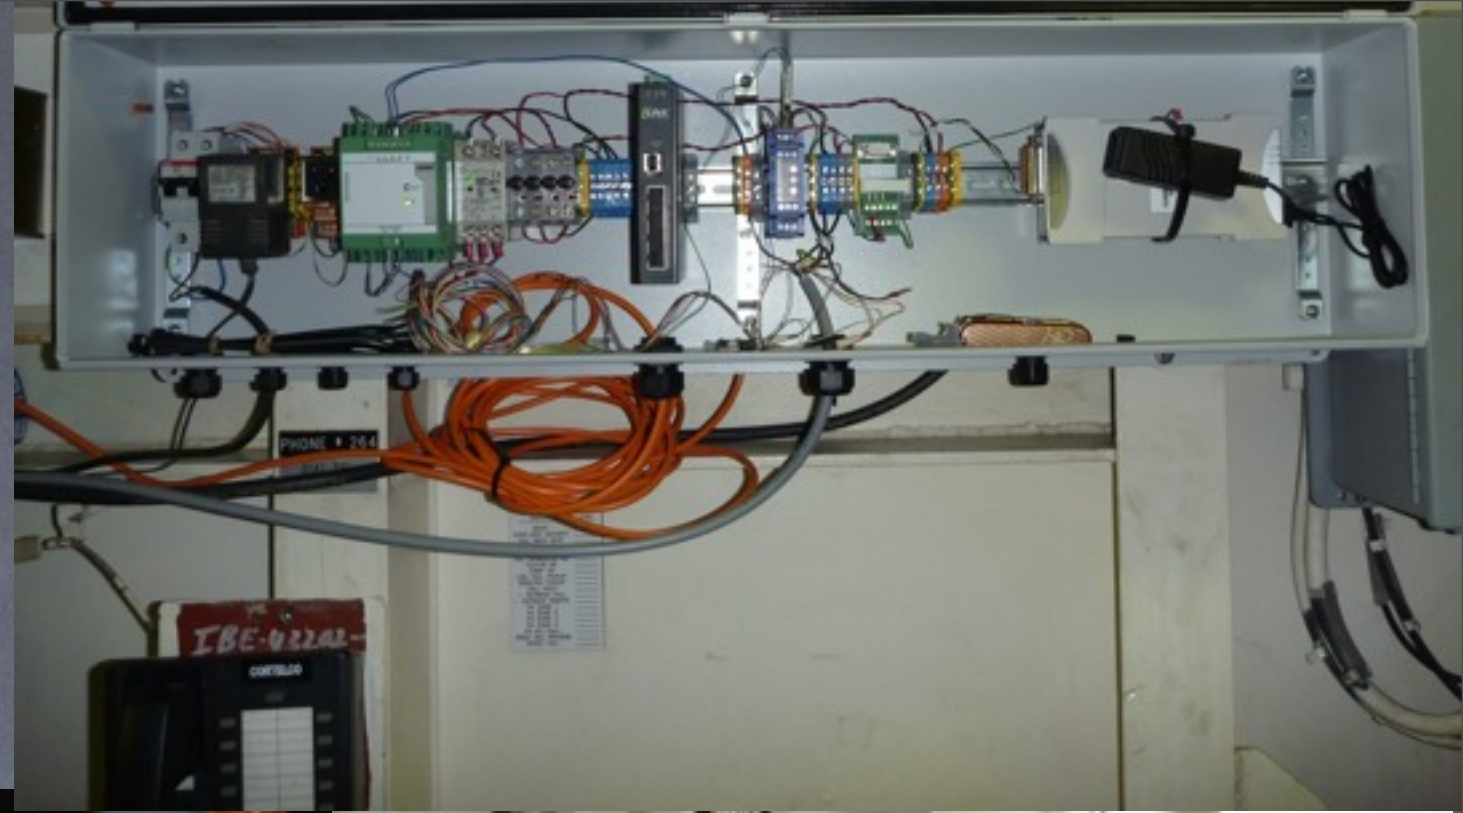
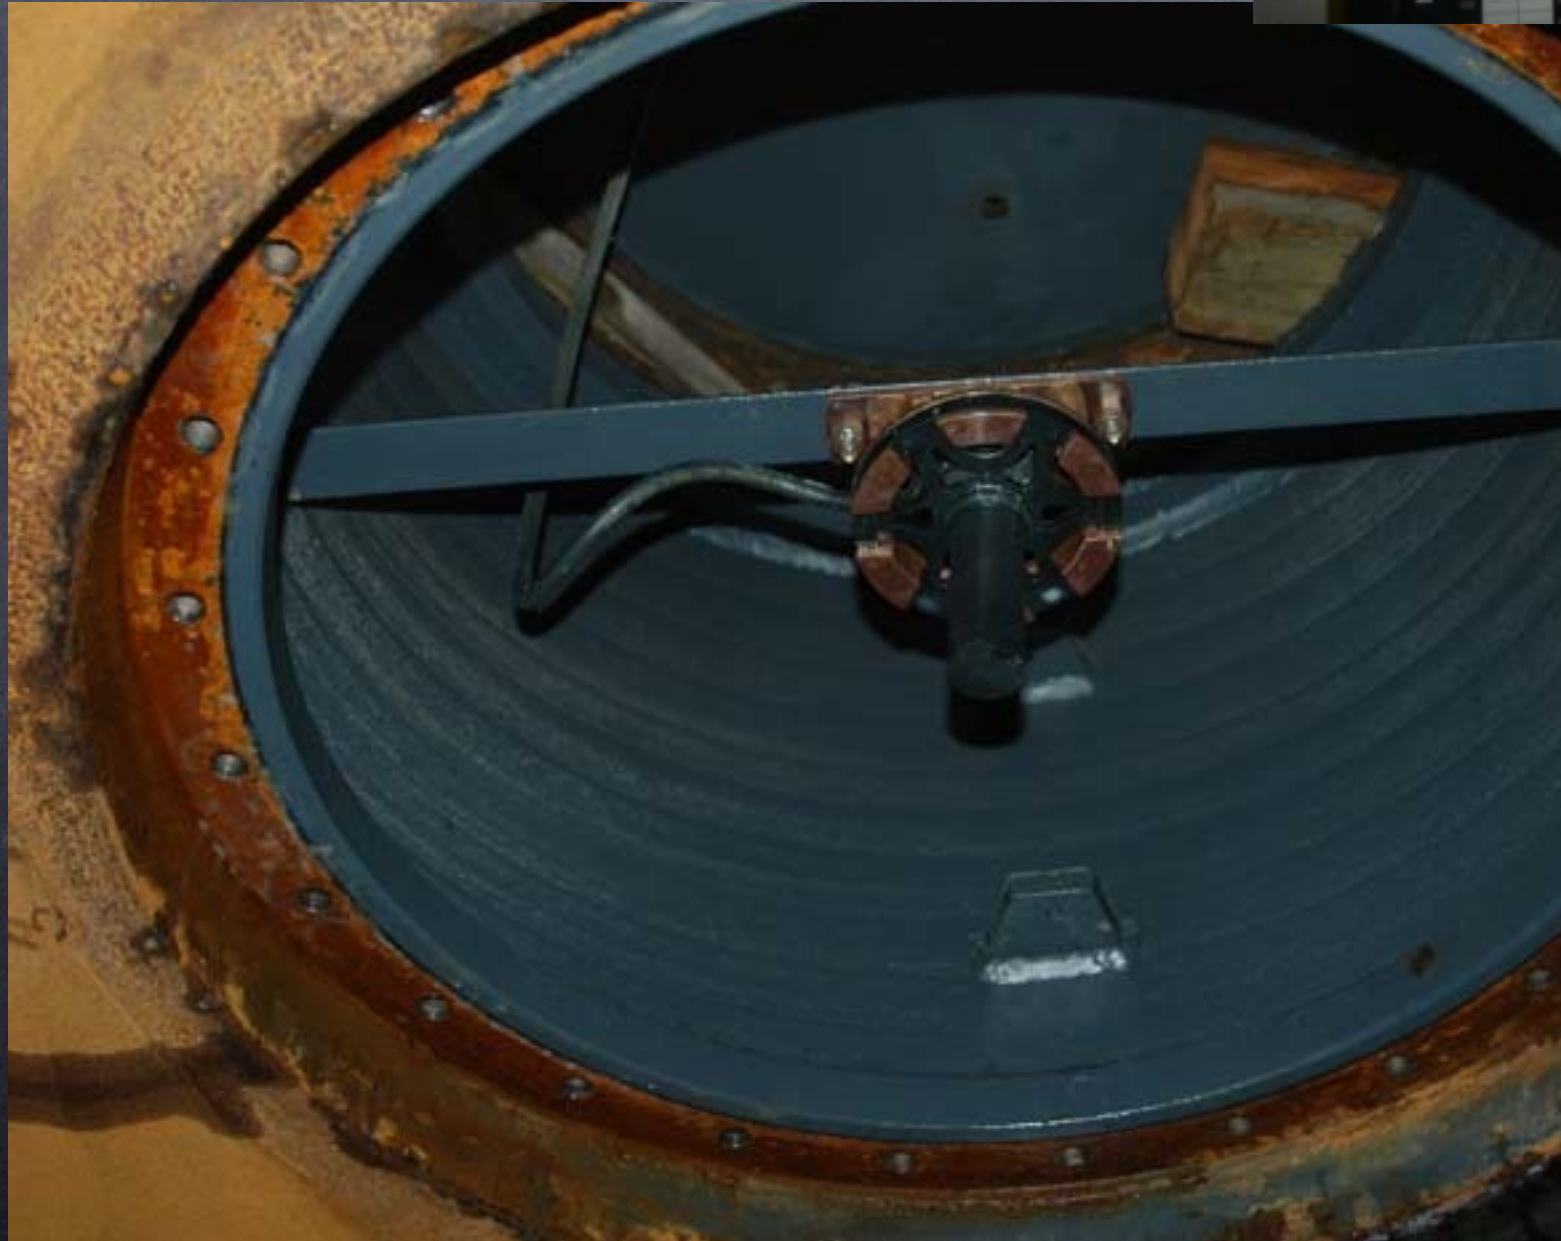
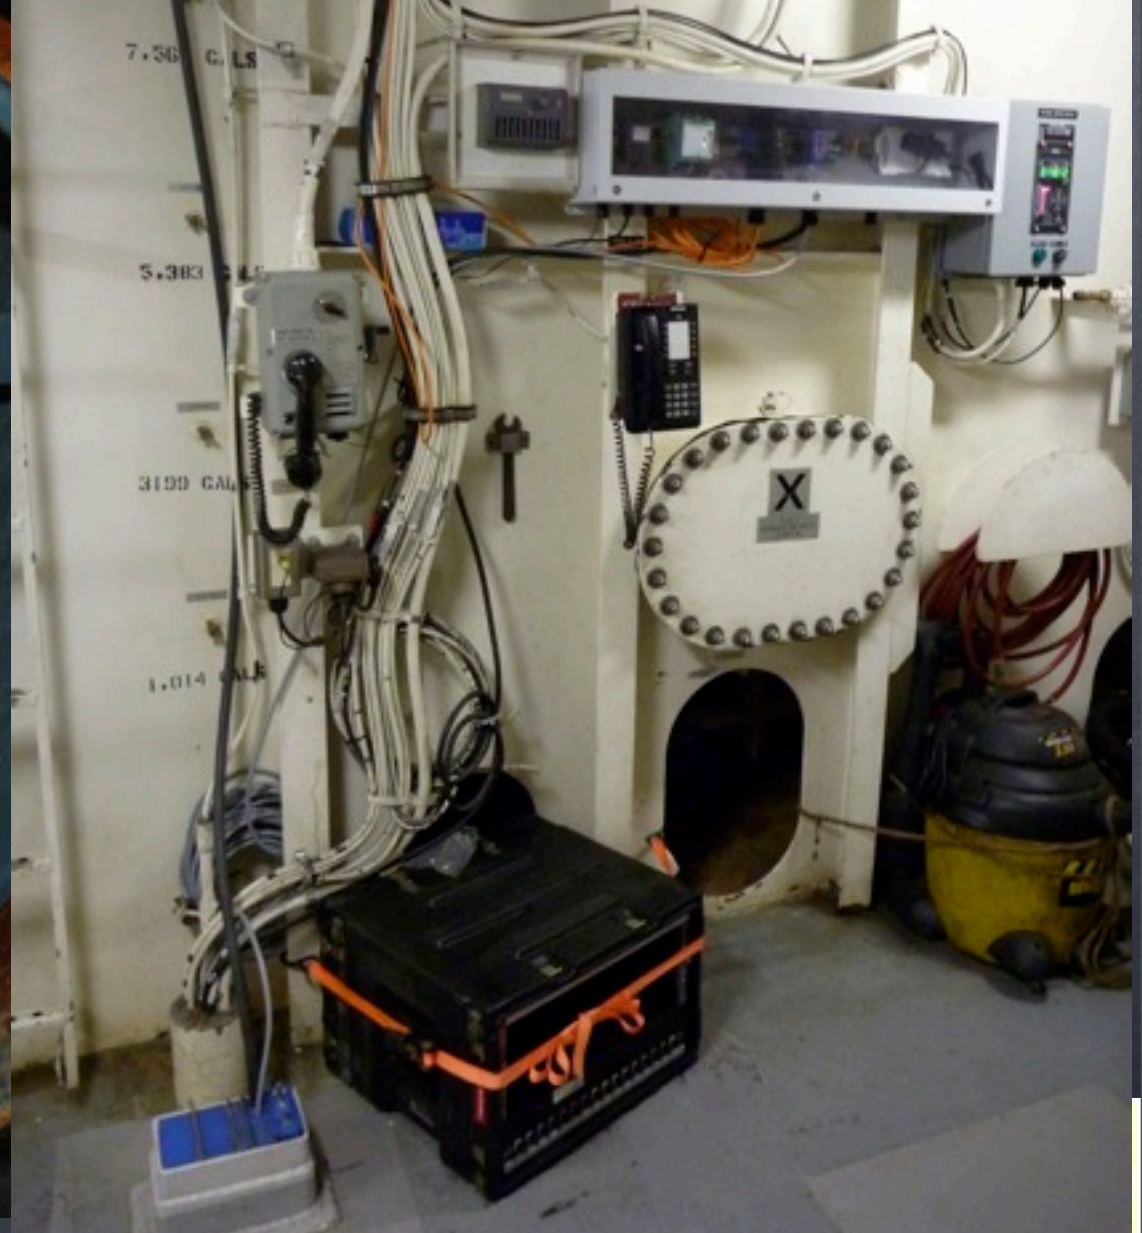
Reference Hydrophone
(bottom left), interface
hardware and junction
box in Potable Water
Pump Room (right)

- A tool to understand and help track down acoustic noise and interference w/ our sonars
- A hydrophone came with the ship
- Hardware and software to provide access to the data is being developed
- Add a higher frequency hydrophone in 2011
