# NATIONAL SCIENCE FOUNDATION SHIP INSPECTION PROGRAM

2011 RVOC MEETING SAN DIEGO, CA

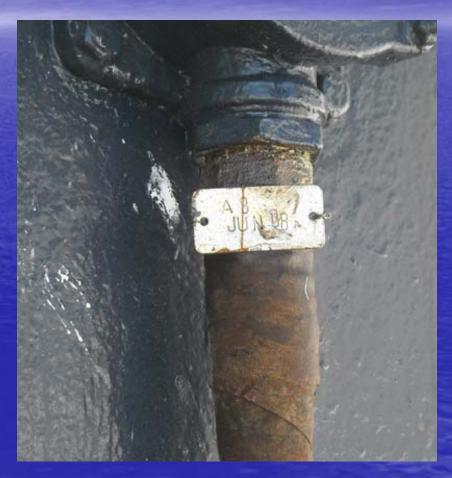
## Best Practices: Hydraulic Hoses

- Tag provides the serial number of the item for cross reference in the Hose Log.
- Installation shall be done in a manner that will not cause damage to the hose or joint.
- The following information should be provided on the tag and/or log:
  - Hose serial number
  - Hydrostatic Test Pressure and Test Date
  - Service Life Date (Replacement Date)

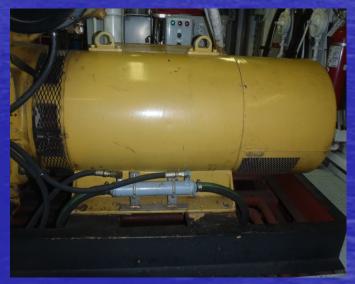
## Best Practices: Deep Fat Fryer

The aft generator (3406 CAT) on the R/V CAPE HATTERAS is capable of running on used cooking oil. The used cooking oil is held in an empty/unused tank (~400 gallon capacity) located in the engine room port side aft. The oil is filtered (10 micron) before being transferred into the holding tank and then again via the fixed generator fuel oil filter. The generator is started and warmed up on diesel fuel. The used cooking oil is heated via generator jacket water heat exchanger to ~180 degrees before being delivered to the engine. A three way valve arrangement is used to switch from diesel fuel to used cooking oil. Prior to shutdown, the engine is switched back to diesel fuel to prevent the "trumpeting" of the fuel oil injector nozzles and fouling of the supply lines.

The generator was modified April of 2008. Approximately 300 gallons of used cooking oil have run through the generator's engine, providing ~4 days of power. The cooking oil was used only while the vessel was at the dock. The R/V CAPE HATTERAS found that the logistics and supply consistency were the biggest challenge of the operation. The HATTERAS crew continues to gather (small scale) used cooking oil.
