Scripps Institution of Oceanography Shipboard Technical Support

Development of Replacement Cable and
Termination for SeaSpy Magnetometer/
Gradiometer System

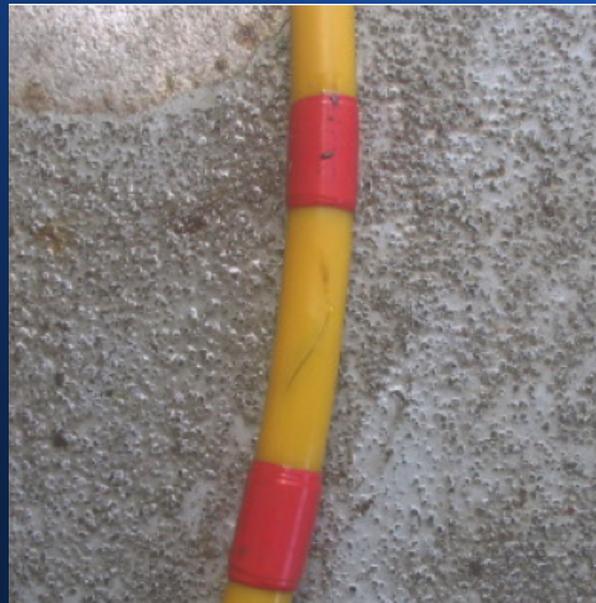
- Small cut in jacket usually from shark bite.

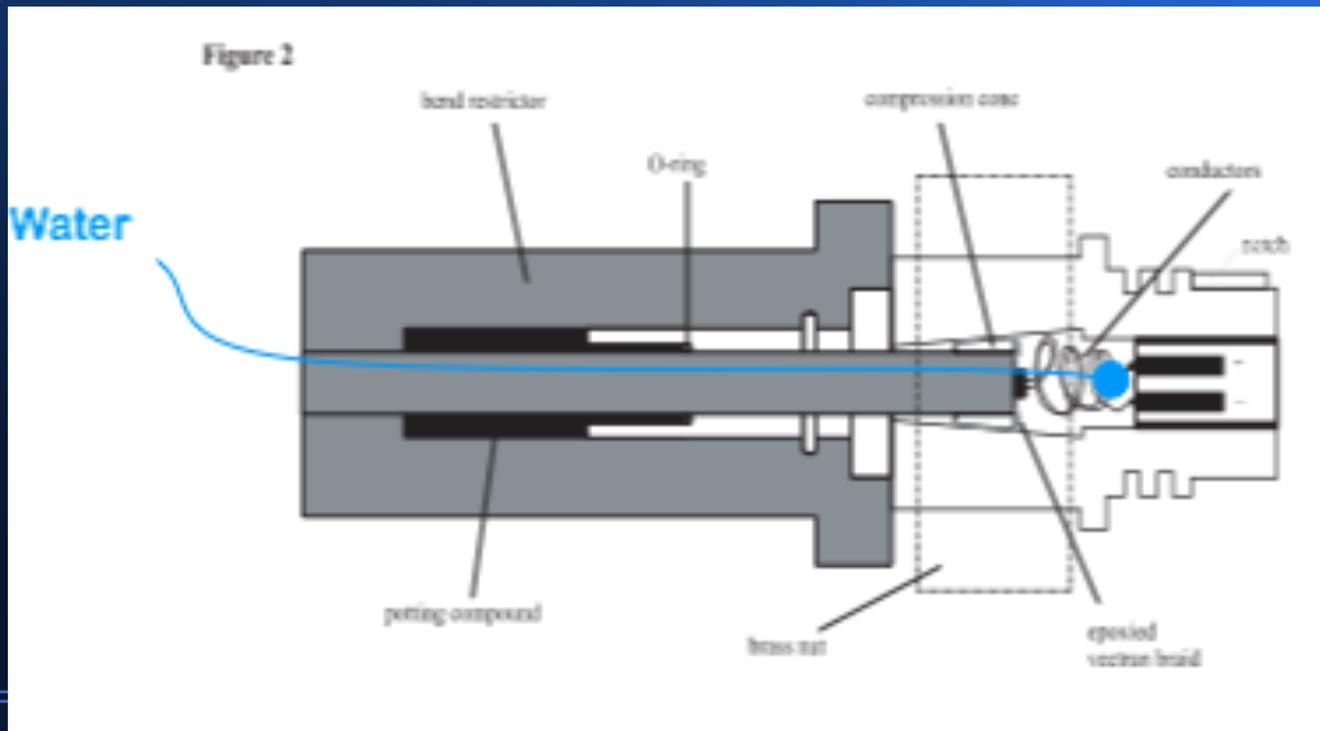
- Saltwater wicks down Vectran strength member into termination.

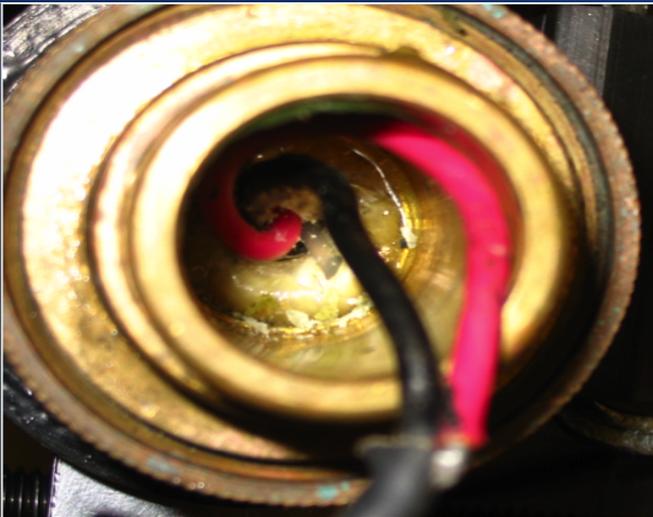
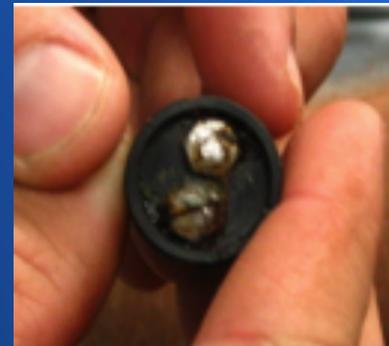
- With no barrier saltwater shorts the electrical component of the termination

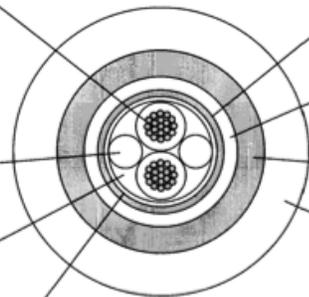
Cable Design

SINGLE CONDUCTORS-2 UNITS

Awg No. 16(19x0.0113")T/C
 DC Resistance @ 20° C ≤ 5.4 Ohms/1000 Ft
 HD Polyethylene Insulation
 Voltage rating: 600 V
 Color code: Red
 Black

FILLERS
 Plastic Rods

INTERSTICES WATERBLOCKED

TAPE
 Mylar tape

SHIELD
 Tinned Copper Braid

INNER JACKET
 HD Polyethylene
 Color: Black

STRENGTH MEMBER
 Vectran™ Braid

OUTER JACKET
 Polyurethane
 Color: Yellow
 Jacket marking:
 Parallel Black Stripe (1/16" wide)

Nominal O.D.	0.420"
Weight in Air	90 Lb/1000 Ft
Weight in Seawater	28 Lb/1000 Ft
Breaking Strength	7,000 Pounds
Maximum Load	1,000 Pounds
Min. Bend Diameter	12 Inches
