Naval Architects & Salvage Engineers

NATIONAL SCIENCE FOUNDATION SHIP INSPECTION PROGRAM

2014 RVOC MEETING

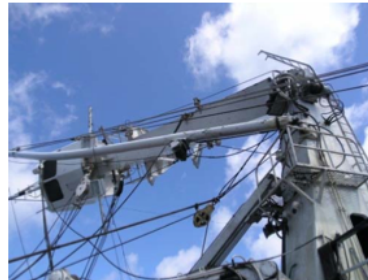
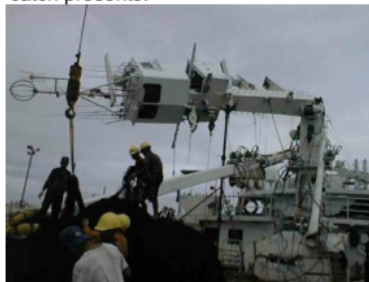
Recently, several catastrophic failures of masts, booms, and lift cables have occurred on purse seine fishing vessels that have resulted in loss of life and severe injuries. Over the years many casualties have occurred onboard all types of fishing vessels attempting to haul in catches that exceeded the capacity of their winches, hoists, and associated equipment. These types of casualties are not unusual. This alert serves to remind all purse seine fishing vessel owners/operators and other fishing segments to ensure safe use of the haul equipment particularly matching the size and the capacity of the nets to the rated size and capacity of the winch/haul/hoist equipment, taking into account safety factors for various species, and other concerns such as the variable platform that a rolling fishing vessel and variable catch presents.

Several catastrophic failures of masts, booms, and lift cables have occurred on vessels that have resulted in loss of life and severe injuries.

- * Know the design limits of load bearing structures and winches, hoist, and haul components;
- * Ensure they are inspected and tested on a regular basis;
- * Evaluate and revise operational procedures as needed.

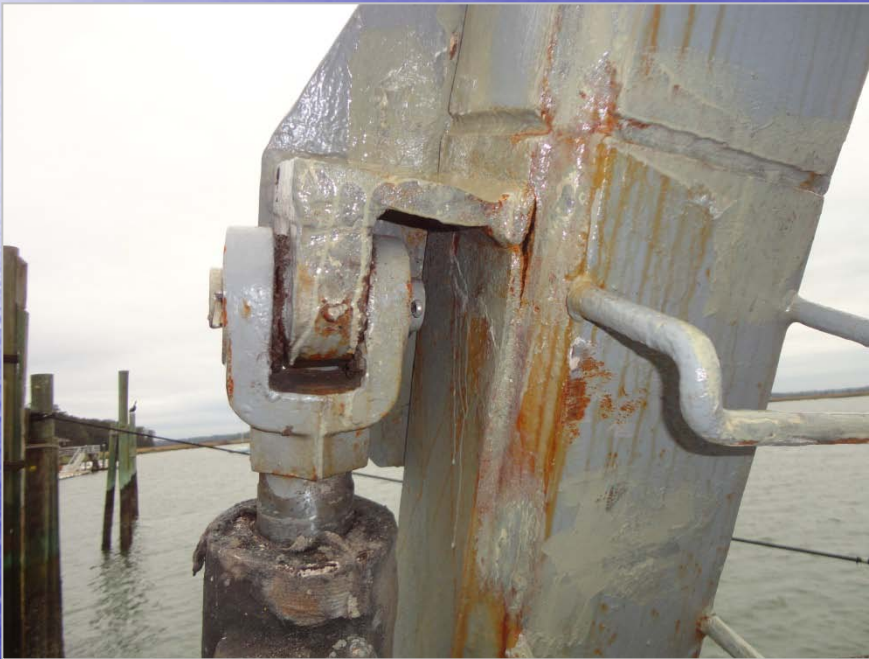
RVSS Appendix A & B Compliance:

- Know the design limits of load bearing structures and winches, hoist, and haul components;
- Ensure they are inspected and tested on a regular basis;
- Evaluate and revise operational procedures as needed.

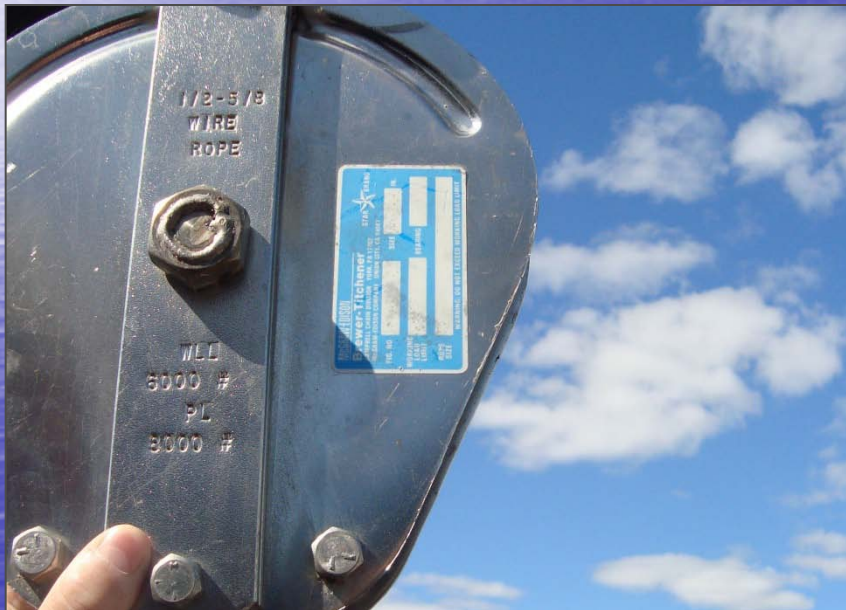
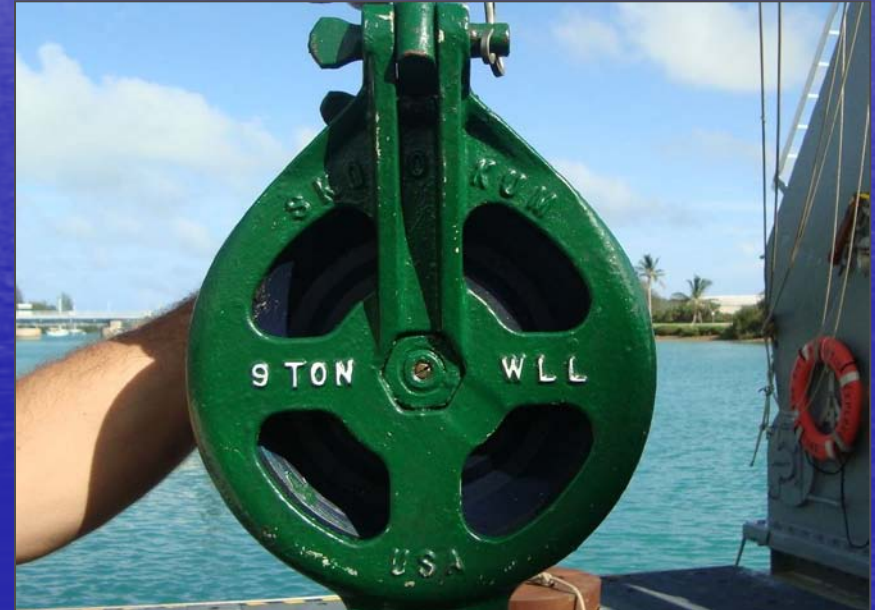
Common Findings: SWL Documentation

WLL or SWL identified on a block is not the same as max permissible tension. These blocks don't indicate if the WLL is for the tension member or for the shackle/block.

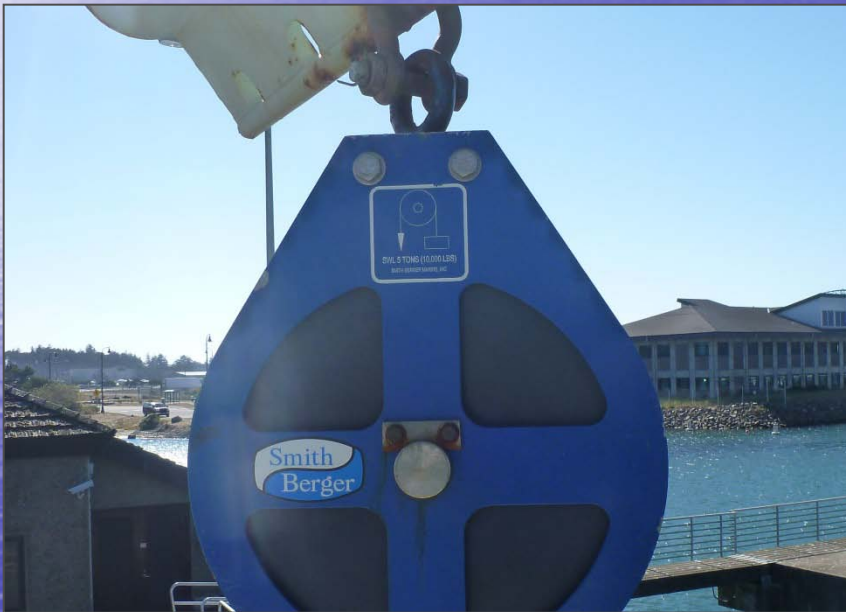
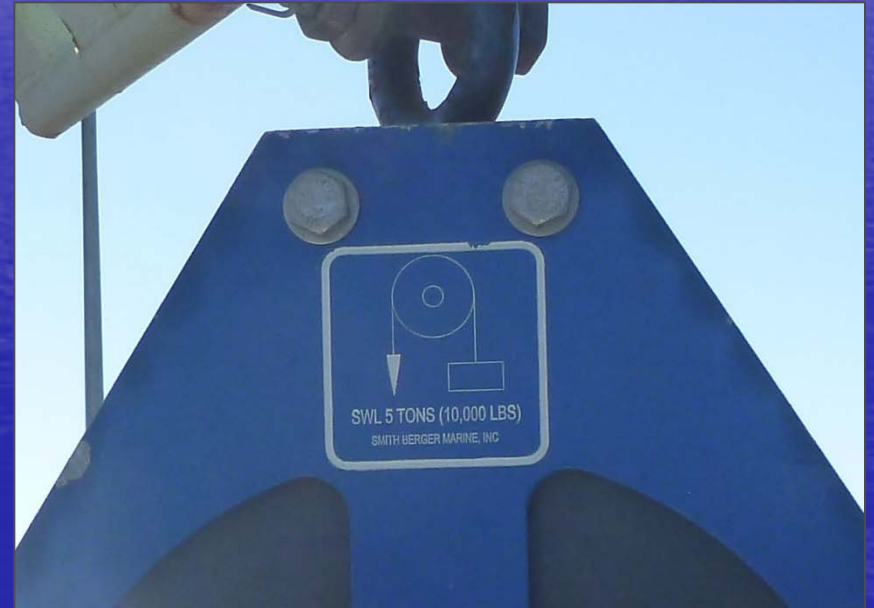
Best Practice: Sheaves

Clear indication of SWL expressed in terms of MPT.

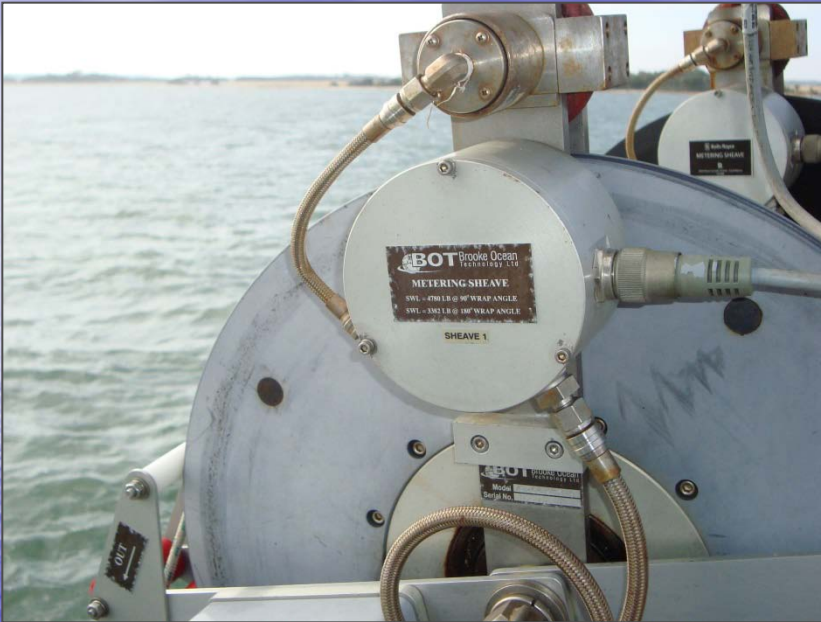
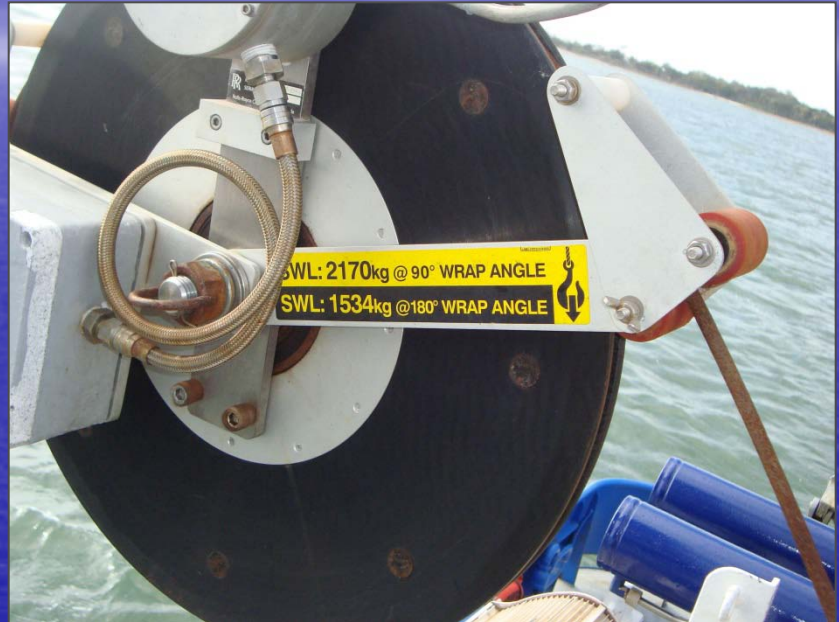
Best Practices: Sheave Wrap Angle

RV SAVANNAH: Instrument blocks that measure the wrap angle in order to measure the tension in the cable.

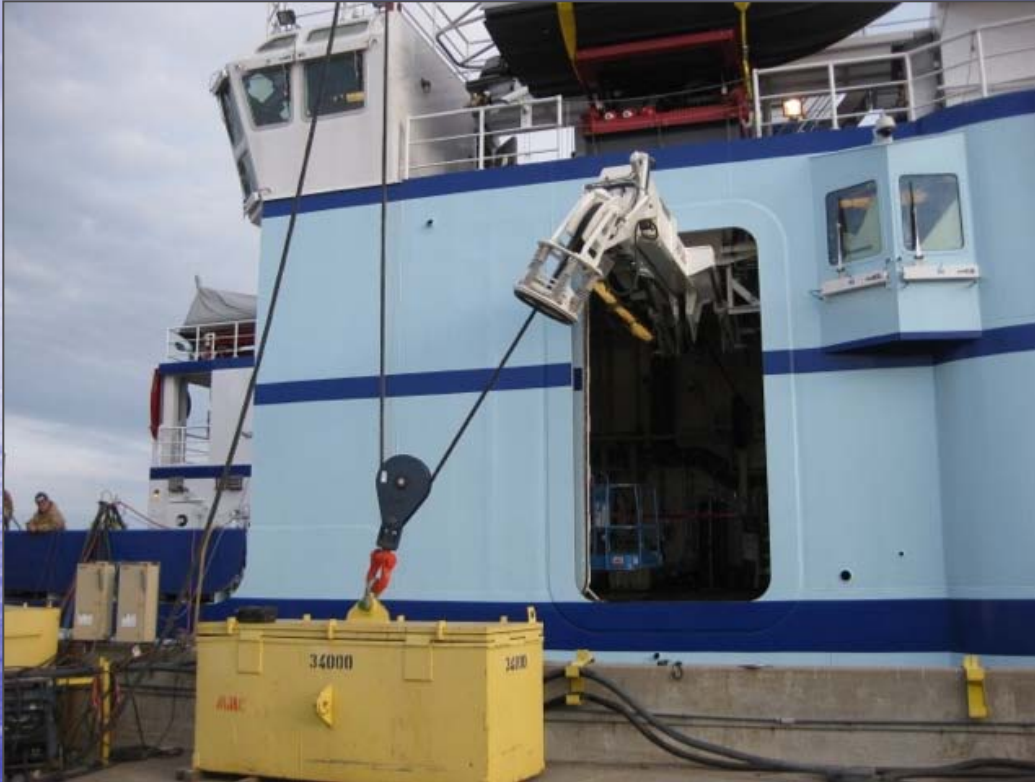
RV SIKULIAQ: Testing in the towing position

Develop a test plan/procedure

Include a line diagram

Test the system (all components) as it is intended to be used

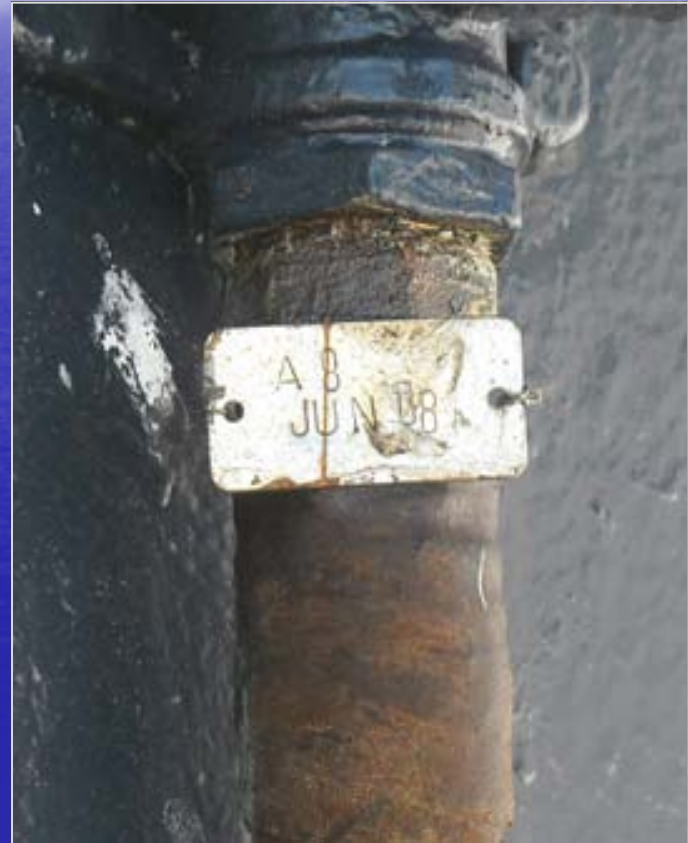
Best Practice: Hydraulic Hoses

- Tag provides the serial number of the item for cross reference in a Hose Log and installation date.
- The following information should be provided on the tag and/or log:
 - Hose serial number
 - Hydrostatic Test Pressure and Test Date
 - Installation or Replacement Date

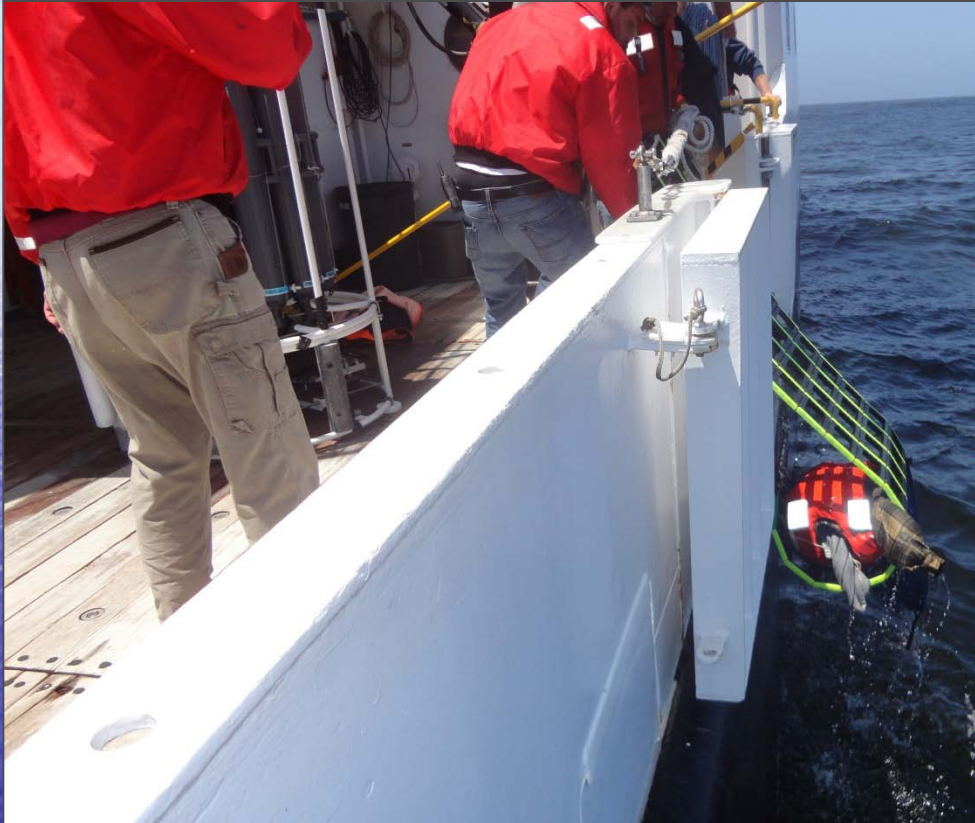
POINT SUR Life-size MOB

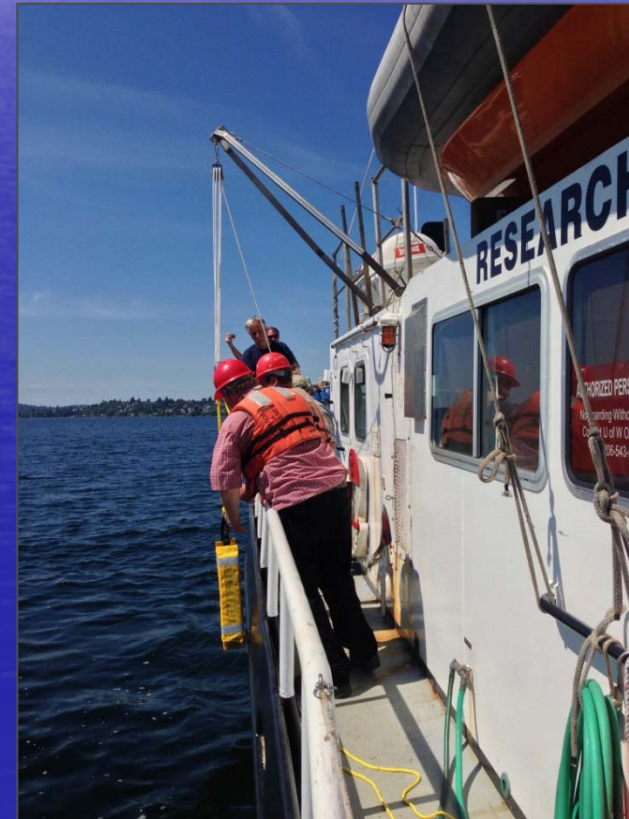
BARNES Pre-rigged Davit

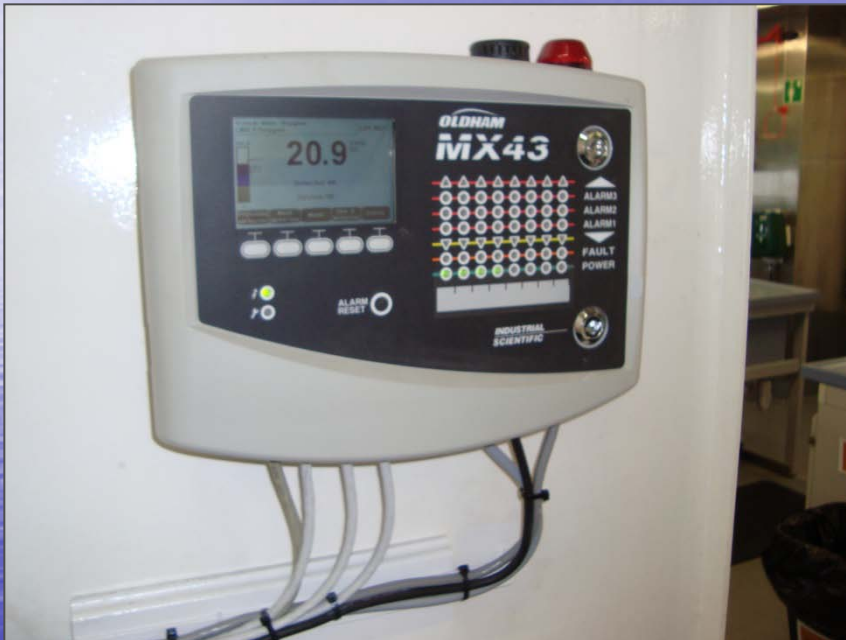
Best Practices: Wet Lab Gas Detector

RV FALKOR: Installed gas sensor system that measures the level of multiple gases in the Wet Lab where the fume hood is located.

Oldham MX43

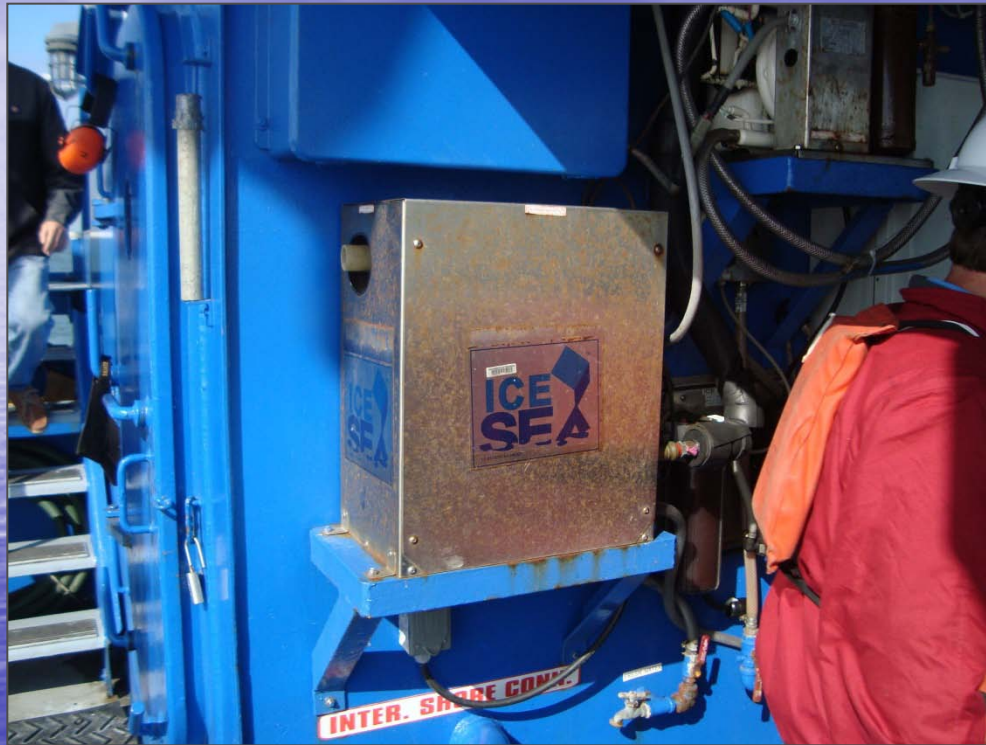
RV SAVANNAH:

Ice machine on aft deck makes ice from fresh or sea water

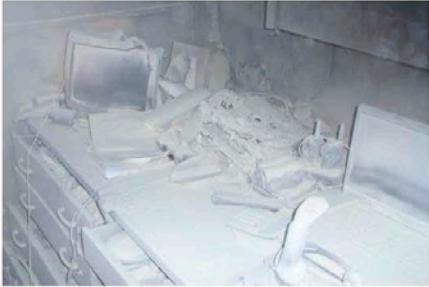
Most surge protectors are designed for use ashore and will interrupt only the hot conductor.

A Delta wired circuit has two hot leads one at ± 60 VAC, the other at ± 60 VAC, simultaneously to provide the 120 VAC potential. Here lies the problem with inexpensive and older SPDs that only disconnect one "hot" terminal lead. The other "hot" terminal remains hot if the circuit breaker supplying the receptacle and SPD does not trip.

A marine casualty investigation of two separate stateroom fires onboard a U.S. Flag Container ship revealed that the sources of the fires were attributed to the use of SPDs plugged into a lighting circuit. It was discovered that a ground had developed on another circuit that was connected to the same distribution panel providing power to the staterooms. This ground created an imbalance of voltage between the two power conductors supplying the SPDs which caused excessive currents, overheating, and subsequently, a fire. In this instance, even if the SPDs automatically tripped as designed, only one power conductor would have been secured while the other would continue to provide power, possibly shorting to the device's ground wire and the structure of the vessel.

It should be noted that related issues (mismatches between Delta or WYE systems) have been reported with 120 VAC Uninterrupted Power Supplies purchased ashore and used onboard vessels. Such devices should be selected to match the power supply configuration.

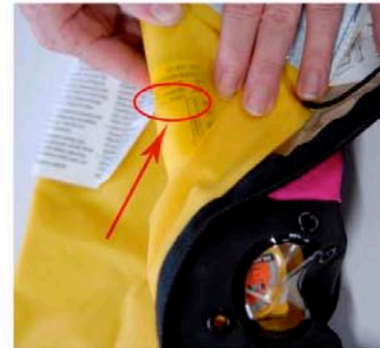
Certain Mustang Survival Inflatable PFDs with Hammar MA1 hydrostatic (HIT) inflation systems may not inflate and require a new re-arm kit to properly inflate by manual or automatic activation.

Photograph showing view of lot number through fabric.

Lot number on cylinder label.

If you have a re-arm kit MA7214 or MA7218 you need only to check the lot number on the CO₂ cylinder label. If your CO₂ cylinder is marked with lot numbers 404121 or 404122 please contact Mustang Survival's customer service group at the number below.

If you have a PFD listed above refer to the sewn-in approval label to determine if it was "Made in Canada" and the "MFG DATE" is April or May 2012. If so, you will need to check the lot numbers of the CO₂ cylinder. The CO₂ cylinder lot number is visible through the yellow bladder fabric. Manually unpack your PFD by opening the zippers and unfolding your PFD. Find the CO₂ cylinder that is attached to the round inflator within the yellow bladder. Press the yellow bladder fabric against the cylinder to read the label to view the lot number through the fabric. If your CO₂ cylinder is marked with lot numbers 404121 or 404122, please contact Mustang Survival's customer service group for instructions and to arrange for a replacement inflator assembly.

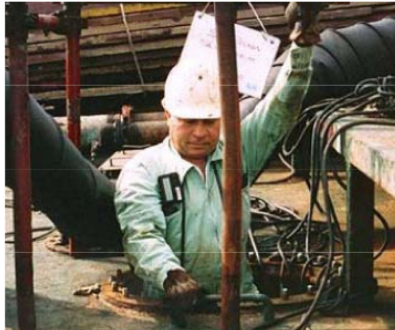
In the first case, an inspector was on board a tank vessel to conduct a Port State Control Examination. In anticipation of the examination, the crew opened the hatch to the Freefall Lifeboat to let it air out. As the Inspector entered the lifeboat his gas meter alarmed and he quickly exited. Upon investigation, it was confirmed with ship's equipment that Carbon Monoxide had collected in the lifeboat. Wind conditions had been blowing exhaust from the main stack into the lifeboat. Although not a confined space by OSHA or Coast Guard standards, the risks were the same.

In the second instance, while inspecting the #1 deep ballast tank on a deep draft container ship, an experienced marine inspector was going to climb through a box-like structure formed by floors and longitudinals in the #1 bay, just aft of the collision bulkhead. The "box" had only two lightening holes. Prior to entering the first lightening hole the inspector put his 4-gas meter through. It immediately alarmed for low O₂. The inspector exited the ballast tank. While the ballast tank had been ventilated and was safe, the inspector failed to recognize that the "box" formed a confined space within a confined space and had not been cleared by the shipyard competent person.

The Coast Guard **strongly reminds** all shipboard personnel and those associated with inspections, surveys or audits of vessels worldwide, that hazardous atmospheres are frequently present onboard vessels and pose a great risk to personal safety. Besides the use of a personal gas meter for immediate protection, all organizations should have policies and procedures in place that address accessing these areas and make available the appropriate safety equipment for personnel.

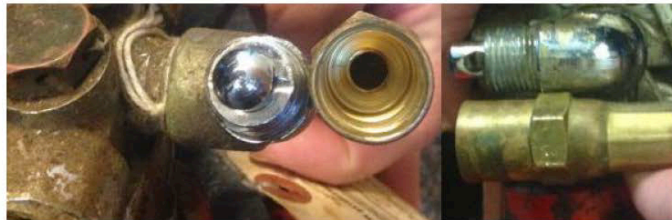
The investigators had the extinguisher examined at a fire-fighting equipment service center. They determined that the hose and discharge horn had been replaced at an earlier time. The end of the hose screws on to a diffuser on the side of the discharge valve/handle assembly of the extinguisher. The diffuser is a ported protrusion on the male end of a ninety degree fitting. On the side of the protrusion are orifices through which the CO₂ flows. The examination revealed that the spherical end of the protrusion, which contains no orifices, bottomed out against the orifice in the connection fitting that leads to the hose and horn assembly. The flow of CO₂ was thus completely blocked.

It was further noted that the male threads of the diffuser were tapered US national pipe threads, while the female threads of the hose connection were straight. This difference likely allowed the hose connection to be tightened further than intended on the diffuser threads, permitting the spherical end of the diffuser to bottom out against the orifice in the tube. This may have also resulted in the reported leakage from the neck of the extinguisher due to back pressure.

Investigators determined that the hose and discharge horn had been replaced at an earlier time. The end of the hose screws on to a diffuser on the side of the discharge valve/handle assembly of the extinguisher. The diffuser is a ported protrusion on the male end of a ninety degree fitting. On the side of the protrusion are orifices through which the CO₂ flows. The examination revealed that the spherical end of the protrusion, which contains no orifices, bottomed out against the orifice in the connection fitting that leads to the hose and horn assembly. The flow of CO₂ was thus completely blocked.
