Nereus Loss

Nereus Failure Analysis Report Outline

Objectives of Report: Determine the most likely root-cause leading to loss of the vehicle

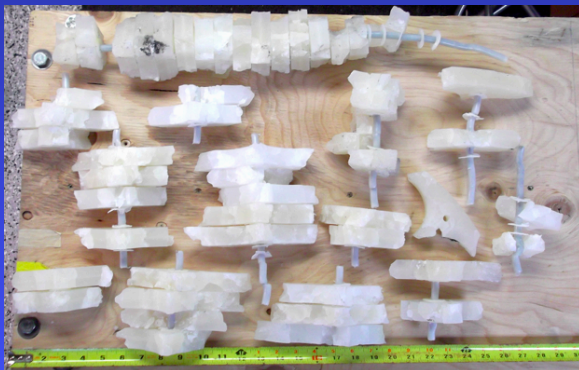
Port Nose Debris Reconstruction
