SWAB REPORT #1098

R/V Kilo Moana

REPORT FOR SWAB # 1098

LOCATION: San Francisco, CA
VESSEL/LAB: *R/V Kilo Moana*

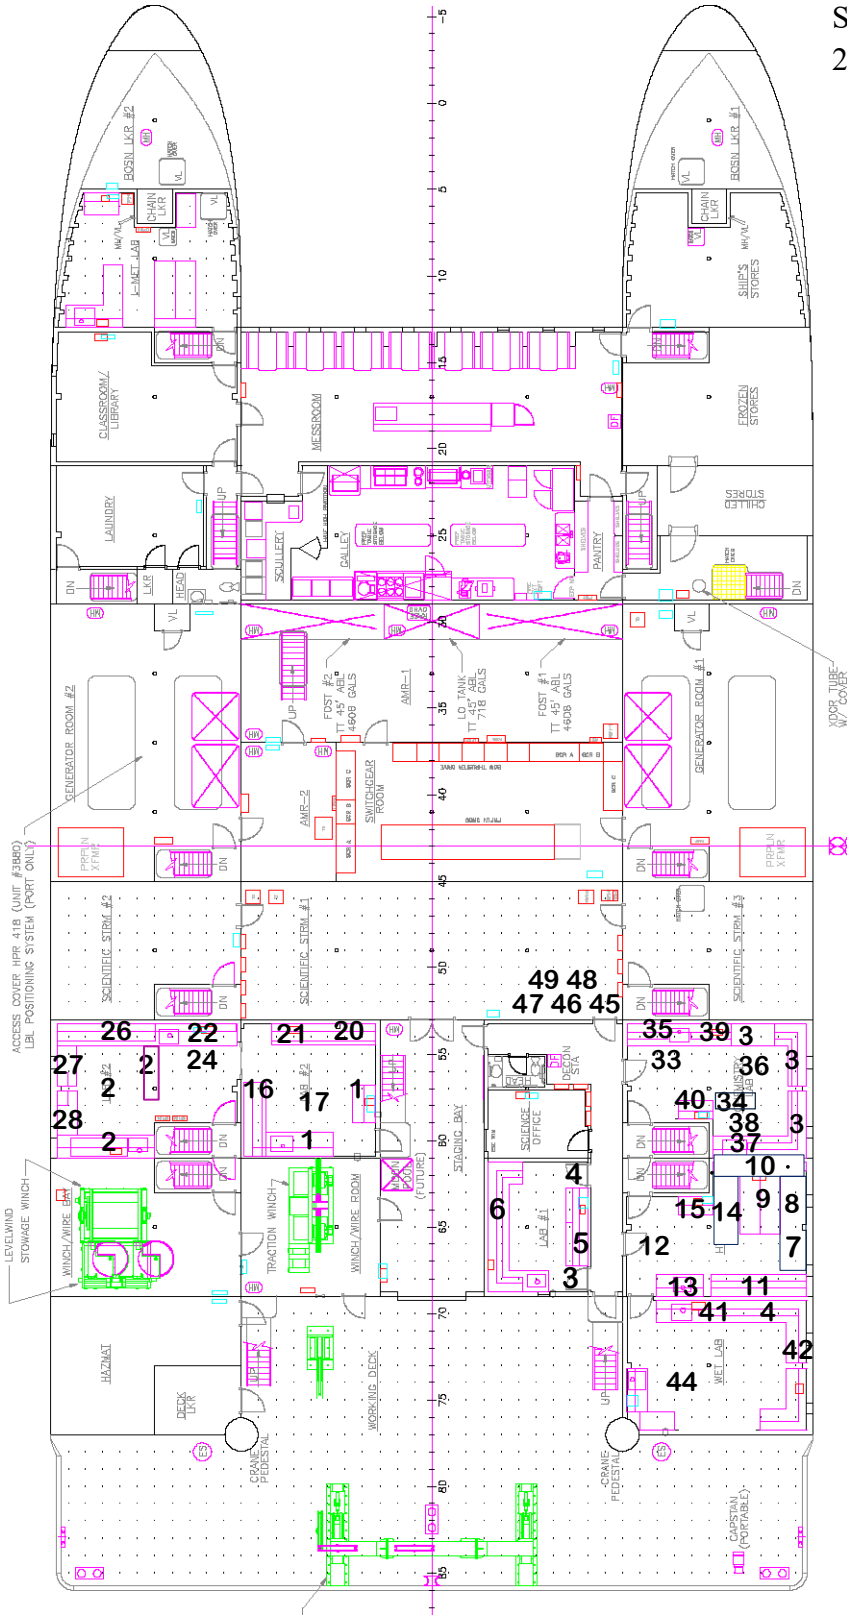
Figure 1
 SWAB # 1098
 28 June 2024

| Sample # | Sample Identification | ³ H dpm/m ² | | ¹⁴ C dpm/m ² | |
|---|--|---|---|---|---|
| 5 | Starboard benchtop | *2144 | ± 128 | 40 | ± 6 |

Please note that the error reported for each isotope is the two-standard deviation counting error. Reports may now contain values less than zero. Decay counting background samples will be distributed about the background vial, which means that negative values are possible. In the past we rounded the negative values to zero. Values are only significantly above background when they are positive and larger than the error. Please note that we are now using a Quantulus 6220 LSC which counts very near natural background. While the cleanup standards have not changed; all values above background will now be in bold. One areas of minor ³H contamination was found in Lab #1. This benchtop should be cleaned.

| Category | ^3H (dpm/m^2) | ^{14}C (dpm m^2) | Recommendations |
|---|--|---|--|
| B* | 500-10,000 | 50-10,000 | Needs cleaning before any natural tracer work. Decks in radiation vans with activities above 1000 dpm/m^2 should be cleaned. |
