West Coast Van Pool

Christine Golden & Ethan Roth
Marine Operations - Oregon State University

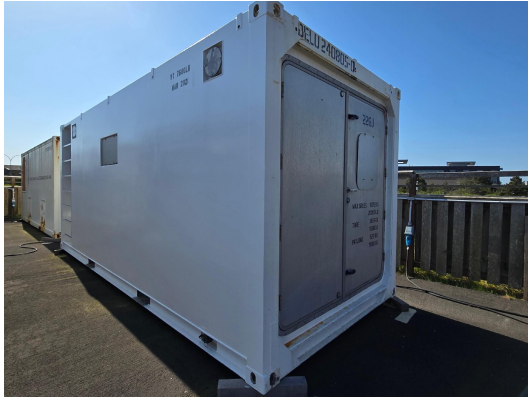
GP-2 Exterior waiting for decal application

- **Complete Refurbishment of GP-2:** WCVF has selected one or two vans to repair any damages and repaint labs for the past 4 years, GP-2 is one of the last vans on the list. R-4's interior has been completed and is going through final outfitting.

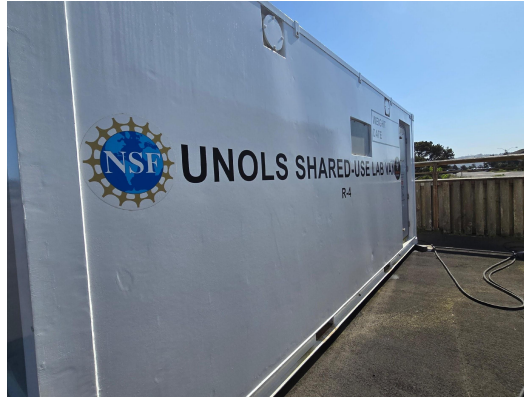
R-4 Exterior completed

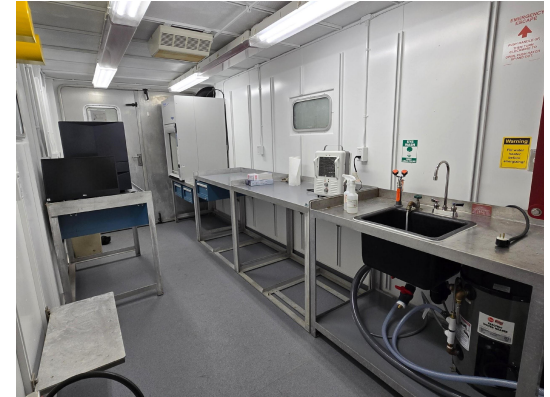
R-4 structural interior completed, waiting for arrival of equipment to complete lab outfitting

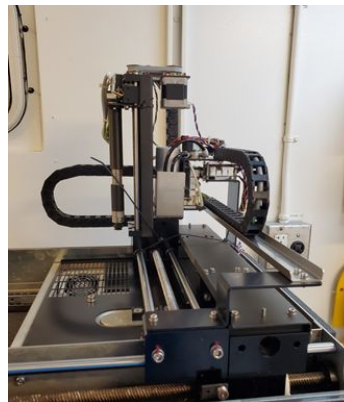
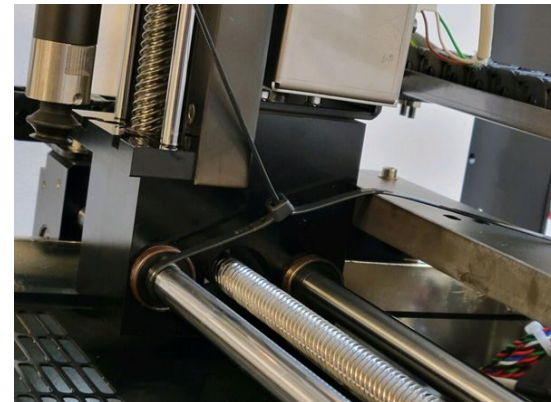
Hidex LSC Units:

- There's a noted issue with the arm inside the counter picking up the vials for processing while in a heavy sea state. It's recommended that when in transport, the arm inside the unit is zip tied in place until loaded onto the ship and lab is set up for use – we are working on implementing this procedure prior to transport-heavy requests. Please read the updated Standard Operating Procedures guide provided in the labs or reach out to the West Coast Van Pool for more information.
- There are less issues overall when users are processing with 20mL vials instead of 7mL.
