SWAB REPORT # 1131

SWAB DATE: 6 October 2025

*R/V Atlantic Explorer*  
UNOLS Radioisotope Van #2408-04

# REPORT FOR SWAB # 1131

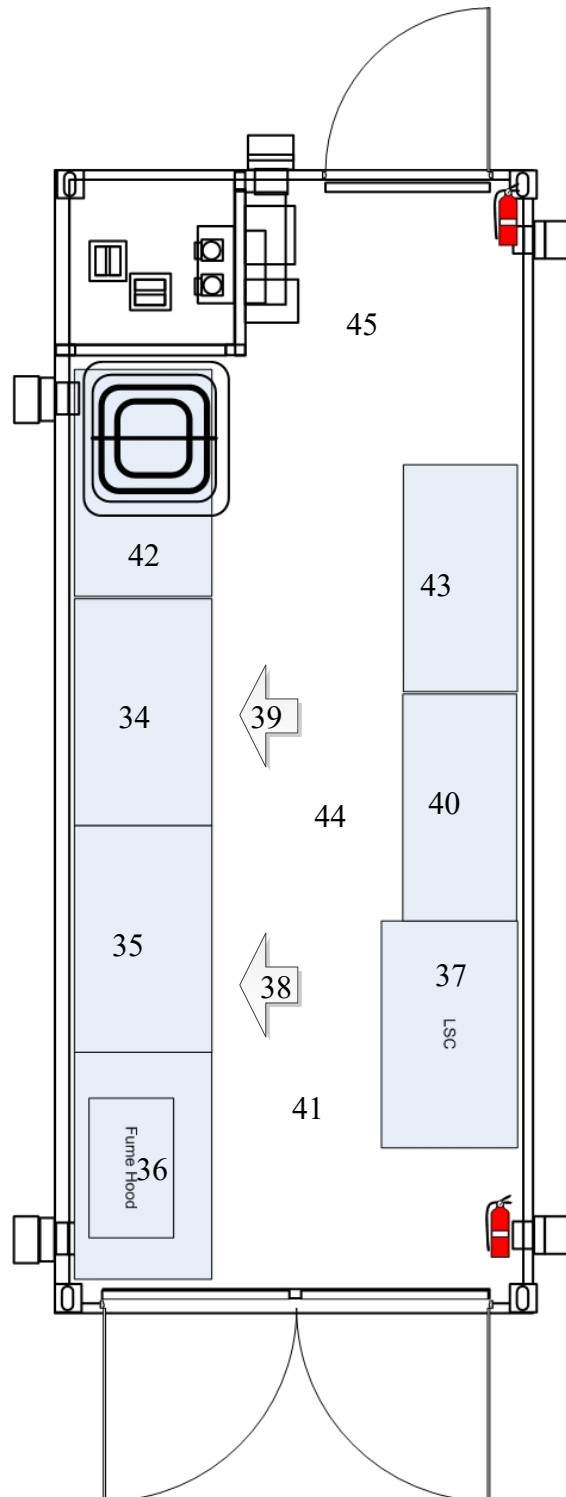
Figure 2  
SWAB #1131  
6 October 2025

| Sample # | Sample Identification | <sup>3</sup> H dpm/m <sup>2</sup> | | <sup>14</sup> C dpm/m <sup>2</sup> | |
|---|---|---|---|---|---|
| <u>Radioisotope Van #2408-04 (Figure 2)</u> | | | | | |
| 34 | Benchtop adjacent to sink | <b>30</b> | ± 22 | <b>29</b> | ± 15 |
| 35 | Benchtop adjacent to fume hood | <b>45</b> | ± 28 | 11 | ± 18 |
| 36 | Inside fume hood | <b>87</b> | ± 26 | <b>49</b> | ± 14 |
| 37 | Top of LSC | <b>97</b> | ± 28 | <b>44</b> | ± 14 |
| 38 | Inside freezer | <b>55</b> | ± 25 | <b>26</b> | ± 14 |
| 39 | Inside refrigerator | <b>153</b> | ± 36 | <b>28</b> | ± 12 |
| 40 | Benchtop adjacent to LSC | <b>65</b> | ± 24 | <b>43</b> | ± 14 |
| 41 | Deck in front of fume hood | <b>66</b> | ± 26 | <b>24</b> | ± 14 |
| 42 | Sink area | 26 | ± 37 | 14 | ± 17 |
| 43 | Benchtop across from sink | 9 | ± 15 | <b>25</b> | ± 15 |
| 44 | Deck in center of van | <b>108</b> | ± 30 | <b>40</b> | ± 14 |
| 45 | Deck inside entrance | <b>62</b> | ± 25 | <b>32</b> | ± 14 |

Please note that the error reported for each isotope is the two-standard deviation counting error. Reports may now contain values less than zero. Decay counting background samples will be distributed about the background vial, which means that negative values are possible. In the past we rounded the negative values to zero. Values are only significantly above background when they are positive and larger than the error. Please note that we are now using a Quantulus 6220 LSC which counts very near natural background. While the cleanup standards have not changed all values above background will now be in bold. All areas sampled inside the ship and in the Rad Van were free from isotope contamination requiring cleaning.
