SWAB REPORT # 656

R/V N. B. Palmer

REPORT FOR SWAB # 656

LOCATION: Punta Arenas, Chile VESSEL: *R/V N.B. Palmer*

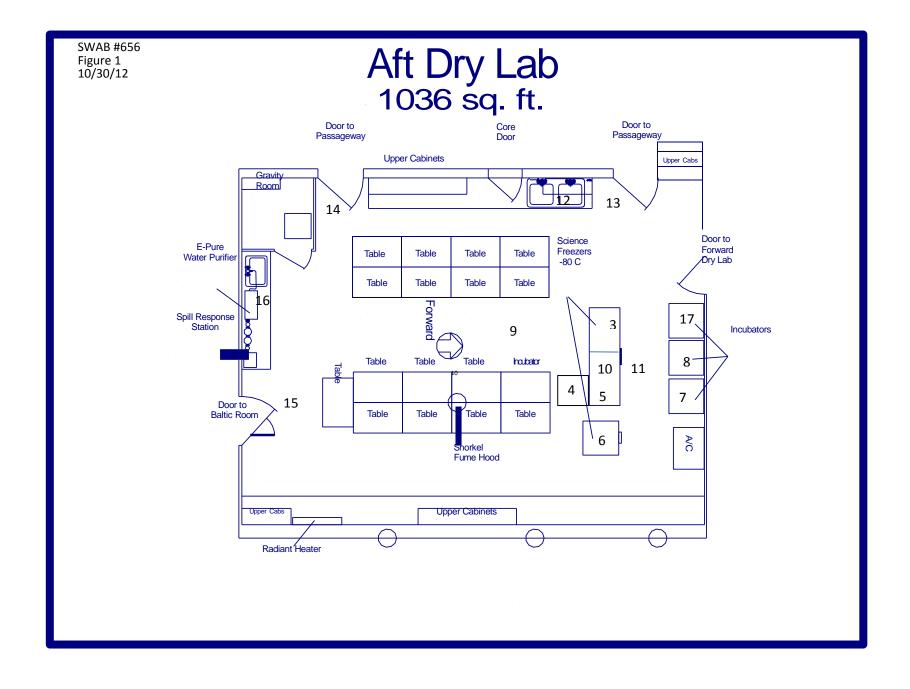
Sample # Sample Identification	³ H dpn	³ H dpm/m ²			¹⁴ C dpm/m ²		
	activity		rror	activity	(error	
1 1st Vial Bkgnd	0	±	0	0	±	0	
2 Initial bucket blank #1	0	±	0	17	±	37	
Aft Dry Lab (Figure 1)							
3 Top of Revco chest freezer	0	±	0	9	\pm	42	
4 Inside Fisher 00010623	0	\pm	0	0	\pm	0	
5 Inside Thermo Scientific freezer	0	\pm	0	0	\pm	0	
6 Inside Revco freezer 12063	0	±	0	23	±	35	
7 Inside Percival incubator 00011176	0	±	0	0	\pm	0	
8 Inside Fisher incubator 00113062	0	±	0	6	±	54	
9 Deck between tables	0	±	0	9	\pm	36	
10 Inside Revco chest freezer	0	\pm	0	4	\pm	64	
11 Deck in front of freezers	0	\pm	0	15	\pm	36	
12 Port sink area	0	±	0	10	\pm	35	
13 Deck at forward door to passageway	0	±	0	1	±	0	
14 Deckat at aft door to passageway	0	±	0	0	±	0	
15 Deck at aft door to Baltic Room	0	±	0	7	±	37	
16 Aft sink area	0	±	0	6	\pm	41	
17 Inside Percival incubator 00011176	0	±	0	0	±	0	
Forward Dry Lab (Figure 2)

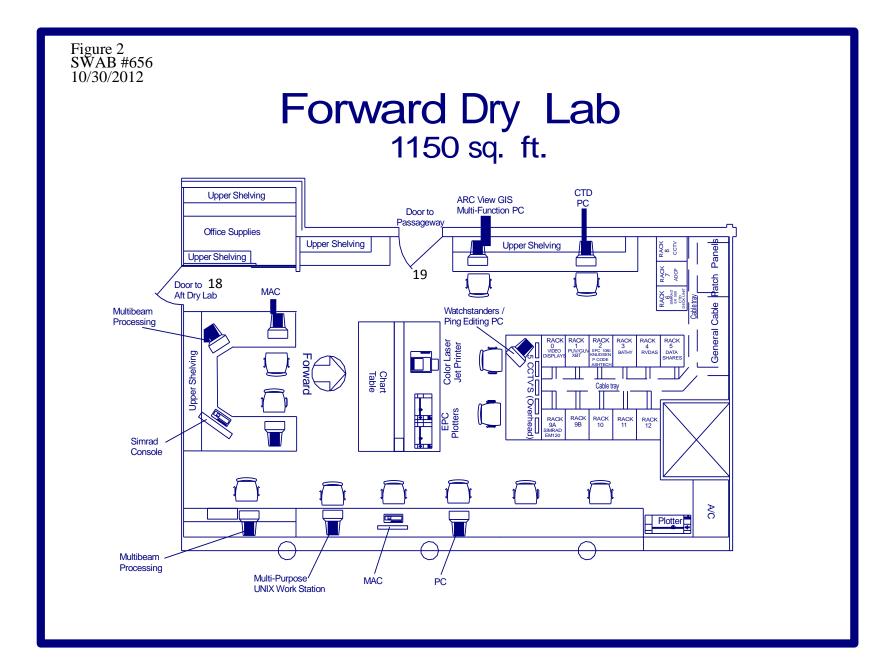
18 Deck inside Forward Dry Lab	8	±	53	0	±	0	
19 Deck inside door to passageway	0	±	0	4	±	43	
Bio Lab (Figure 3)							
20 Sink area inside fwd. cooler	0	±	4	9	±	33	
21 Benchtop right of sink inside aft cooler	2	±	18	6	\pm	32	
22 Inside aft fume hood	0	±	0	19	\pm	37	
23 Inside fwd. fume hood	0	\pm	0	11	\pm	42	
24 Port sink area	0	±	0	13	\pm	39	
25 Deck in front of aft fume hood	0	±	0	0	\pm	0	
26 Deck in front of fwd. fume hood	6	±	52	0	±	0	
27 Deck inside fwd. entrance	0	±	0	6	\pm	46	
28 Deck in front of port sink	0	±	0	0	±	0	
29 Aft sink area	0	±	0	5	\pm	38
