SWAB REPORT # 666

SWAB DATE: 17 December 2012

R/V Atlantic Explorer and UNOLS Van #2409.01

REPORT FOR SWAB # 666

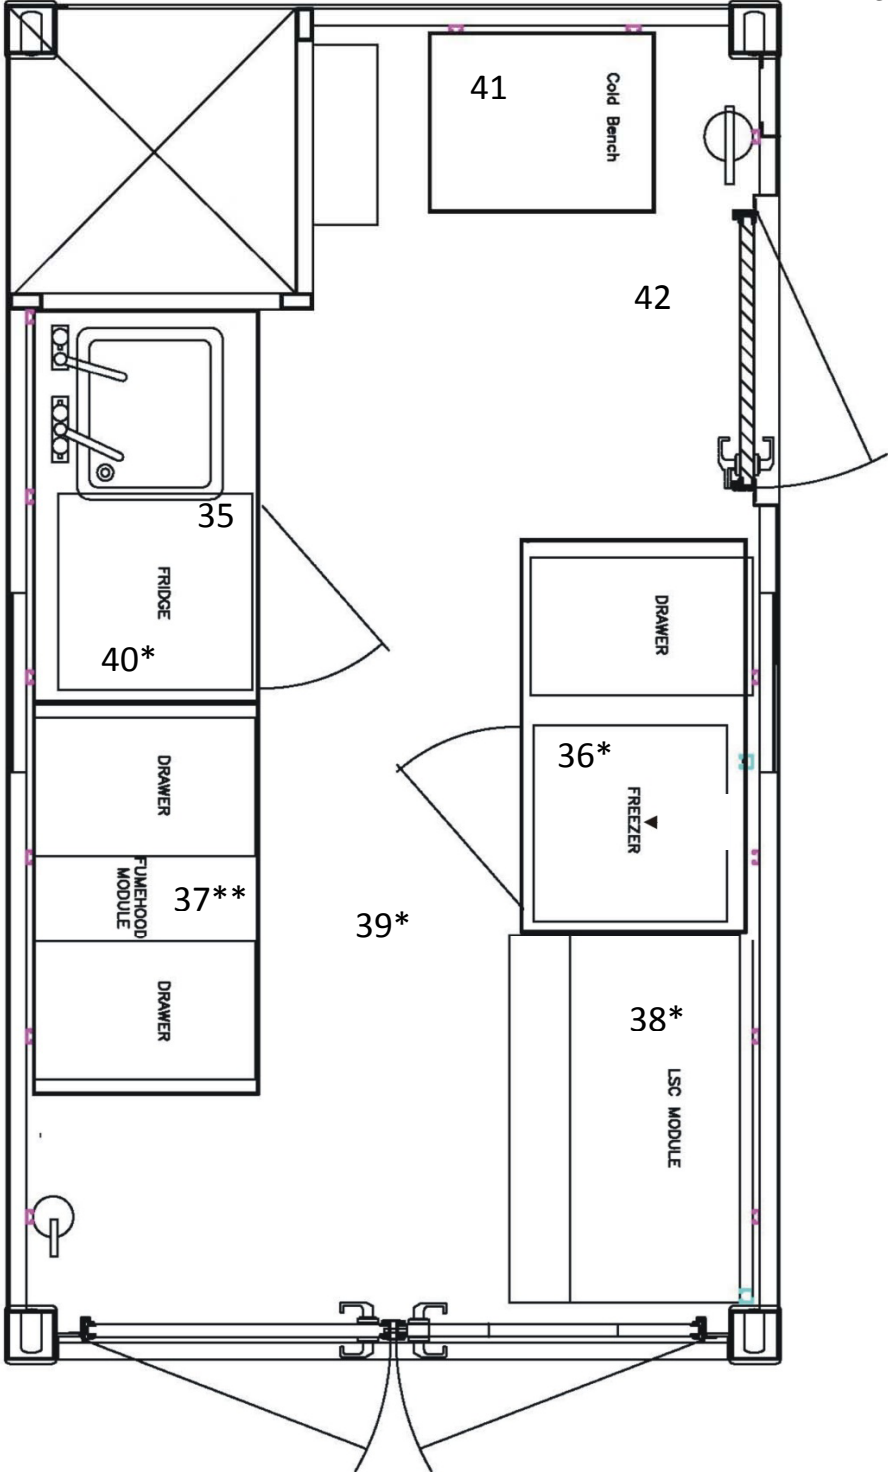
Figure 2

Minor to moderate ³H and minor ¹⁴C contamination found in the van. The fume hood and inside Danby refrigerator needs to be cleaned before any further use.

Cleaning of deck is recommended to prevent tracking contamination out of van.
