SWAB REPORT # 697

*R/V Kilo Moana
and Univ. of Hawaii Radioisotope Van*

REPORT FOR SWAB # 697

LOCATION: Honolulu, HI
VESSEL/LAB: R/V Kilo Moana

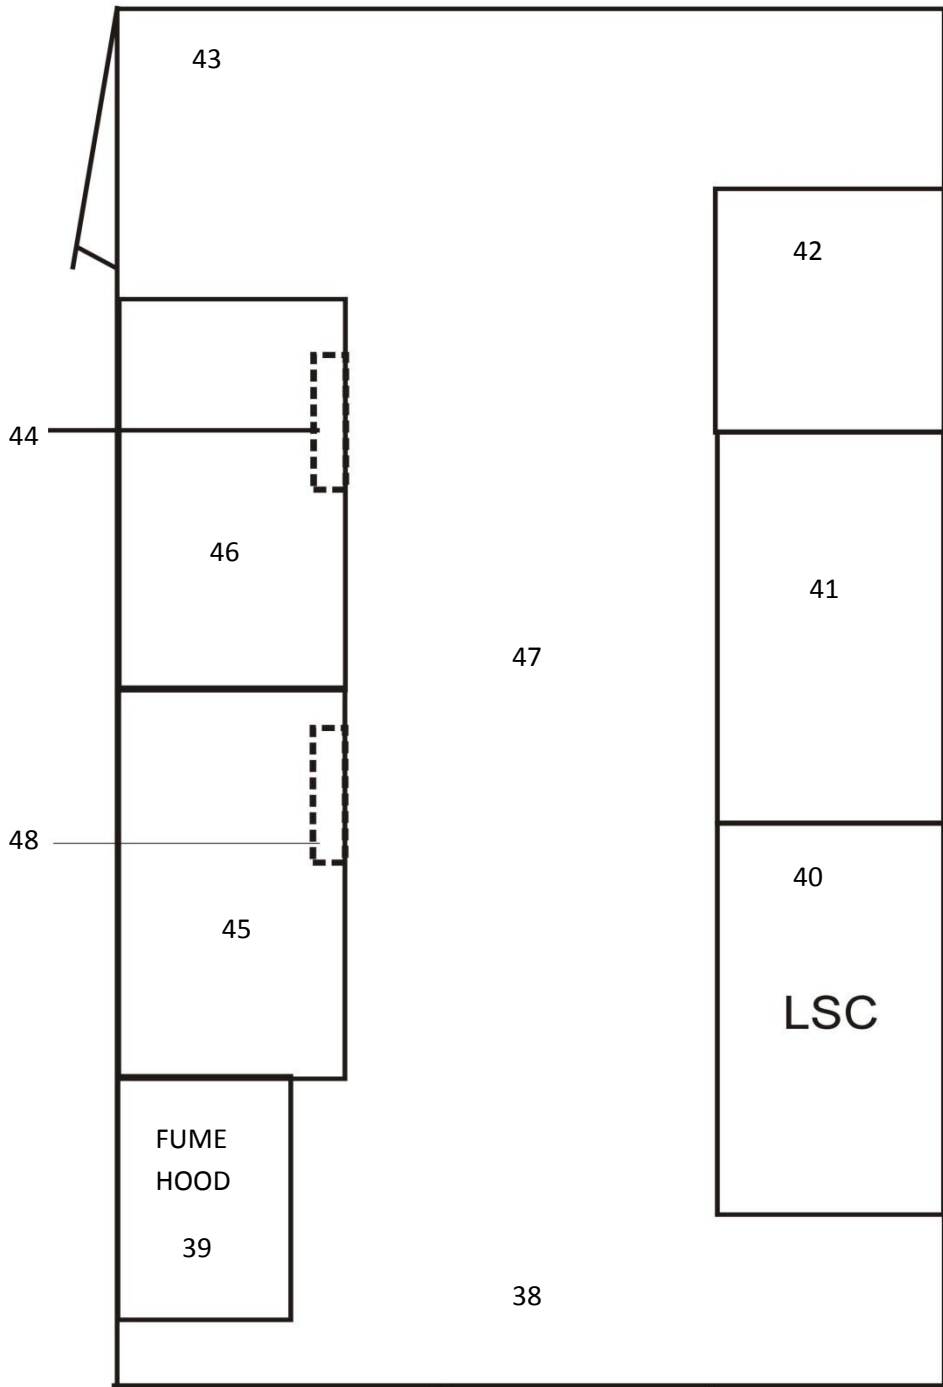
R/V KILO MOANA
RADIOISOTOPE VAN

Sample #	Sample Identification	³ H dpm/m ²		¹⁴ C dpm/m ²	
		activity	error	activity	error
1	1st Vial Bkgnd	0	± 0	0	± 0
2	Initial bucket blank	1	± 8	10	± 34
	<u>Lab #2 (Figure 1)</u>				
3	Deck inside entrance	4	± 0	0	± 0
4	Aft sink area	0	± 0	20	± 36
5	Deck below hydro monitor	0	± 0	44	± 36
6	Foreward sink area	0	± 0	26	± 35
7	Aft sink area	0	± 0	11	± 37
8	Port bench top	0	± 0	16	± 39
9	Deck in front of fwd. sink	21	± 63	0	± 0
10	Deck in front of aft sink	1	± 3	20	± 35
	<u>Scientific Storage (Figure 1)</u>				
11	Inside OCE group Kenmore freezer	30	± 39	14	± 31
12	Inside GE chest Karl freezer	14	± 60	0	± 0
13	Inside Cospolich #1 830.0.014	24	± 35	21	± 33
14	Inside Cospolich #2 830.00.012	0	± 0	32	± 36
15	Inside Cospolich #3 830.00.015	12	± 31	12	± 33
16	Inside Thermo Science	16	± 48	0	± 0
17	Top of Kenmore Karl chest freezer	0	± 0	12	± 37
	<u>Chemistry Lab (Figure 1)</u>				
18	Foreward sink area	0	± 0	26	± 36

19	Aft sink area	4	± 26	7	± 33
20	Deck inside entrance	23	± 36	17	± 32
21	Deck center of lab	32	± 45	4	± 24
22	Inside small fridge	0	± 0	16	± 35
23	Inside fume hood	0	± 0	14	± 39
	<u>Lab #1 (Figure 1)</u>				
24	Deck inside foreward entrance	5	± 34	4	± 32
25	Inside aft entrance	0	± 0	0	± 0
	<u>Hydro Lab (Figure 1)</u>				
26	Deck starboard of center benchtop	13	± 34	11	± 32
27	Deck at entrance	0	± 0	0	± 0

Sample #	Sample Identification	^3H dpm/m ²		^{14}C dpm/m ²	
		activity	error	activity	error
28	Sink area	0	± 0	0	± 0
29	Center benchtop	0	± 0	18	± 36
<u>Wet Lab (Figure 1)</u>					
30	Inside Labconco hood	0	± 0	2	± 35
31	Sink area	0	± 0	6	± 36
32	Deck center of lab	0	± 0	11	± 38
33	Foreward benchtop	0	± 0	6	± 40
<u>Miscellaneous Areas (Figure 1)</u>					
34	Deck under eyewash station	0	± 0	0	± 0
35	Deck inside clean power room	14	± 34	11	± 32
36	Final bucket blank C.O. #1	6	± 0	0	± 0
<u>UH Radioisotope Van (Figure 2)</u>					
37	Initial bucket blank C.O. #2	6	± 29	7	± 33
38	Deck at entrance next to hood	*1226	± 103	*72	± 21
39	Deck inside fume hood	*986	± 94	49	± 18
40	Top of LSC	*966	± 93	*59	± 20
41	Benchtop left of LSC	472	± 71	*66	± 27
42	Benchtop across side entrance	494	± 72	*63	± 26
43	Deck inside side entrance	*3556	± 169	*376	± 35
44	Inside freezer next to side entrance	*509	± 59	*475	± 48
45	Benchtop next to hood	*3934	± 171	*147	± 19

46	Benchtop next to side entrance	*1519	± 98	*1221	± 65
47	Deck center of van	*7487	± 246	*990	± 51
48	Inside freezer closest to hood	*15118	± 327	*2183	± 72
49	Final bucket blank C.O. #2	0	± 0	13	± 36

Please note that the error reported for each isotope is the two-standard deviation counting error. All areas tested on the ship were free from radioisotope contamination that requires cleaning. The radioisotope van had minor ^3H and ^{14}C contamination. No action is required but it is recommended that the van deck be cleaned to help prevent tracking radioisotopes into the ship.
