SWAB REPORT # 954

SWAB DATE: 27 May 2019

R/V Laurence M. Gould and USAP Rad Van #4

LOCATION: Punta Arenas, Chile
VESSEL: *R/V Laurence M Gould*

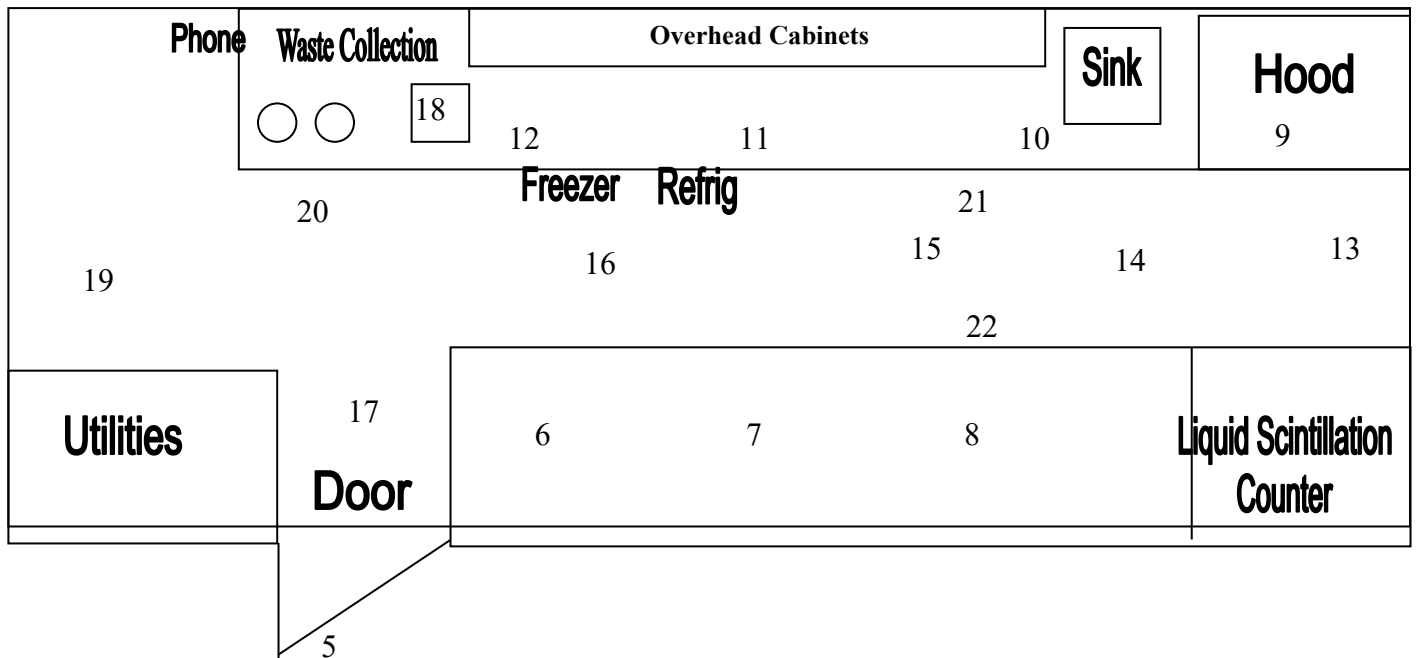
USAP Van # 4
Figure 1
SWAB #954
27 May 2019

Please note that the error reported for each isotope is the two-standard deviation counting error. The reports may now contain values less than zero. When decay counting background samples will be distributed about the background vial, which means that negative values are possible. In the past we rounded the negative values to zero. Values are only significantly above background when they are positive and larger than the error. It appears that the bucket was contaminated with a minor amount of ¹⁴C. The three samples taken from deck areas on the ship had minor ¹⁴C contamination. This could be due to the bucket contamination, but the areas should be cleaned regardless. Minor ³H and ¹⁴C contamination was found in Rad Van #4. No action is necessary in the van.
