SWAB REPORT # 878

SWAB DATE: 26 October 2017

R/V Atlantic Explorer

LOCATION: St. George, Bermuda
VESSEL: R/V *Atlantic Explorer*

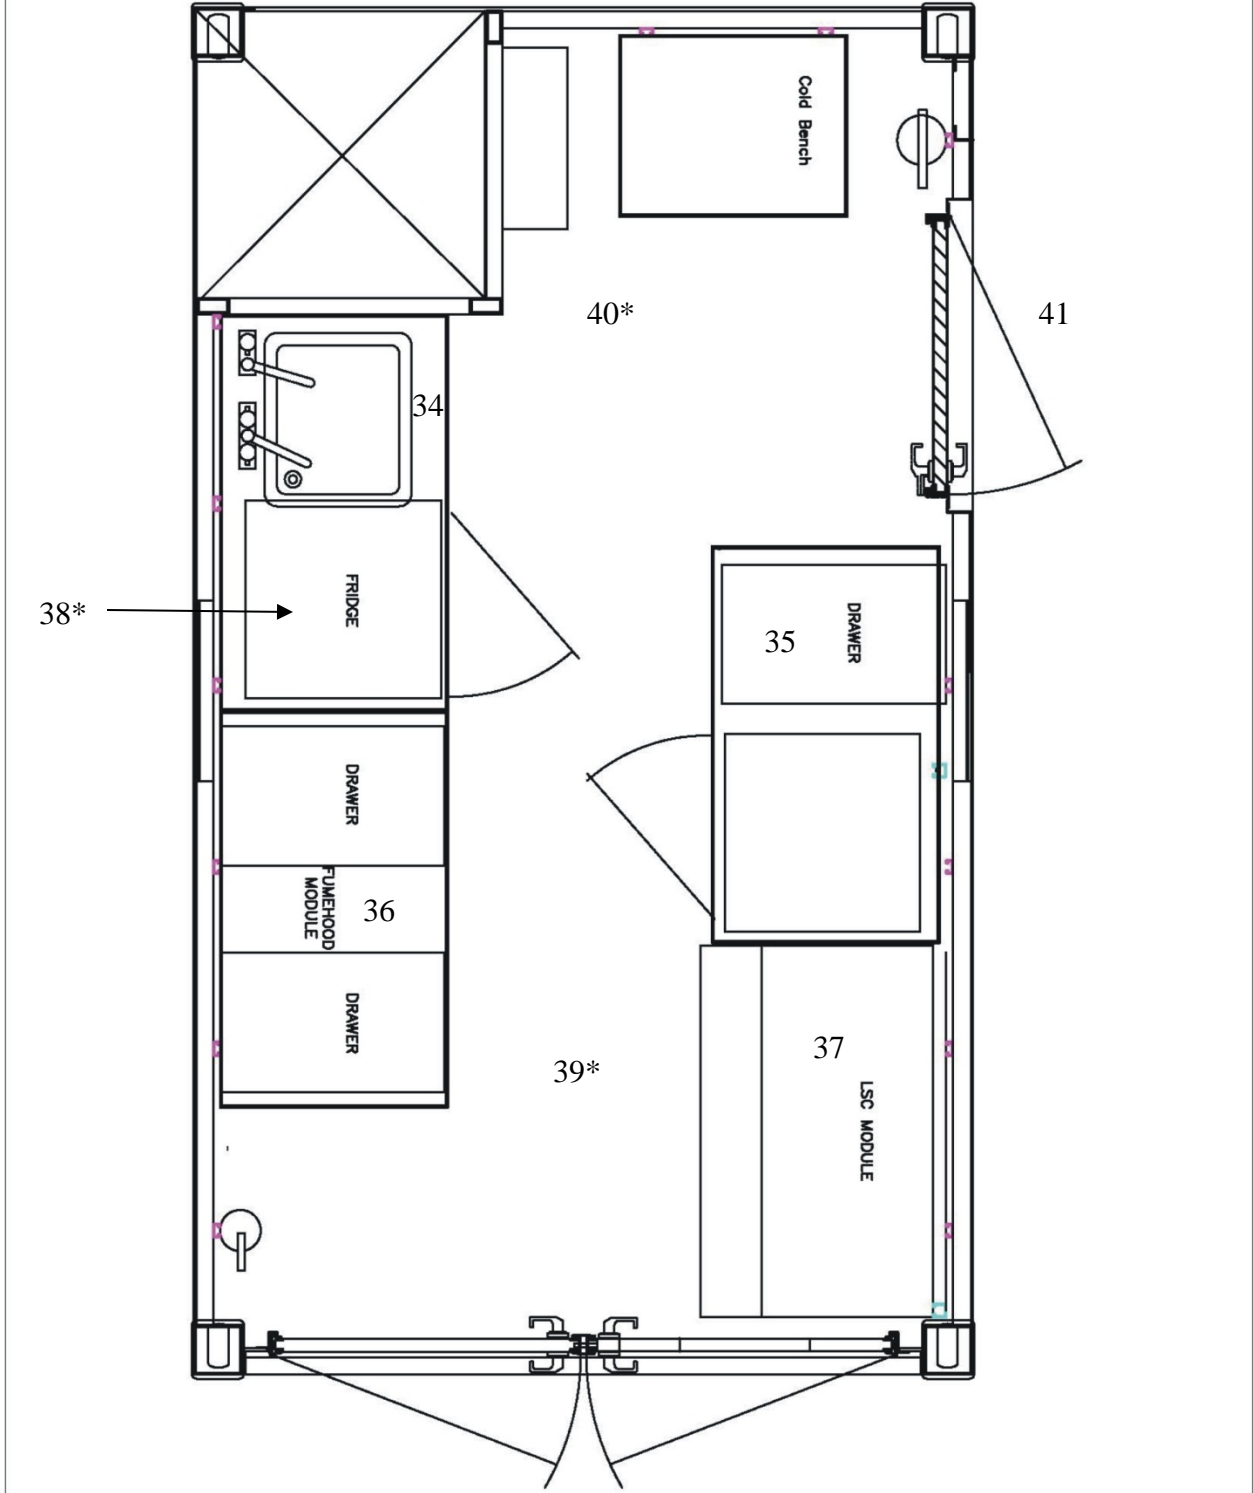
Figure 2

38	Inside Danby refrigerator under sink	*1595	± 122	*55	± 17
39	Deck between LSC and hood	*2236	± 139	*84	± 18
40	Deck at entrance	*1615	± 123	*57	± 17
41	Deck outside van entrance on 01 Deck	43	39	36	36
42	Final bucket blank	-22	31	37	40

Please note that the error reported for each isotope is the two-standard deviation counting error. The reports may now contain values less than zero. When decay counting background samples will be distributed about the background vial, which means that negative values are possible. In the past we rounded the negative values to zero. Values are only significantly above background when they are positive and larger than the error. All areas tested on the ship were free from any isotope contamination that requires cleaning. Minor ^3H and ^{14}C contamination found in the Rad Van. No action is necessary in the Rad Van
