SWAB REPORT #846

SWAB DATE: 29 January 2017

R/V Kilo Moana

REPORT FOR SWAB # 846

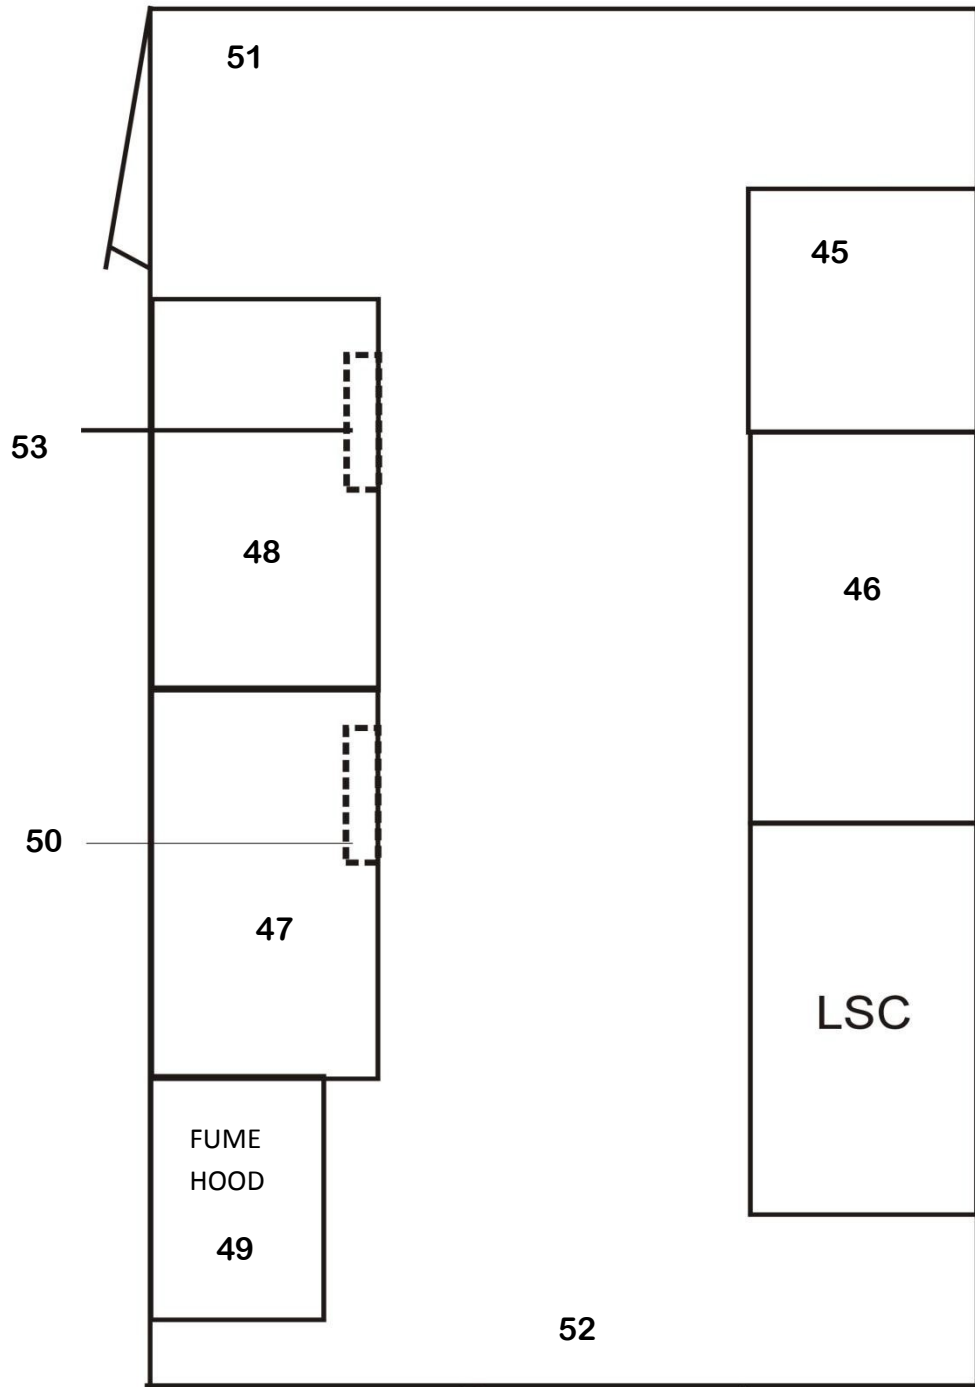
R/V KILO MOANA
RADIOISOTOPE VAN

Please note that the error reported for each isotope is the two-standard deviation counting error. The reports may now contain values less than zero. When decay counting background samples will be distributed about the background vial, which means that negative values are possible. In the past we rounded the negative values to zero. Values are only significantly above background when they are positive and larger than the error. The fume hood in the Chemistry Lab had minor ^3H and ^{14}C contamination. This hood should be cleaned before any further use. Minor ^{14}C contamination was found in the refrigerator across from the LSC in the Rad Van. No action is necessary in the Rad Van.
