SWAB REPORT # 753

SWAB DATE: 5 December 2014

R/V New Horizon

LOCATION: San Diego, CA
VESSEL/LAB: *R/V New Horizon*

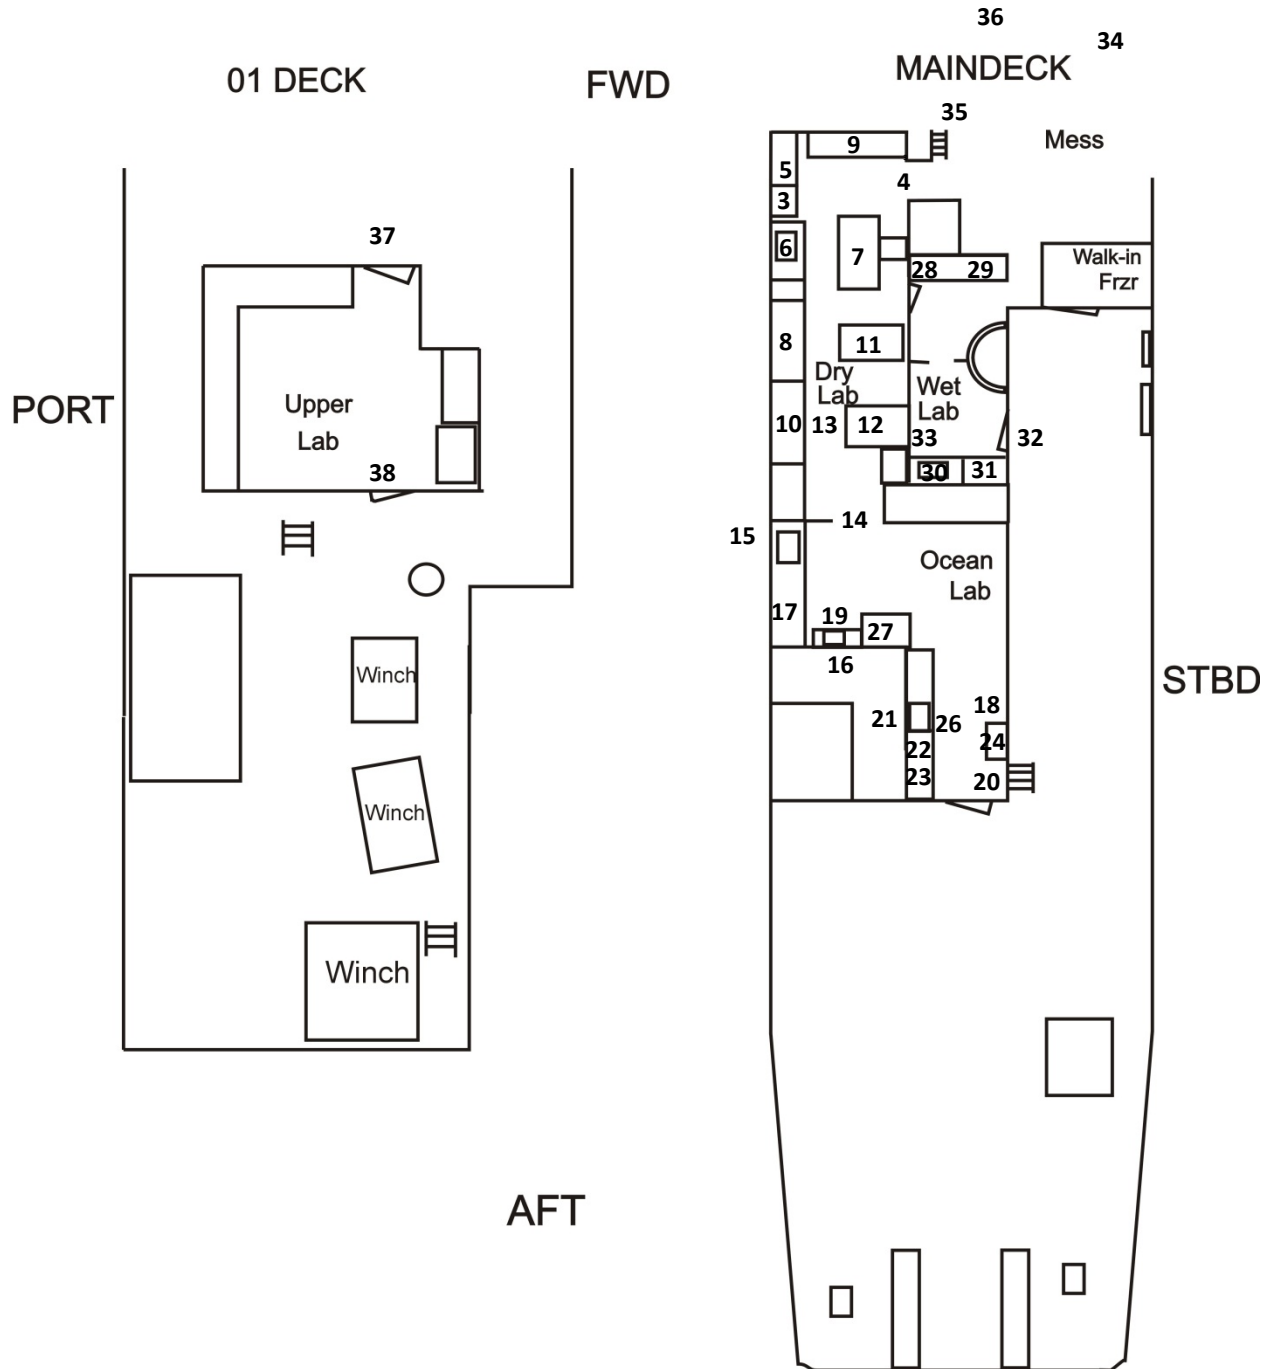
SWAB #753
5 December 2104
Figure 1

Sample #	Sample Identification	³ H dpm/m ²		¹⁴ C dpm/m ²	
		activity	error	activity	error
1	1st Vial Bkgnd	0	± 0	0	± 0
2	Initial bucket blank	23	± 60	0	± 0
	<u>Main Lab (Figure 1)</u>				
3	Inside Norland refrigerator	0	± 0	0	± 0
4	Deck outside forward entrance	0	± 0	0	± 0
5	Deck in front of -80 freezer	0	± 0	11	± 37
6	Port sink area	0	± 0	2	± 39
7	Benches across from port sink	5	± 41	2	± 30
8	Port benchtop aft of sink	0	± 0	0	± 0
9	Top of chest freezer	0	± 0	18	± 38
10	Port benchtop center section	13	± 32	16	± 33
11	Starboard benchtop by Wet Lab entrance	31	± 50	0	± -2
12	Aft starboard benchtop between computer stations	0	± 0	9	± 42
13	Deck in center of lab	0	± 0	20	± 36
14	Deck at aft entrance to Ocean Lab	0	± 0	0	± 0
	<u>Ocean Lab (Figure 1)</u>				
15	Port forward sink area	16	± 84	0	± 0
16	Port aft sink area	38	± 63	0	± 0
17	Benchtop aft of port forward sink	0	± 0	10	± 37
18	Benchtop opposite of aft sink (bare wood	0	± 0	21	± 57

19	Deck in front of aft port sink	19	± 144	0	± 0
20	Deck at stair to lower decks	0	± 0	15	± 37
21	Aft sink next to fume hood	0	± 0	8	± 38
22	Inside fume hood	14	± 28	25	± 34
23	Benchtop adjacent to fume hood	0	± 0	1	± 0
24	Benchtop opposite of aft sink	16	± 60	0	± 0
25	Benchtop aft and starboard of stair to lower	0	± 0	14	± 39
26	Deck below fume hood and sink	0	± 0	15	± 35
27	Benchtop next to aft port sink	0	± 0	3	± 46

Sample #	Sample Identification	³ H dpm/m ²			¹⁴ C dpm/m ²		
		activity	error		activity	error	
<u>Wet Lab (Figure 1)</u>							
28	Forward port benchtop	0	±	0	0	±	0
29	Forward starboard benchtop	0	±	0	0	±	0
30	Aft sink area	0	±	0	30	±	38
31	Benchtop adjacent to sink	0	±	0	9	±	37
32	Small port benchtop forward of sink	0	±	0	0	±	0
33	Aft deck outside entrance	0	±	0	0	±	0
<u>Mess/Laundry (Figure 1)</u>							
34	Mess deck in front of hot food server	0	±	0	0	±	0
35	Mess deck in front of coffee machine	0	±	0	0	±	0
36	Mess deck in Laundry room below dryer/wa	10	±	46	2	±	25
<u>Upper Lab (Figure 1)</u>							
37	Deck outside forward entrance	0	±	0	1	±	55
38	Deck inside aft entrance	0	±	0	0	±	0
39	Final bucket blank	0	±	0	11	±	39

Please note that the error reported for each isotope is the two-standard deviation counting error. All areas tested were free from radioisotope activity that requires cleaning.
