SWAB REPORT # 1139

SWAB DATE: 21 February 2026

R/V Atlantic Explorer
UNOLS Radioisotope Van #2408-04

REPORT FOR SWAB # 1139

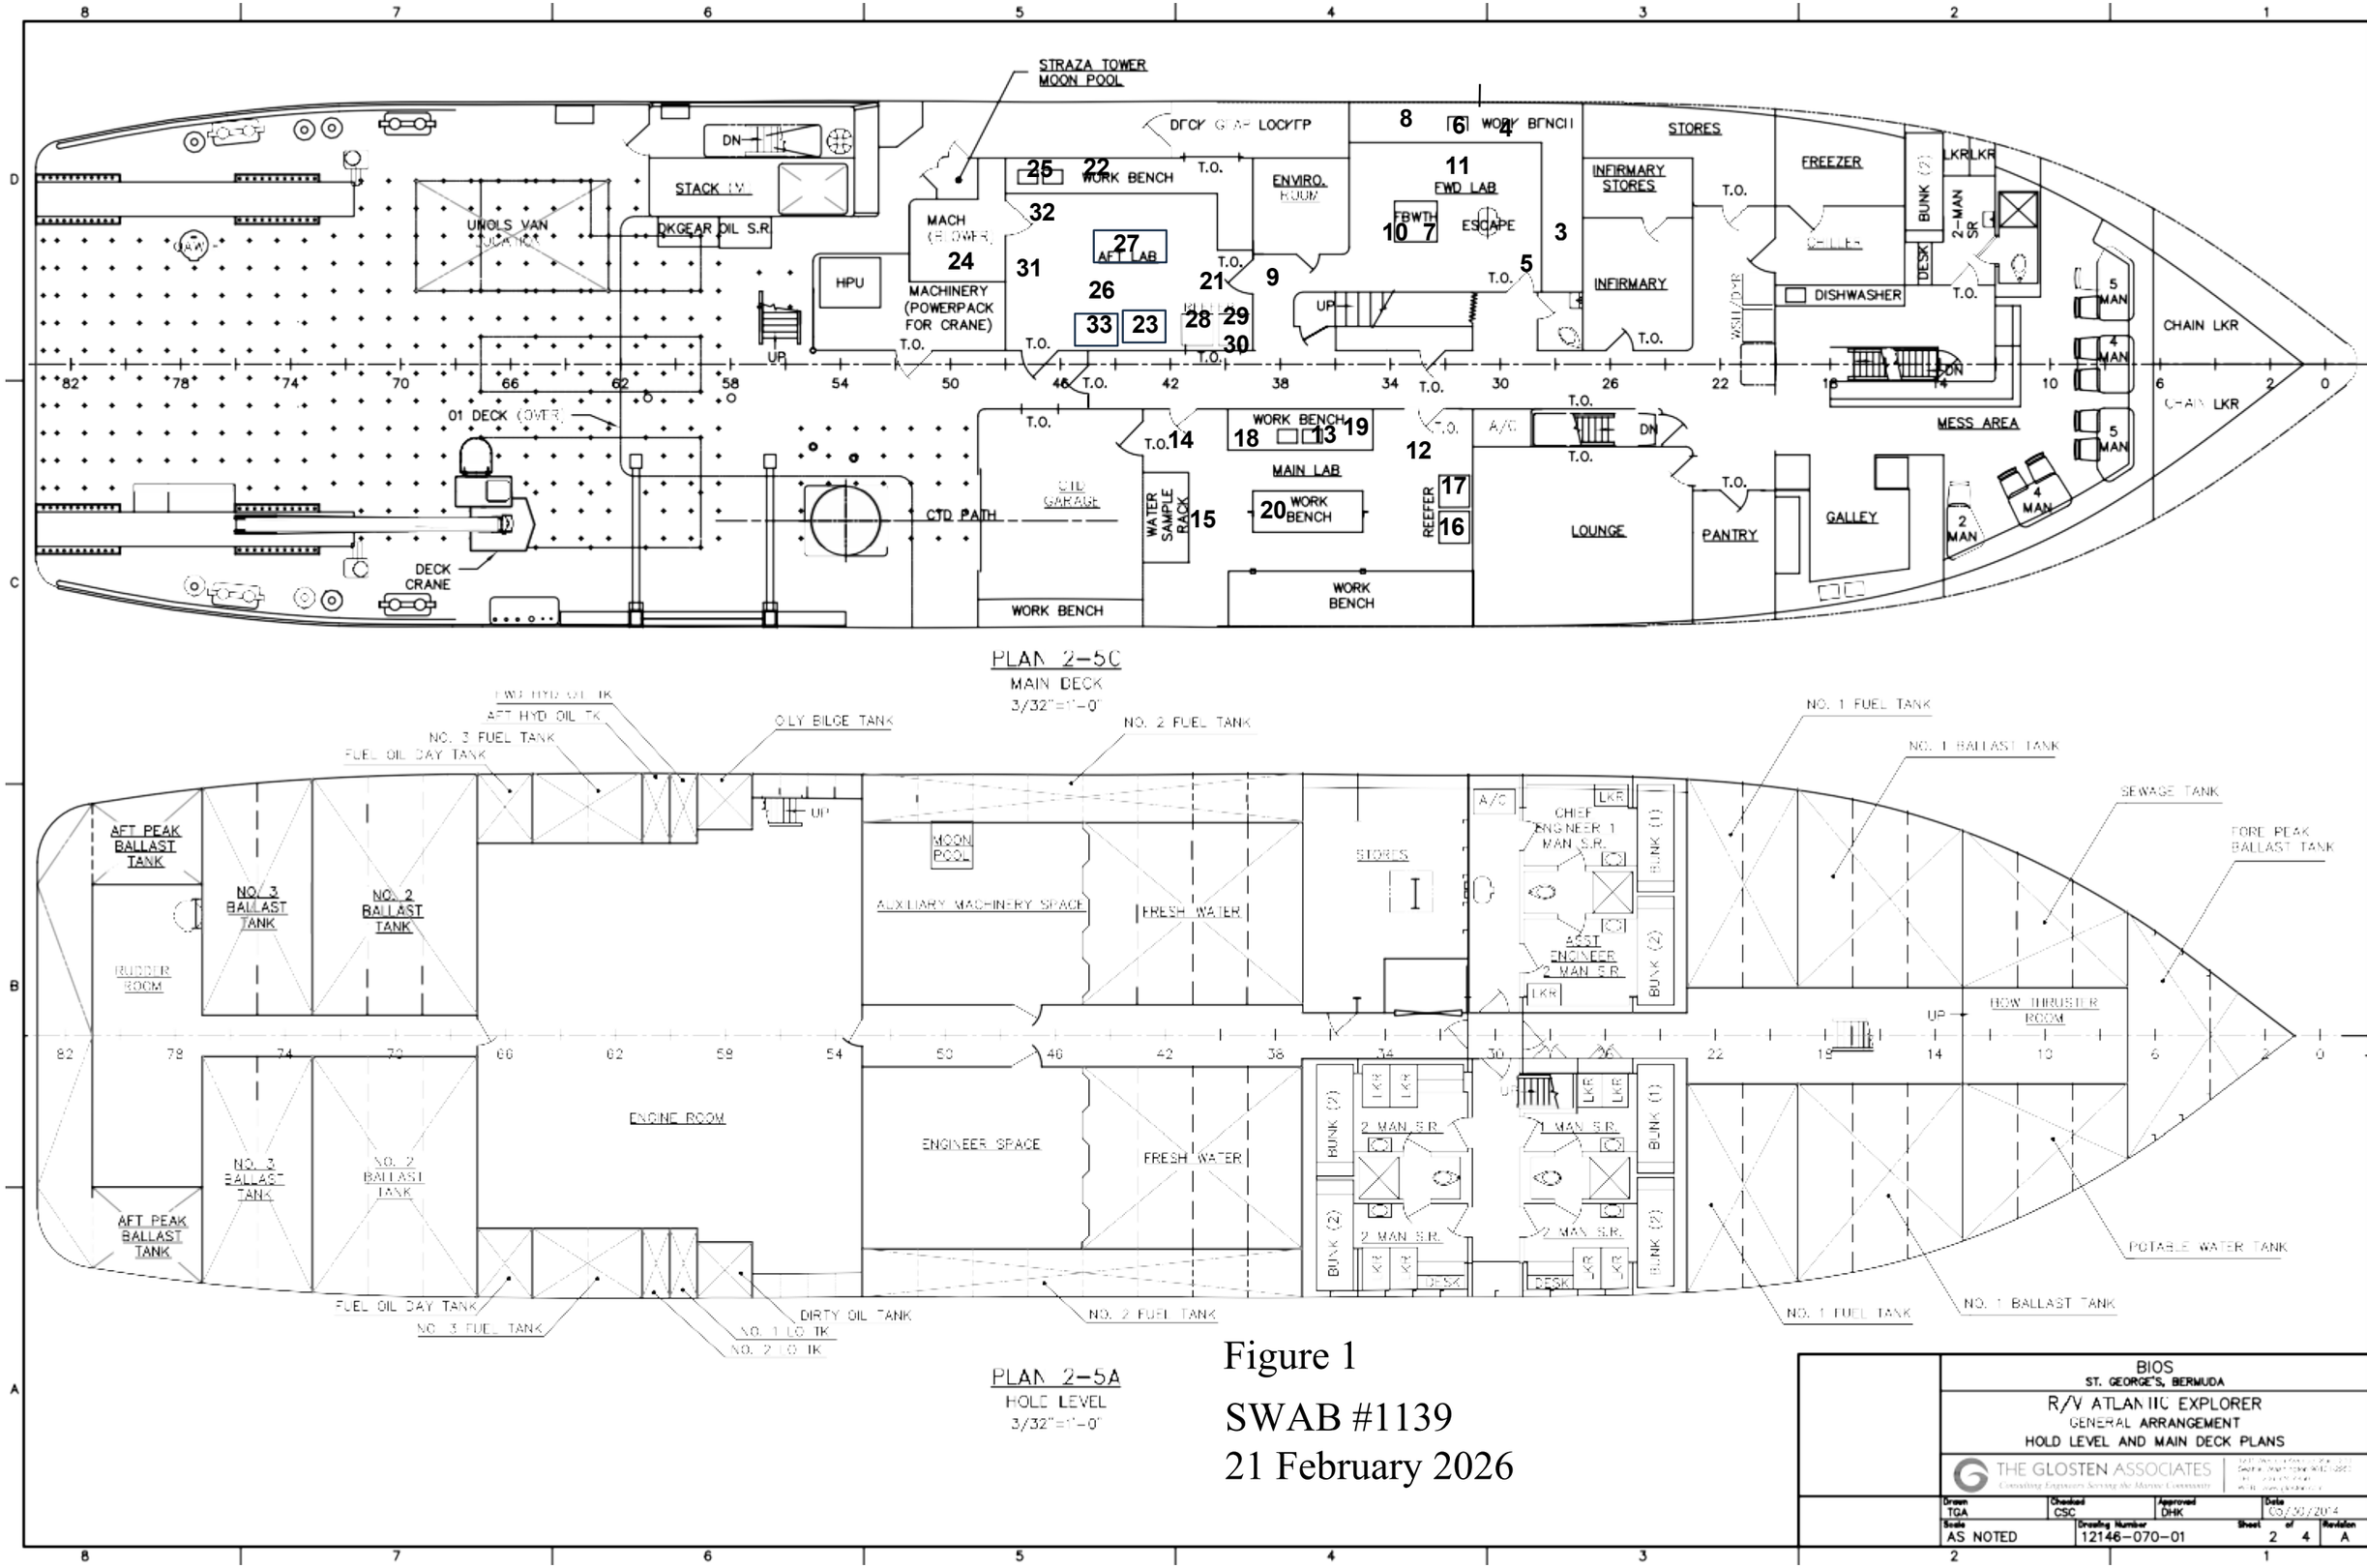
Figure 1

Sample #	Sample Identification	^{3}H dpm/m^{2} activity	±	error	^{14}C dpm/m^{2} activity	±	error
1	1st Vial Bkgnd	0	±	0	0	±	0
2	Initial bucket blank	8	±	32	-22	±	27
	Forward Lab (Figure 1)						
3	Forward benchtop	-28	±	30	-2	±	7
4	Port benchtop forward of sink	-5	±	24	-24	±	30
5	Deck inside stbd entrance	-1	±	3	-18	±	22
6	Port sink area	-54	±	58	-4	±	16
7	Forward section of center benchtop	-2	±	9	-16	±	20
8	Port benchtop aft of sink	-32	±	35	-4	±	17
9	Deck outside Enviro Room	-23	±	24	-8	±	32
10	After section of center benchtop	-2	±	8	-8	±	33
11	Deck in front of sink	-7	±	29	-5	±	20
	Main Lab (Figure 1)						
12	Deck inside forward entrance	-21	±	23	-5	±	19
13	Port sink area	-4	±	17	-16	±	19
14	Deck inside aft entrances	-24	±	26	-6	±	25
15	Deck in front of water sample rack	-18	±	40	-5	±	18
16	Inside live freezer	-37	±	40	-14	±	18
17	Inside live refrgerator	13	±	29	-7	±	29
18	Port benchtop aft of sink	-9	±	40	1	±	87

19	Port benchtop forward of sink	-33	±	36	-13	±	16
20	Center benchtop	-5	±	19	-18	±	22
	Aft Lab (Figure 1)						
21	Deck inside forward entrance	-7	±	29	-9	±	36
22	Port benctop forward of sink	-46	±	50	-8	±	31
23	Inside -80oC freezer #1	6	±	25	-34	±	42
24	Inside fume hood	-22	±	48	-13	±	16
25	Port sink area	11	±	46	-10	±	13
26	Inside -80oC freezer #2	-19	±	42	5	±	18
27	Center benchtop	-41	±	44	-1	±	5
28	Inside dead freezer	-6	±	28	-23	±	28
29	Inside live refrigerator	-19	±	21	-17	±	22
30	Inside live freezer	-31	±	34	-17	±	21

Please note that the error reported for each isotope is the two-standard deviation counting error. Reports may now contain values less than zero. Decay counting background samples will be distributed about the background vial, which means that negative values are possible. In the past we rounded the negative values to zero. Values are only significantly above background when they are positive and larger than the error. Please note that we are now using a Quantulus 6220 LSC which counts very near natural background. While the cleanup standards have not changed all values above background will now be in bold. All areas sampled inside the ship and in the Rad Van were free from isotope contamination requiring cleaning.
