*R/V THOMAS G. THOMPSON (AGOR-23)*

LINGERING ISSUES FROM MID-LIFE

UNOLS – FIC - 20 NOV 2019

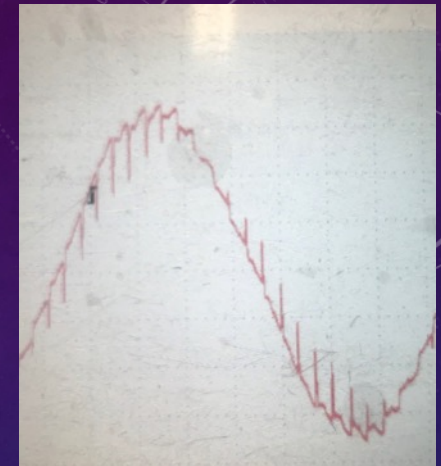
# POWER QUALITY = VOLTAGE NOTCHING

- First cruise, JASON onboard – electrical problems with JASON systems
- Onload deck generator to provide dedicated power to JASON
- Ockerman rep onboard for assessing power quality

- had to use a portable generator on deck again for Sikes cruise
- Dynacon winch couldn't work with lineator L-13 (200A) - too much voltage drop

- Feb – Mar 2019 – SENTRY onboard – electrical problems reported in PCAR
- March-April 2019 - Third party assessment of power quality issue

- Recommend installation of 15 tuned line filters (“lineators”)

Aug 2018 – installed 5 line filters during Kaohsiung port call Nov 2018

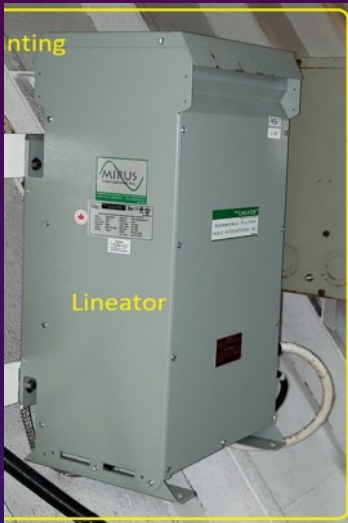
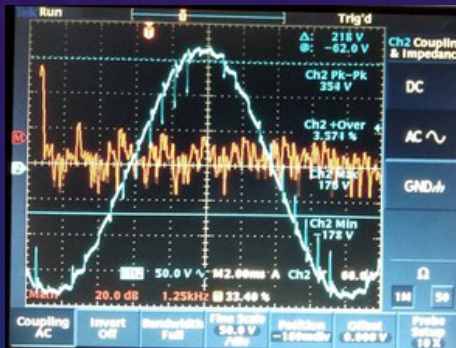
# POWER QUALITY = VOLTAGE NOTCHING

- Sentry PCAR and report document issues during TN-365
- June 2019 – installed 5 additional line filters (10 total)
- Several successful projects without power issued noted:

- Nov (TN-373; Sager) – Current cruise, seismic and magnetometer
- One project with power issues:
  - Sep-Oct (TN-372; Slowey) – Seismic and Coring – several undervoltage releases of non-essential loads at beginning of trip – traced to bad relay. Replaced with more robust relay.

- Troubleshooting of this issue did cause one loss of power event
  - **Continues reputation of 'bad power'; appears not directly related**

- **Additional power quality data needed. Power meter on order to send to ship. Ongoing monitoring and documentation of science loads**
- **Work with oncoming science projects to identify sensitive electronics that may be affected and find ways to provide power from clean power (MG) switchboard**
- Project Engineer – with contractor assistance - to continue to research other potential filters to further reduce the voltage notching issue
