R/V Thompson Update

22 Oct 2012

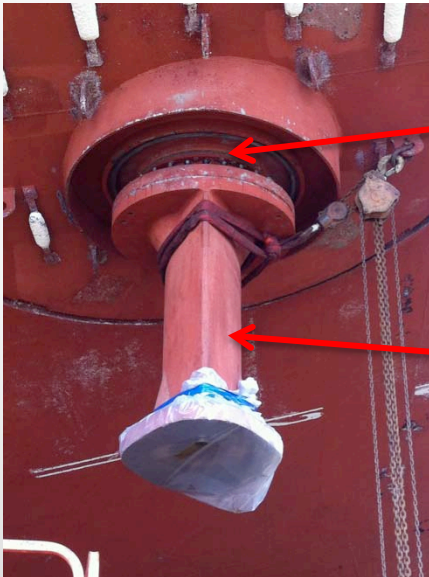
- Replace all internal components – gears, bearings, shims, spacers, seals, bolts, etc.
- Replace bent Steering Pipe
- Replace bent Shank
 - Have to manufacture the last two items in a foundry
