# Pelagic Research Services

## Shallow Profiler Recovery on the OOI Cabled Array

## RSN Endurance Vertical Mooring

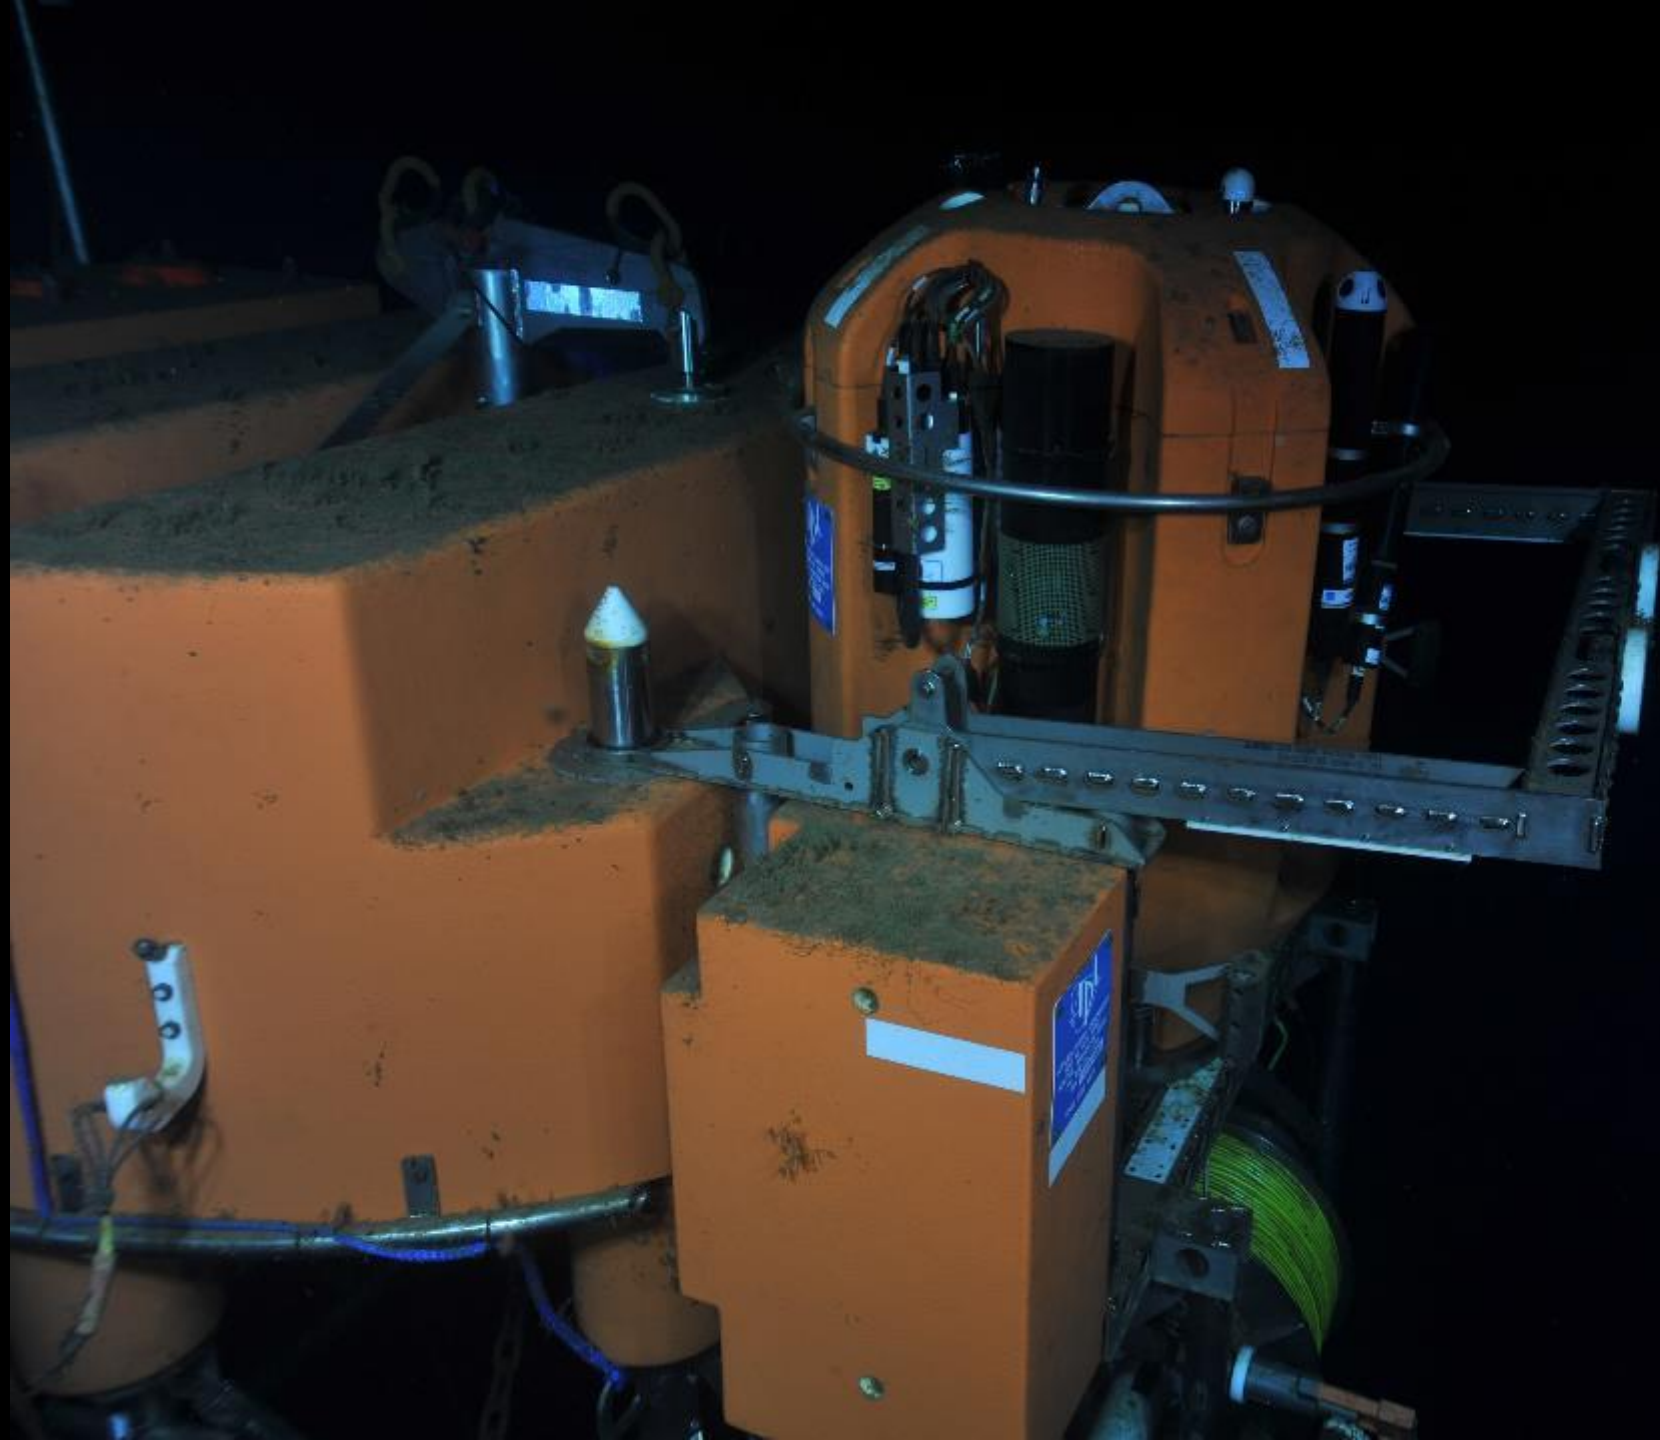
- Mooring array contacted by fishing gear
- Telemetry lost
- Recovery of SciP float 2km from original mooring location
- Multibeam survey confirm the presence of mooring 2km away and a depth

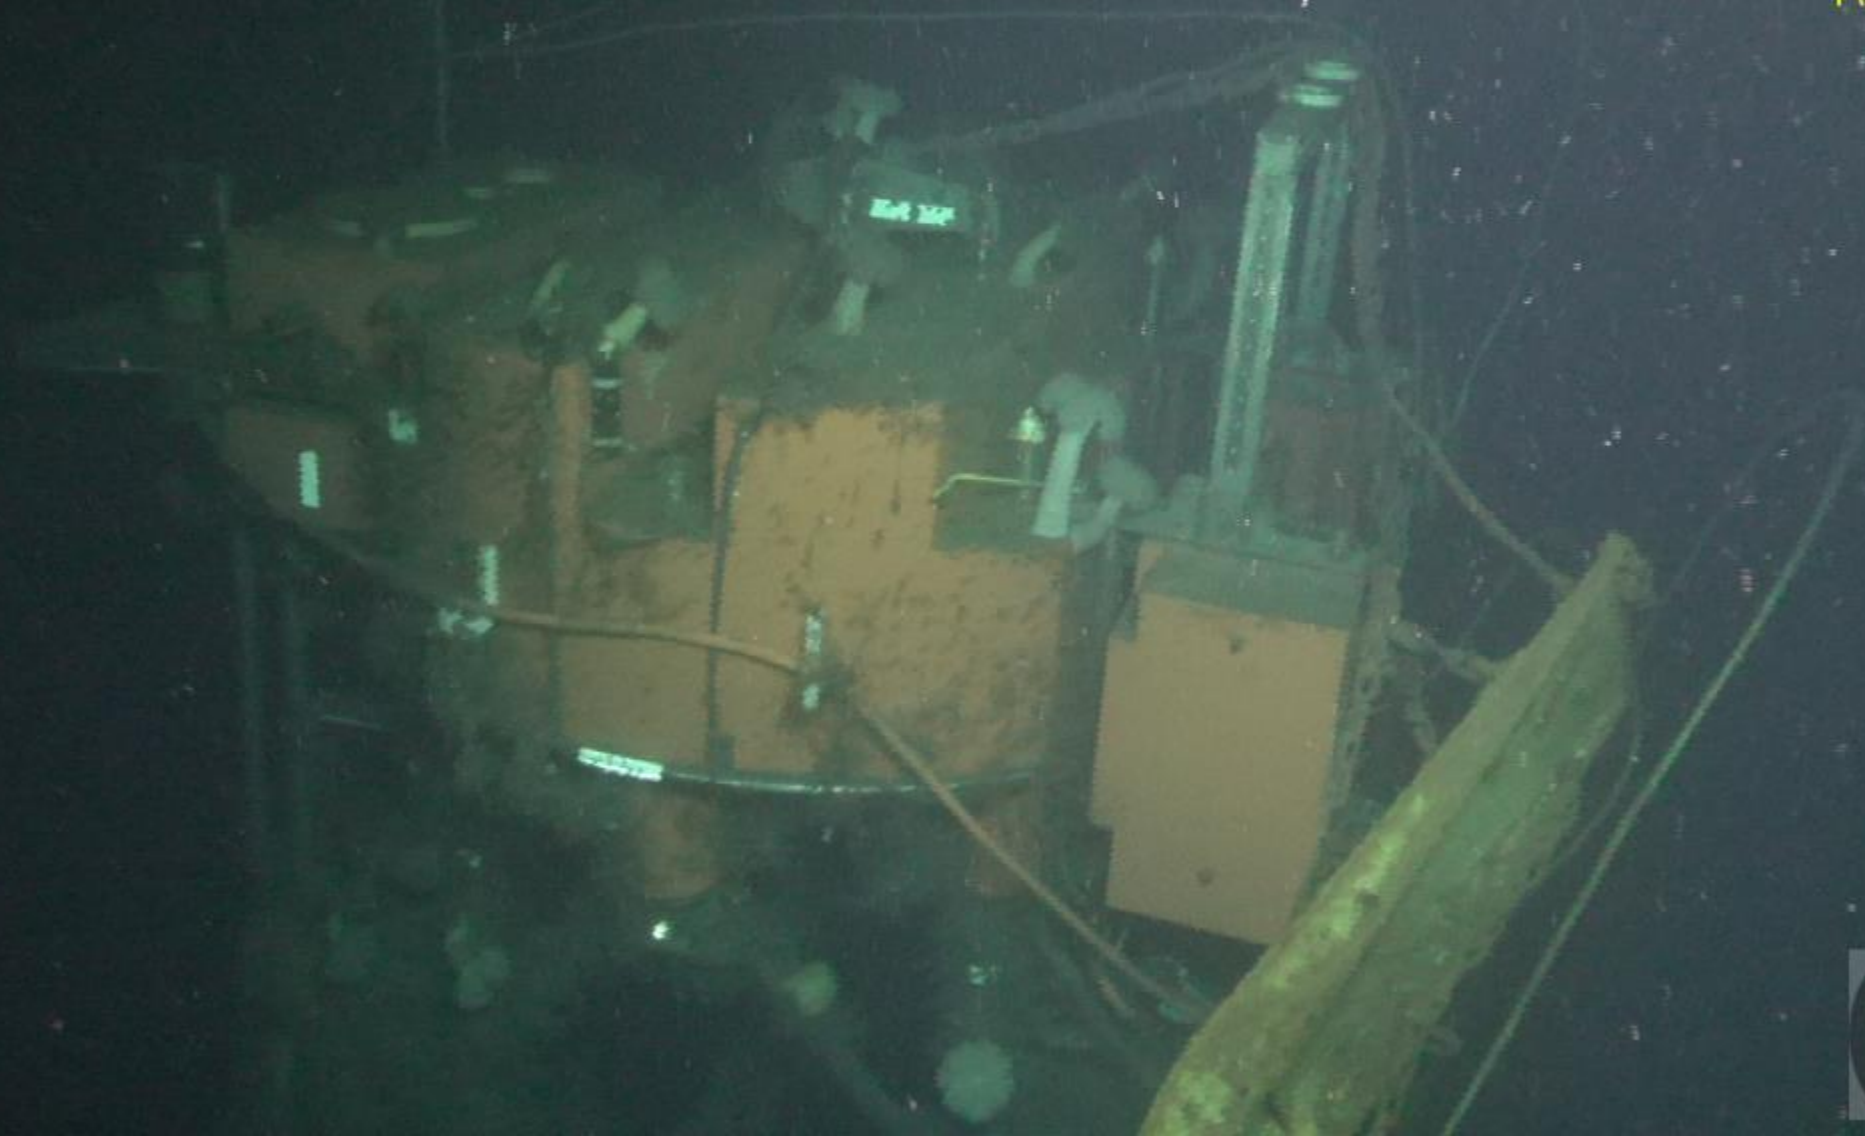
Worse case scenario regarding mooring entangled with trawl
