RV Investigator Marine National Facility Rod Palmer B.Comp | Senior Technical Officer

RV Investigator - Background

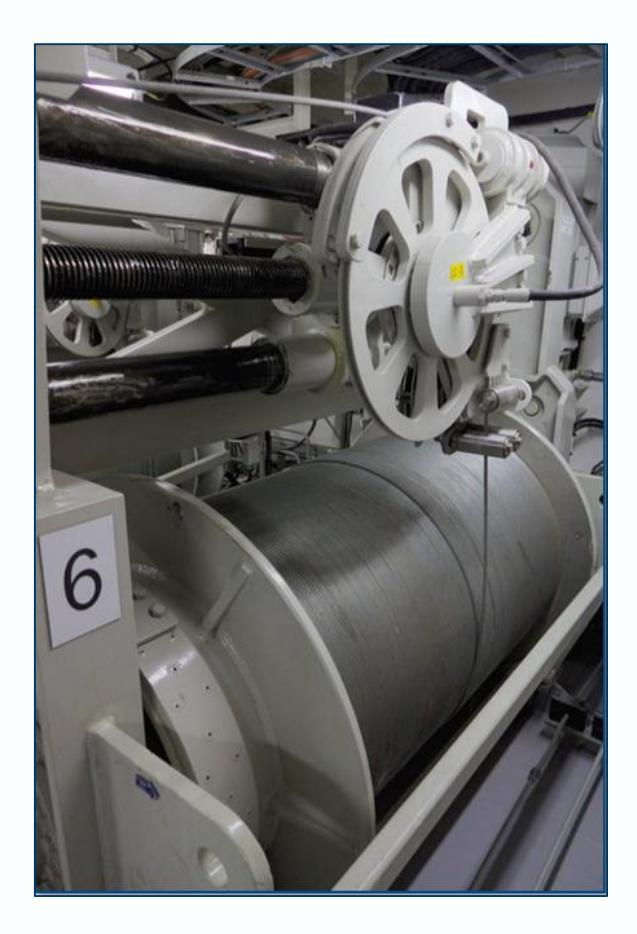
- Two 58KW electric drum motor drive winches controlled by Rapp-Hydema software
- Cable capacity, 7400m of 8.03mm Rochester cable in 25 layers, SWL 1.5t
- Electric driven and synchronised spooling
- Load cell and encoders are mounted in spooling sheave for alternative measurements
- Precise control Auto payout/in to set points of between 1-100m/min, and centimetre-level control using joystick
- Both winches provide Active Heave Compensation

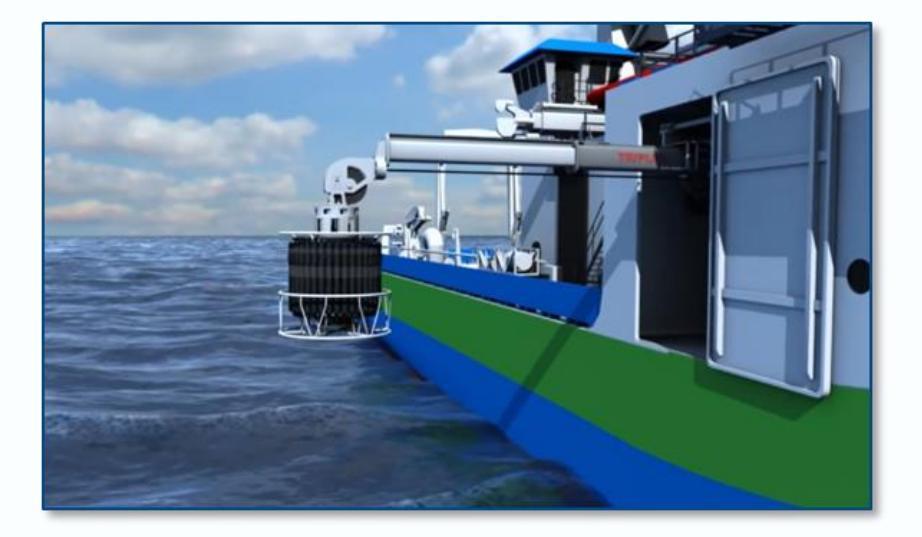
CTD Door – Horizontal Opening

- During Sea trials in 2014:
 - CTD door kept striking the side of the ship
 - Hydraulic rams Undersized
- Challenge:
 - Change the orientation of the CTD door
- Result:
 - Class approval sort
 - Ship's hydraulics and electrics re-routed
 - Ship's drawings updated
 - Vertically opening of CTD door

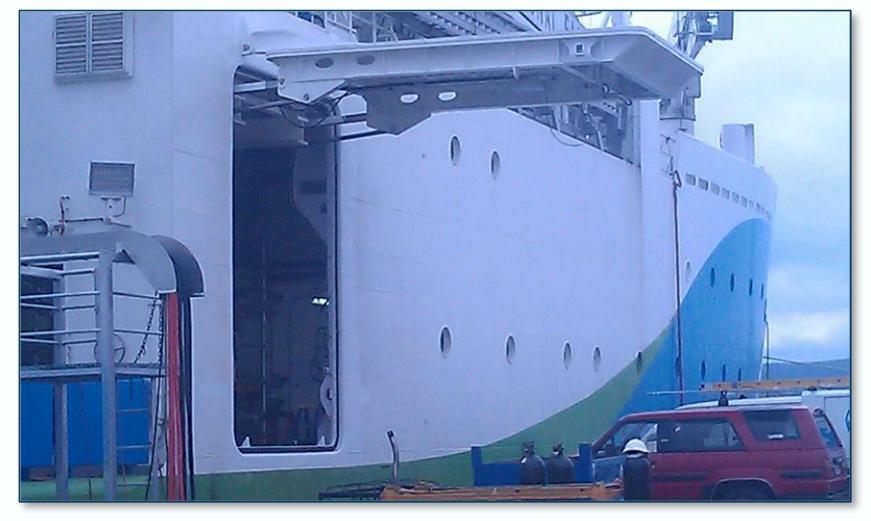
CTD Door – Vertically Opening

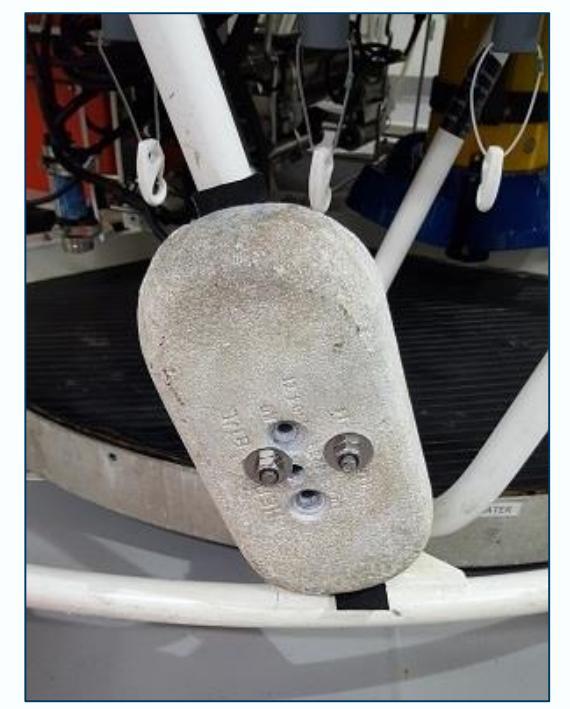
- During deployment of the CTD, we found the descend rate was not correct, we couldn't deploy at 60 m/min as the frame and bottles were to light in the water
- Challenge:
 - Add weights to the 24 & 36 bottle carousels
 - Without affecting the depth rating or 1.5t SWL
- Result:
 - CTD weight in water was calculated
 - Weight of the cable was calculated
 - Weights added to achieve 60m/min

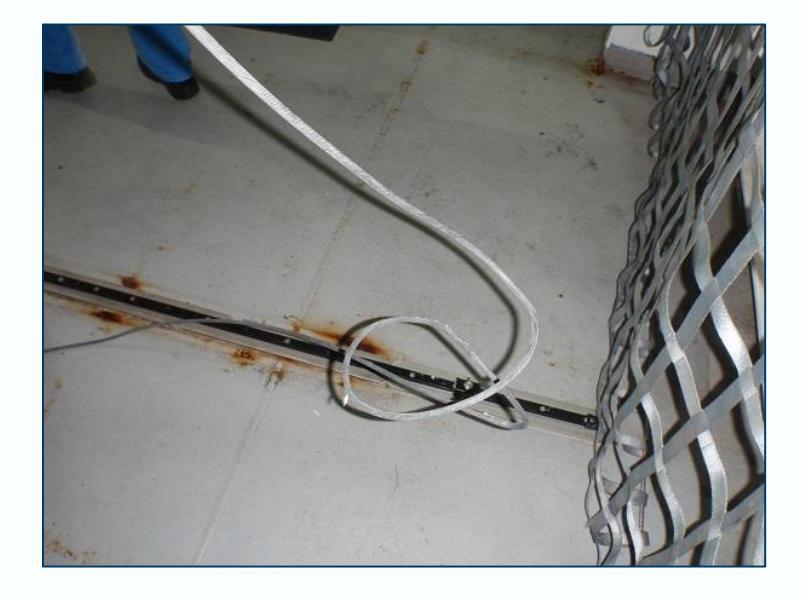
- During a 2016 voyage Active Heave Compensation was not available
 - Winch software required an upgrade
- During deep casts, on retrieval, we found the cable was kinking
 - Affecting the electrical integrity of the cable
 - Causing the deck box to alarm
 - We suspected Carousel rotating
- Challenge:
 - Re-terminate the CTD cable within 3 hours of next station for 30 days
- Result:
 - CTD cable was re-terminated
 - Software upgraded for leg 2
 - Rotation issue put on hold until leg 2

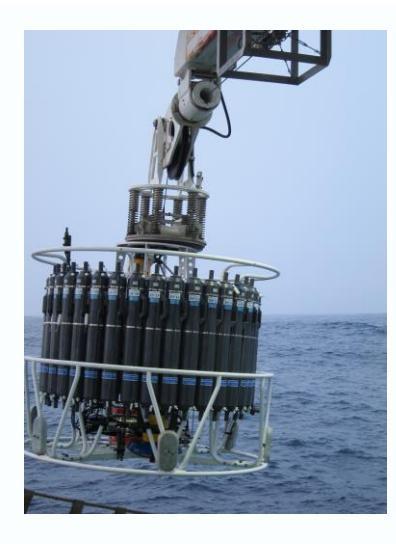
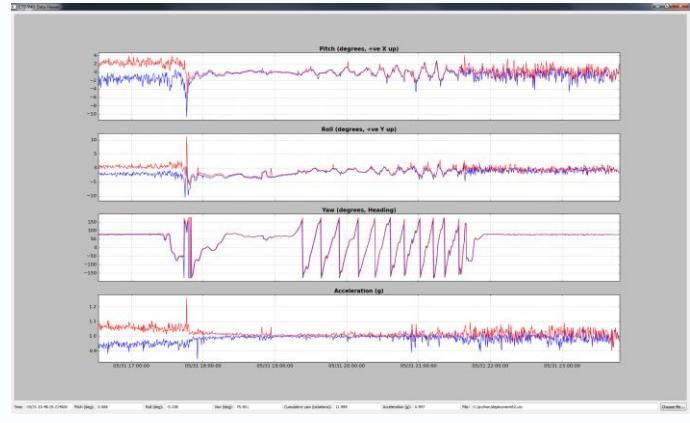
No fin - Showing rotations

- Suspect the 36-bottle carousel was rotating
 - May be contributing to the wire kinking
- Challenge:
 - Investigate rotation issue
 - Develop an Inertial Motion Unit (IMU)
 - Utilised the serial data uplink of the SBE9+
 - Other institutions experienced a similar issue Fin recommended
- Result:
 - Live data showing CTD rotations
 - Installation of a fin, stopped the CTD rotating

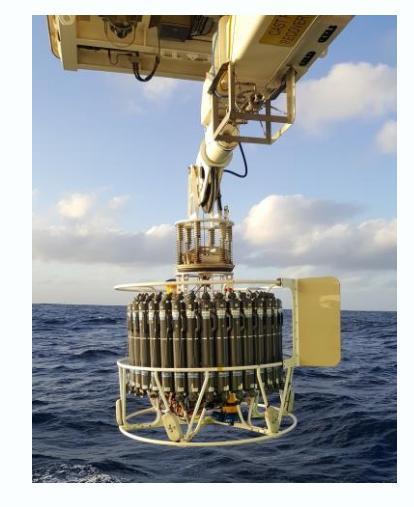
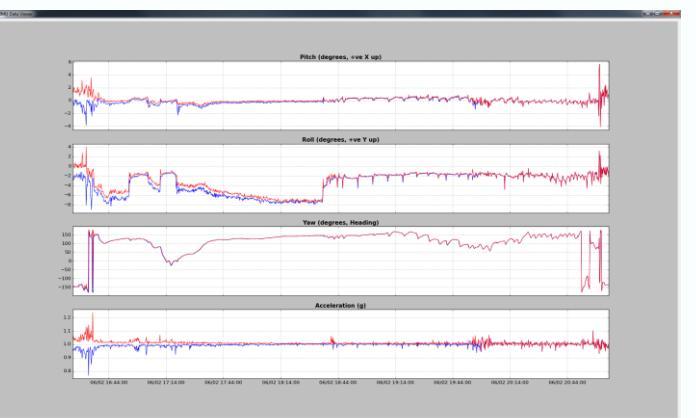
Fin - No rotations

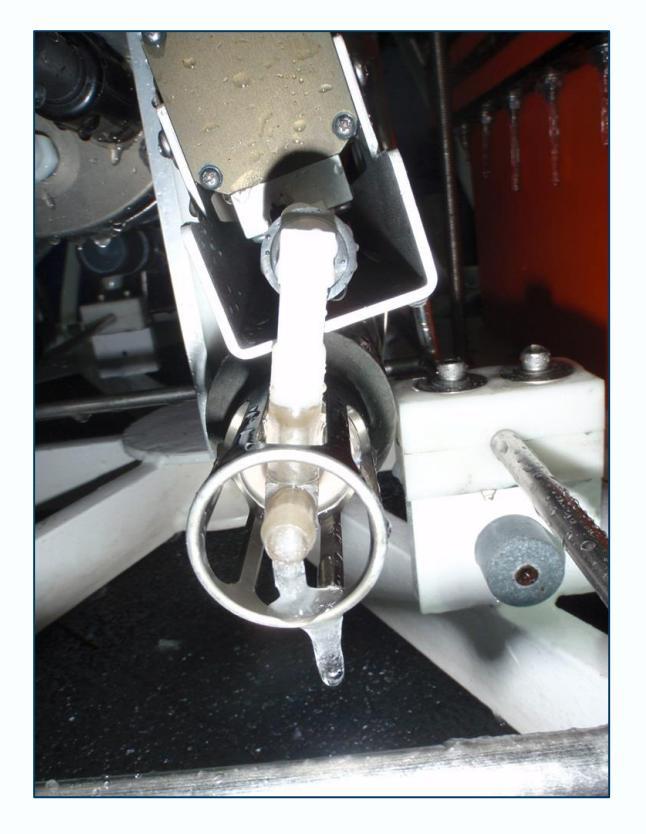
- Prior to deployment, advice was sort from Seabird
 - keep sensors above -2°C
 - blow dry air through instruments
 - Deploy and retrieve the carousel quickly
- Challenge:
 - Stop the seawater freezing
- Result:
 - Unable to keep instruments above -2°C
 - Blew dry air through instruments
 - Water froze in instruments and tubing
 - Warm water used

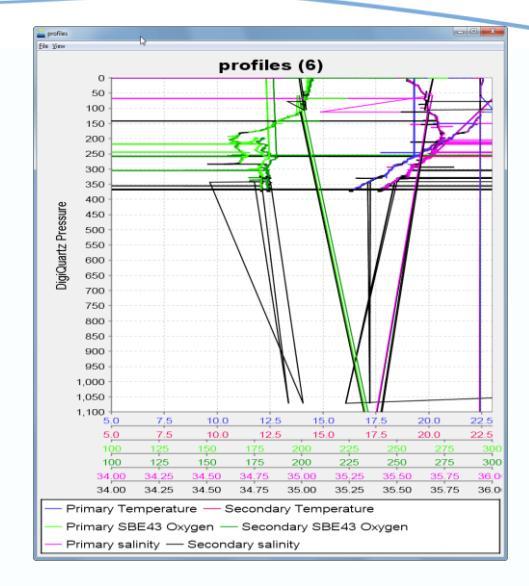
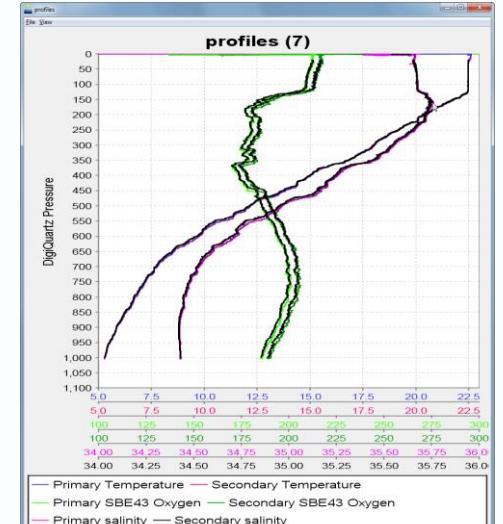
- During the Nov 2016 dry dock
 - CTD winches removed Axle alignment
 - Two 65 Amp heaters installed
 - On initial 2017 voyages, spiking on CTD graphs
- Challenge:
 - Investigate spiking issue
- Results:
 - Winch and slip rings checked
 - Induced interference on SBE11 control cable
 - New electromagnetic shielded conduit installed
 - Earthed "CTD wire" sheath Removed spikes
 - SBE11 deck box modified Removed earth loop

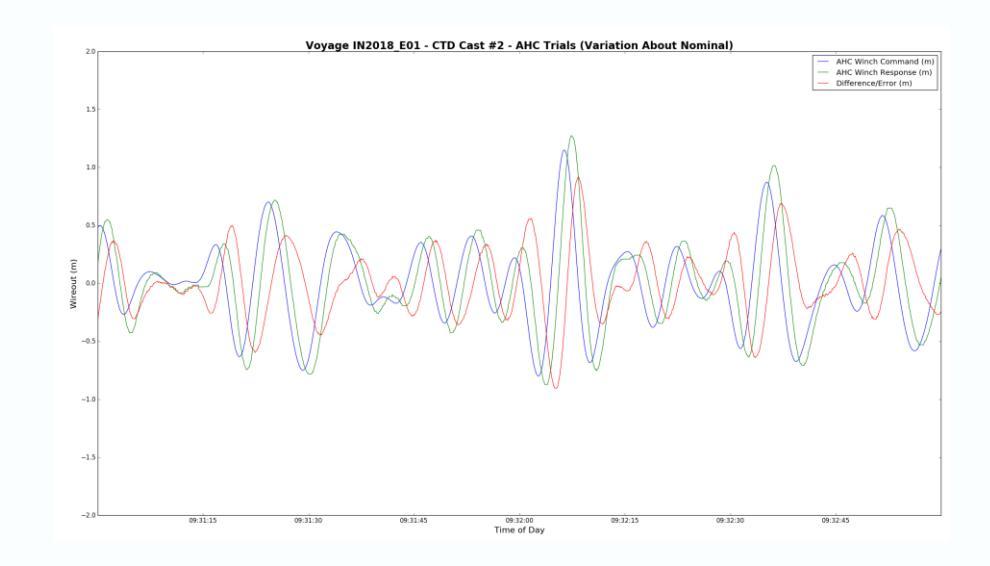
- Result:
 - CSIRO implemented a software solution Kalman Filter
 - Utilises the Seapath's Navigational MRU5+
 - Calculates linear vertical height, velocity and acceleration of the boom head
- Performance:
 - Winch follows the command signal faithfully
 - Lagging by up to 0.9 sec
 - Winch motion out of phase with vessel motion
 - Significant error

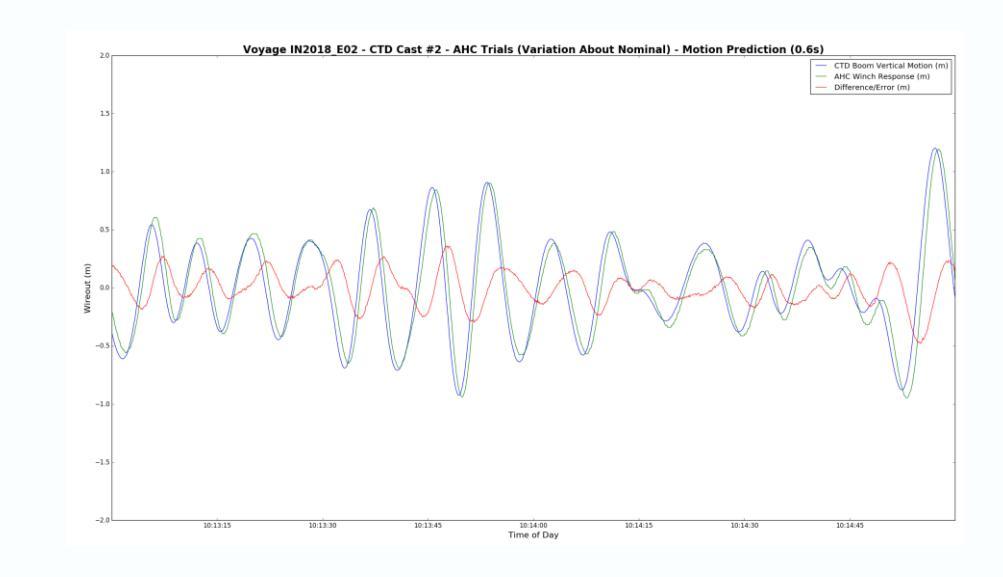
- Work around:
 - Incorporating a "predictor" calculation
 - Using the instantaneous values, height, speed and acceleration of the boom the Kalman filter "predicts" a best estimate of the dynamics of the CTD boom head
 - Predicting up to 0.6 sec -Most accurate
 - Winch trace closely matches the CTD boom head location
 - Residual CTD motion around nominal (0.2/3m)
 - Still consulting with manufacturer
